SKODA OCTAVIA COMBI: 1KT X820

Limited Technical Inspection

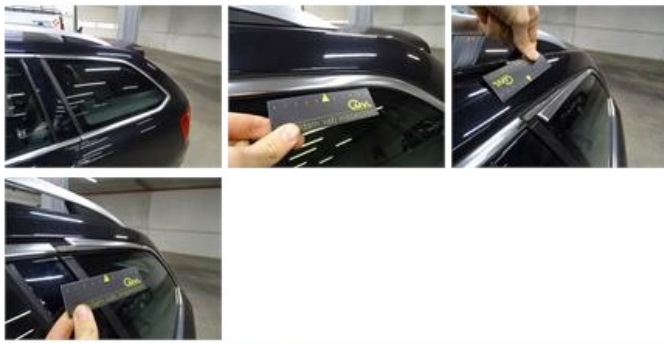
Total cost ex VAT	696,36
Wing trim R L, Deformed / Strained, E - Replace	84,00

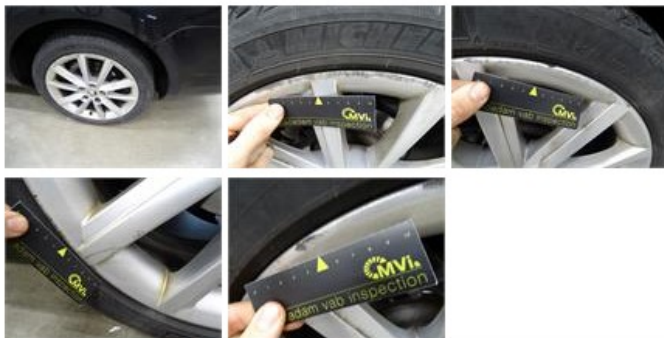
Door R R, Dent(s) and scratch(es), Acceptable	0,00
<i>No pictures to display</i>	
Rocker panel inner R L, Scratch(es), Acceptable	0,00
<i>No pictures to display</i>	
Alloy rim R L, Scratch(es), LI - Repair and paint (complete)	95,00

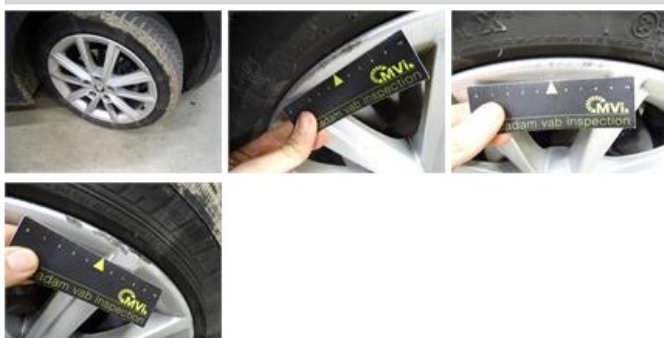
Alloy rim F R, Scratch(es), LI - Repair and paint (complete)	95,00
--	-------

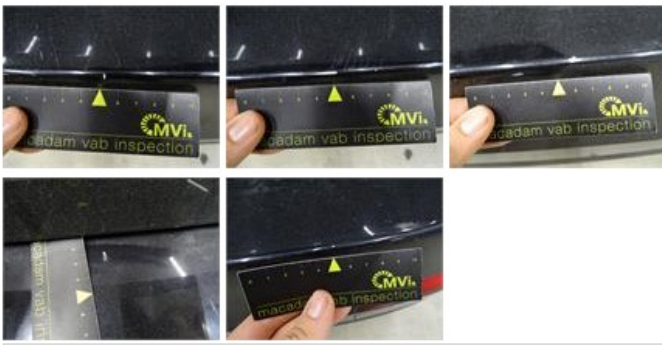
Wing R R, Scratch(es), Acceptable	0,00
<i>No pictures to display</i>	
Wing R L, Scratch(es), Acceptable	0,00
<i>No pictures to display</i>	
Door F L, Scratch(es), Acceptable	0,00
<i>No pictures to display</i>	
Bumper R, Scratch(es), LI - Repair and paint (complete)	211,80

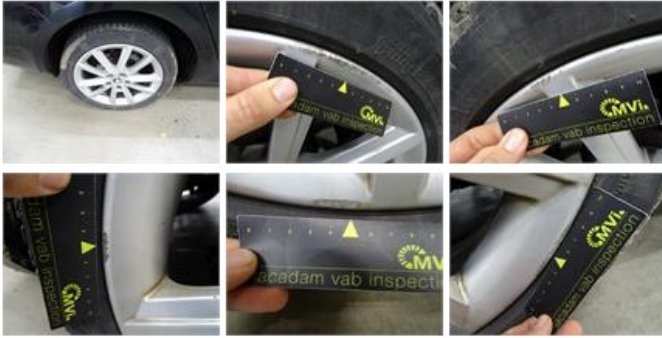
Alloy rim R R, Scratch(es), LI - Repair and paint (complete)
