**VOLVO V40: 1JVK320**

**Limited Technical Inspection**

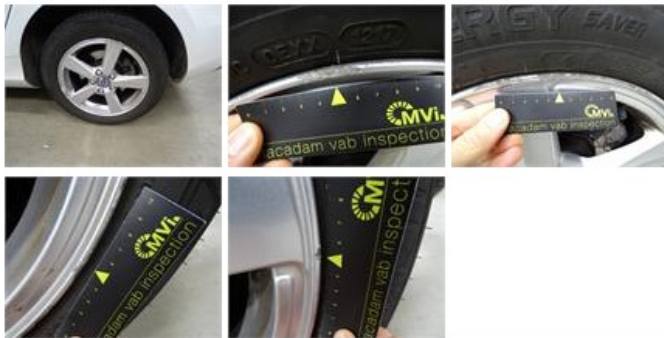
Alloy rim F R, Scratch(es), LI - Repair and paint (complete) 95,00

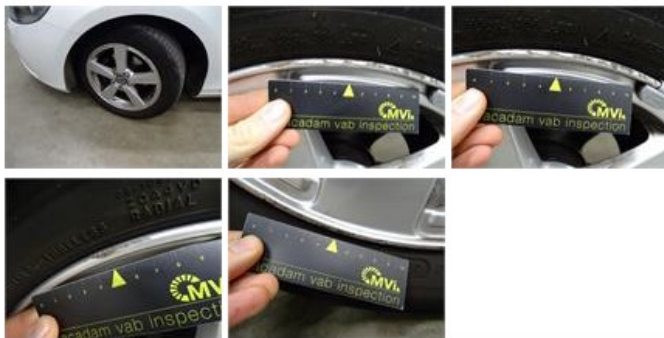
Alloy rim F L, Scratch(es), LI - Repair and paint (complete) 95,00

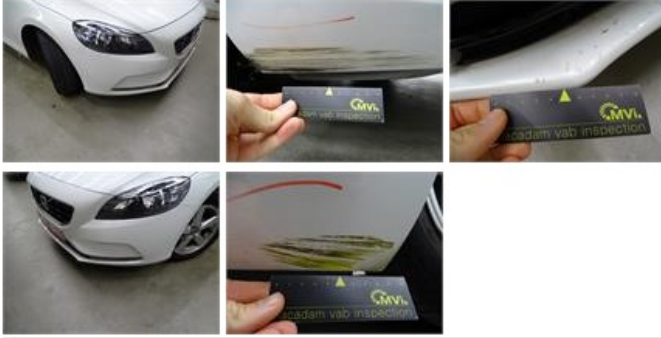
Bumper F, Scratch(es), LI - Repair and paint (complete)

211,80
