**VOLVO V40: 1HDP674**

**Limited Technical Inspection**

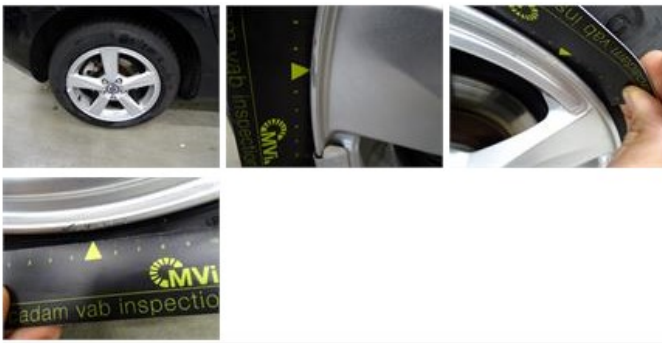
Total cost ex VAT	2226,84
Door F L, Scratch(es), Acceptable	0,00
<i>No pictures to display</i>	
Alloy rim R R, Scratch(es), LI - Repair and paint (complete)	95,00

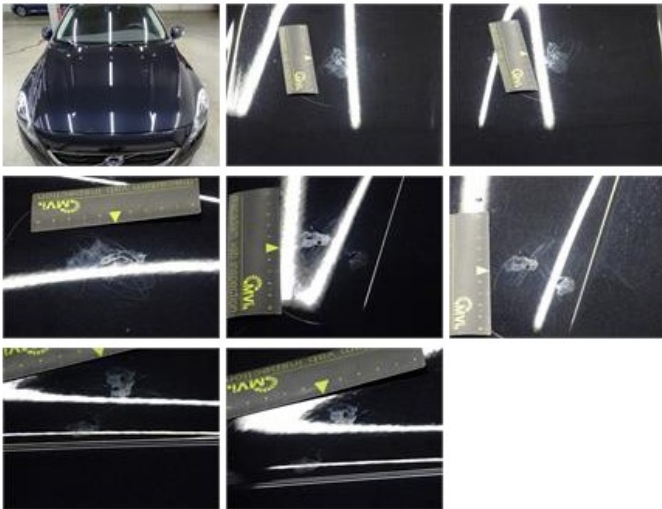
Bonnet, Chemical polution, LI - Repair and paint (complete)

290,08

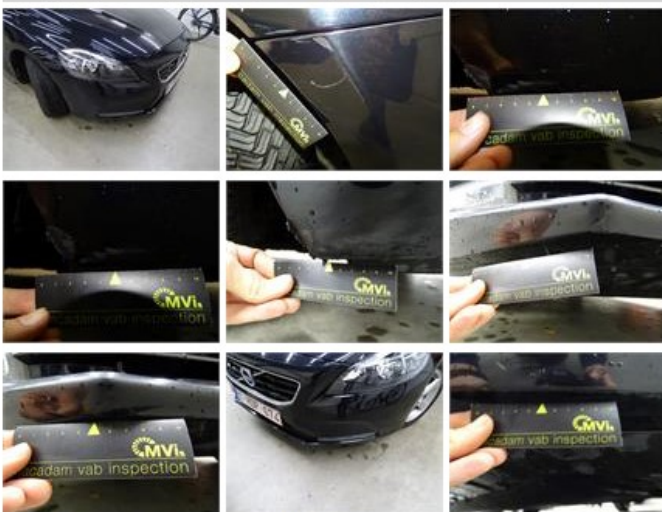
Bumper F, Scratch(es), LI - Repair and paint (complete)

211,80

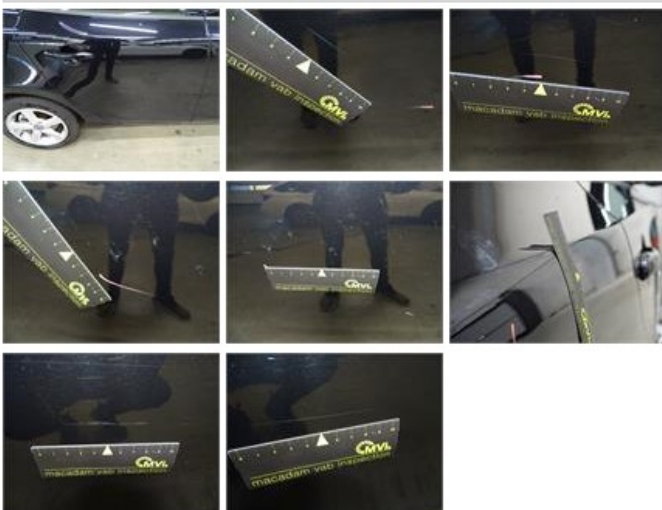
Door R R, Dent(s) and scratch(es), LI - Repair and paint (complete)

318,35

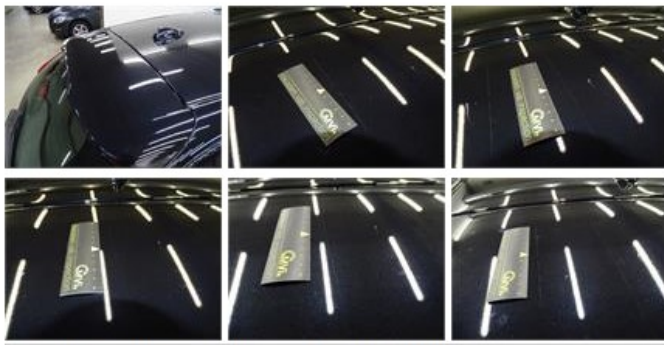
Rear spoiler, Scratch(es), LI - Repair and paint (complete)

115,56

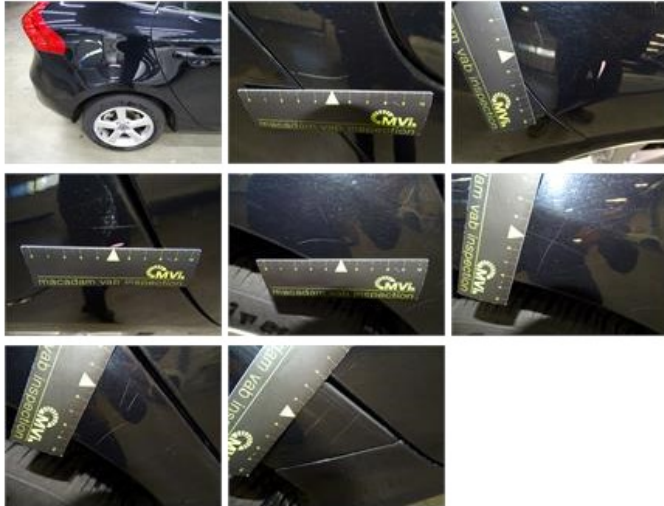
Wing R R, Scratch(es), LI - Repair and paint (complete)

308,20

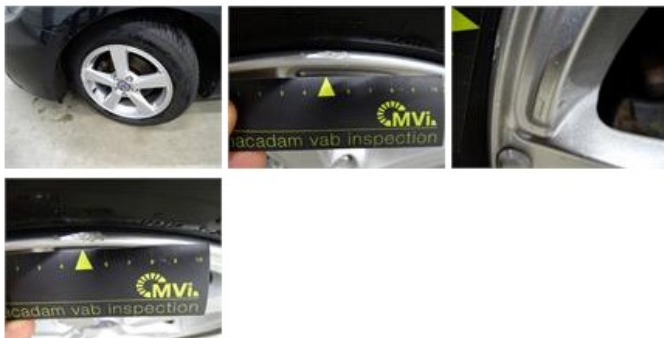
Alloy rim F L, Scratch(es), LI - Repair and paint (complete)

95,00

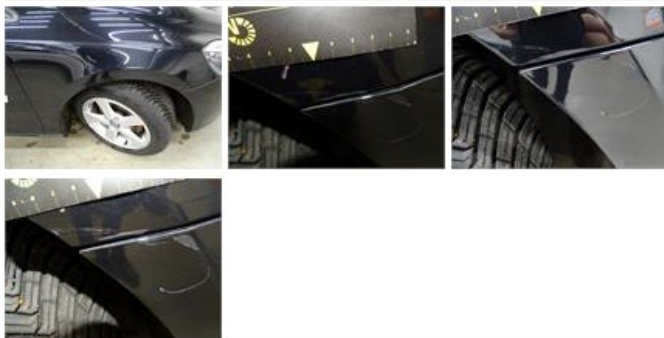
Wing F R, Scratch(es), LI - Repair and paint (complete)

220,18

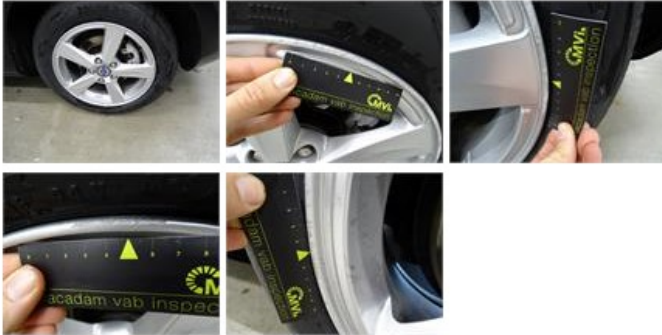
Alloy rim R L, Scratch(es), LI - Repair and paint (complete) 95,00
