**VOLVO V40: 1LFH143**

**Limited Technical Inspection**

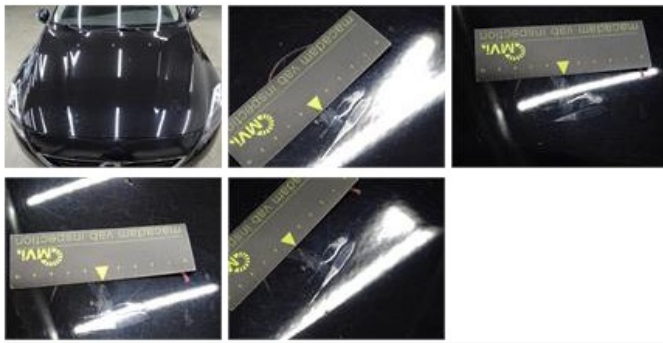
Total cost ex VAT	1466,63
Bonnet, Chemical polution, LI - Repair and paint (complete)	290,08

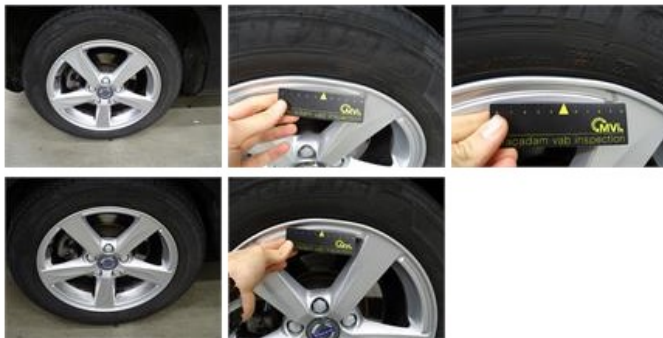
Alloy rim R R, Deformed / Strained, E - Replace 235,20

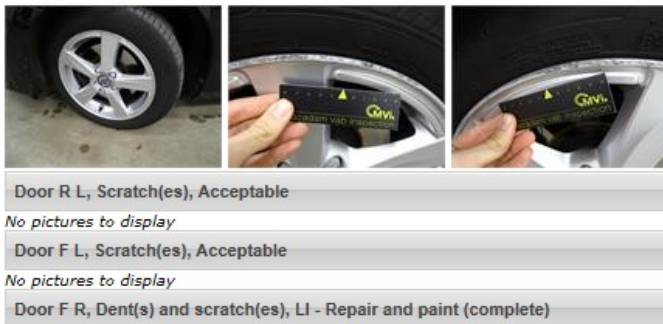
Alloy rim F L, Scratch(es), LI - Repair and paint (complete) 95,00

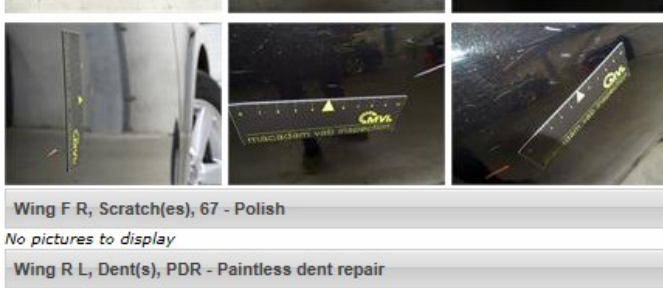
Door F R, Dent(s) and scratch(es), LI - Repair and paint (complete) 318,35

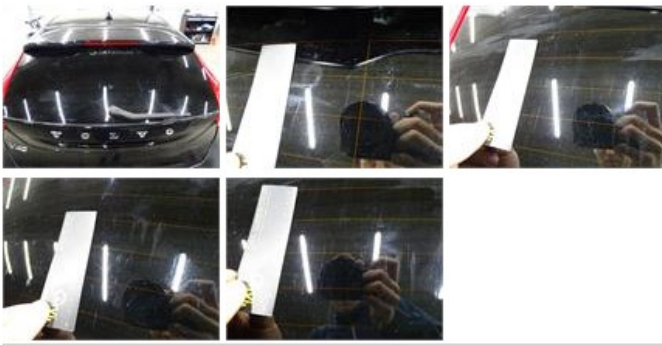
Rear window, Scratch(es), E - Replace 370,00

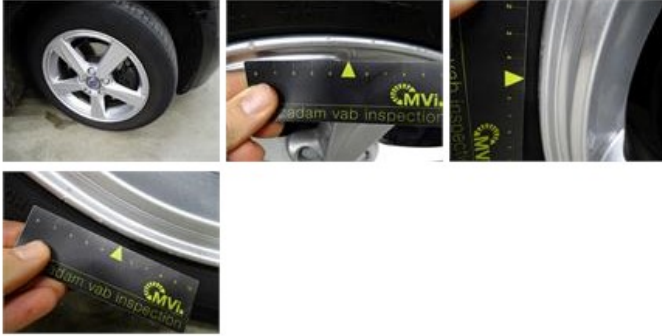
Alloy rim F R, Scratch(es), LI - Repair and paint (complete)
