SKODA Superb: 1GXB001

Limited Technical Inspection

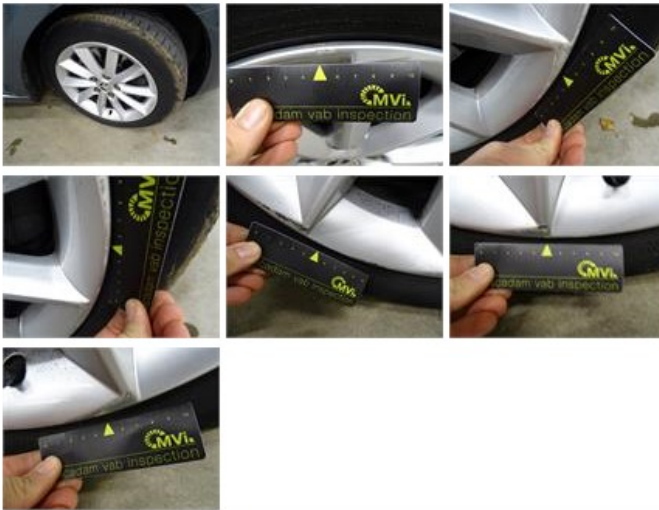
Alloy rim F R, Scratch(es), LI - Repair and paint (complete)

95,00

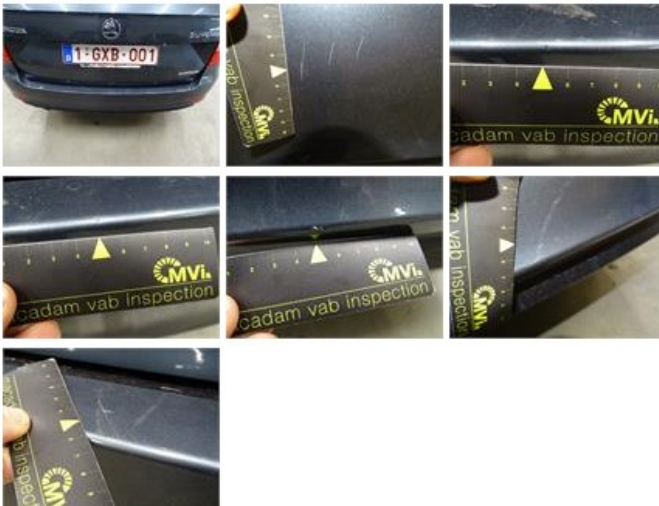
Bumper R, Scratch(es), LI - Repair and paint (complete)

254,16

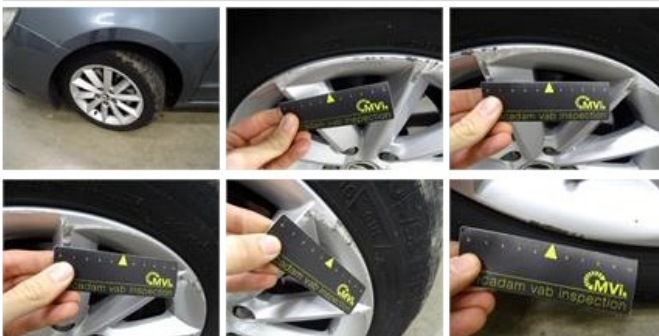
Alloy rim F L, Scratch(es), LI - Repair and paint (complete)

95,00

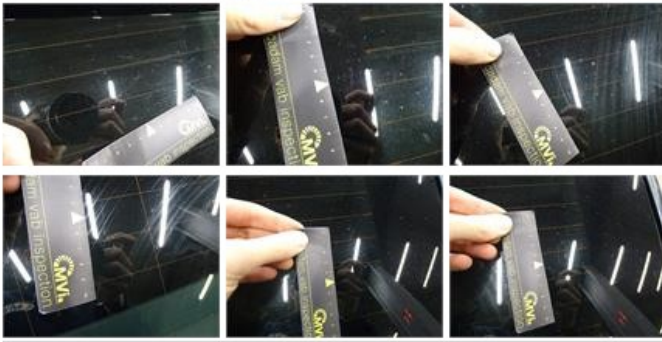
Rear window, Scratch(es), E - Replace

420,00

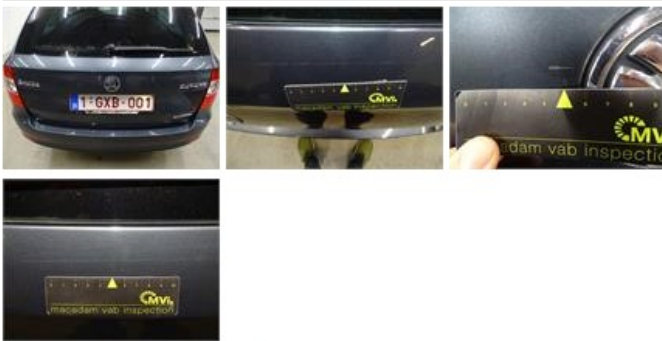
Tailgate, Scratch(es), LI - Repair and paint (complete) 362,02

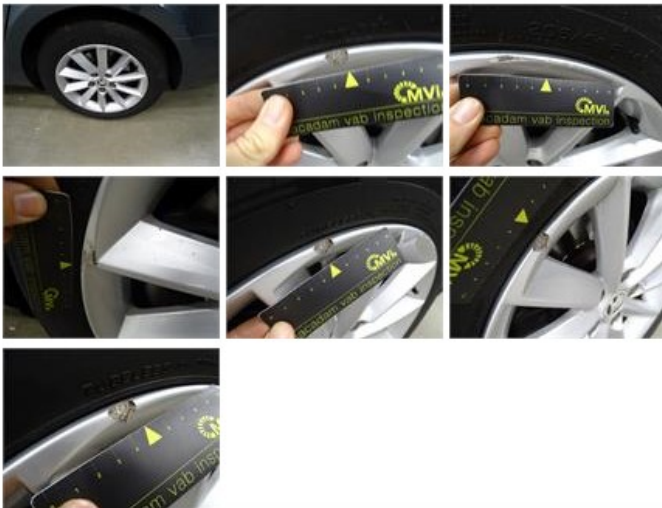
Alloy rim R L, Scratch(es), LI - Repair and paint (complete) 95,00

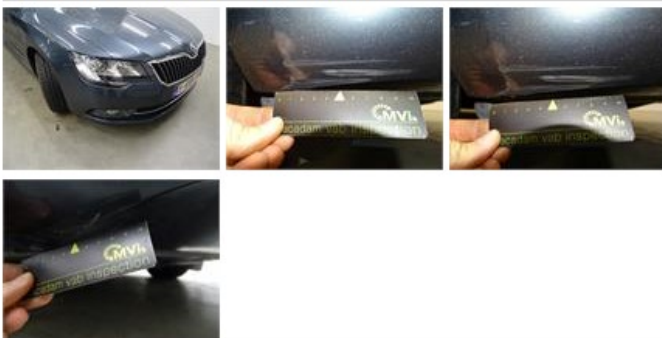
Bumper F, Scratch(es), LI - Repair and paint (complete) 254,16

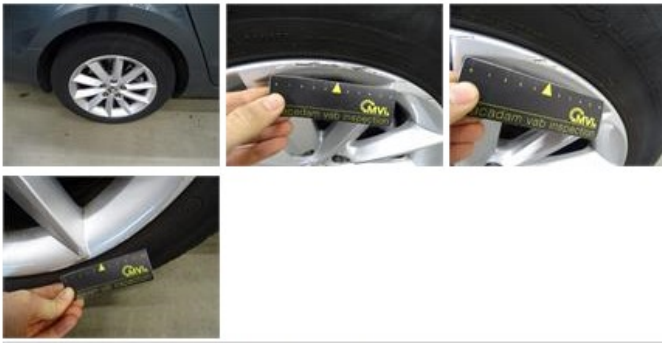
Alloy rim R R, Scratch(es), LI - Repair and paint (complete) 95,00
