**VOLVO V60: 1JUH182**

**Limited Technical Inspection**

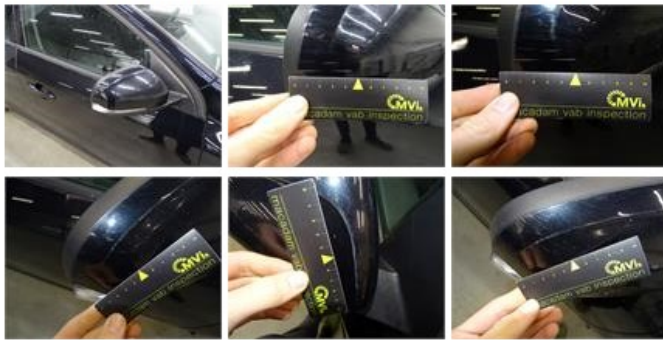
Rearview mirror housing R, Scratch(es), LI - Repair and paint (complete)

115,56

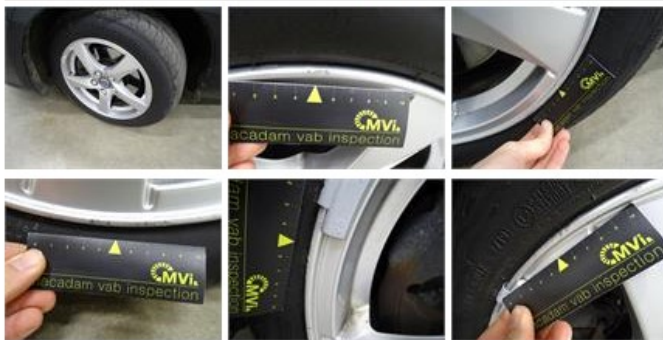
Alloy rim F L, Scratch(es), LI - Repair and paint (complete)

95,00

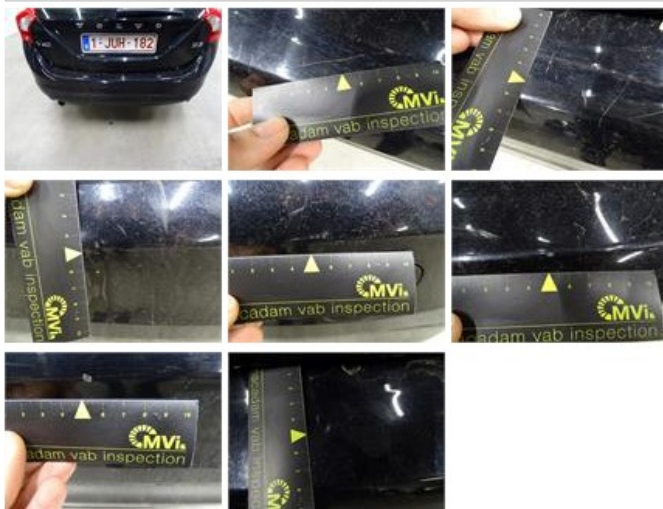
Bumper R, Scratch(es), LI - Repair and paint (complete)

211,80

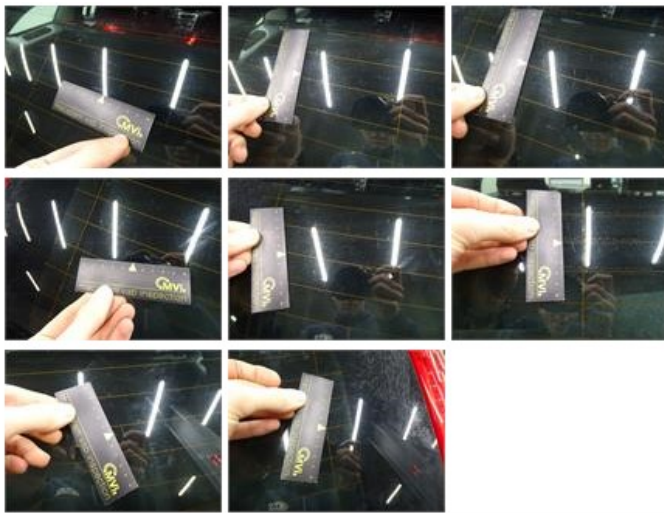
Rear window, Scratch(es), E - Replace

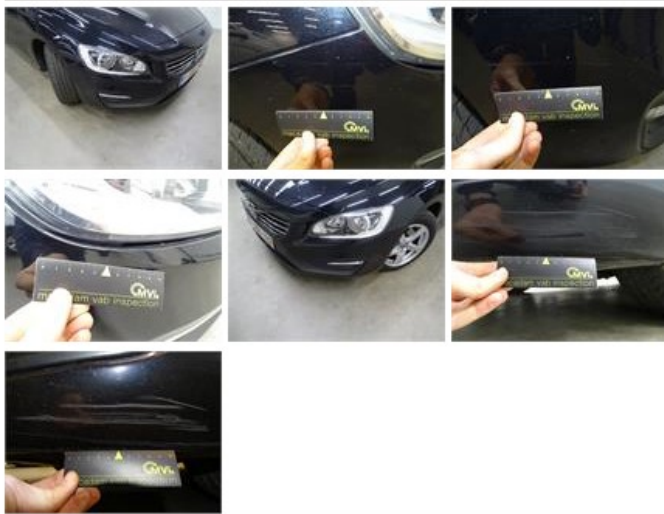
Bumper F, Scratch(es), LI - Repair and paint (complete) 211,80

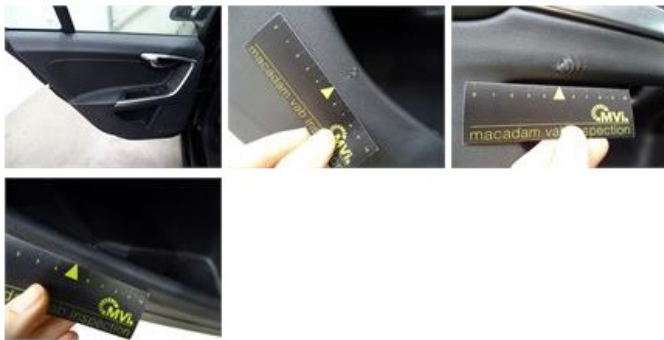
Door panel R L, Tear, Smart repair 110,64
