AUDI A4 AVANT: 1KSU978

Limited Technical Inspection

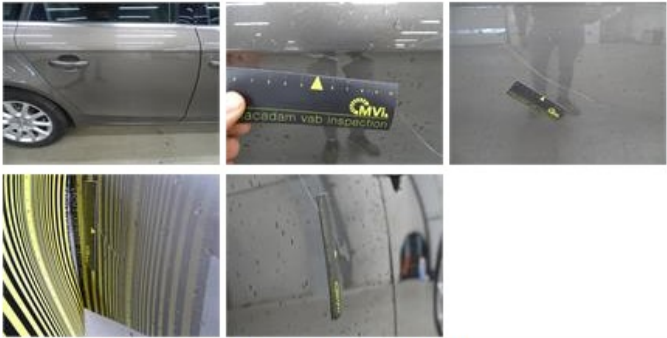
<i>No pictures to display</i>		
Door F L, Scratch(es), Acceptable		0,00
<i>No pictures to display</i>		
Wing R R, Scratch(es), Acceptable		0,00
<i>No pictures to display</i>		
Door F R, Scratch(es), Acceptable		0,00
<i>No pictures to display</i>		
Bumper R, Scratch(es), Acceptable		0,00
<i>No pictures to display</i>		
Bumper F, Scratch(es), Acceptable		0,00
<i>No pictures to display</i>		
Roof, Scratch(es), Acceptable		0,00
<i>No pictures to display</i>		
Door R R, Dent(s) and scratch(es), LI - Repair and paint (complete)		318,35
