MERCEDES A: 1PRT738

Limited Technical Inspection

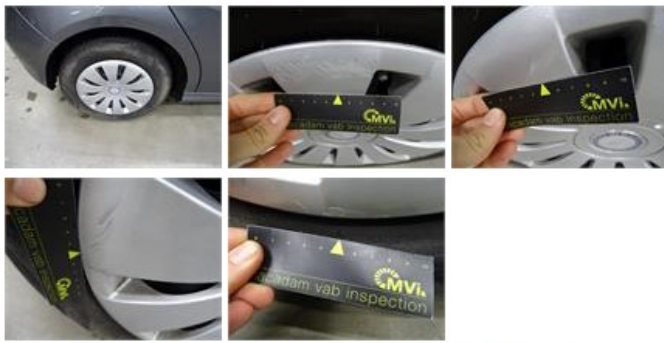
Total cost ex VAT	1379,85
Wheel cover R R, Scratch(es), E - Replace	30,00

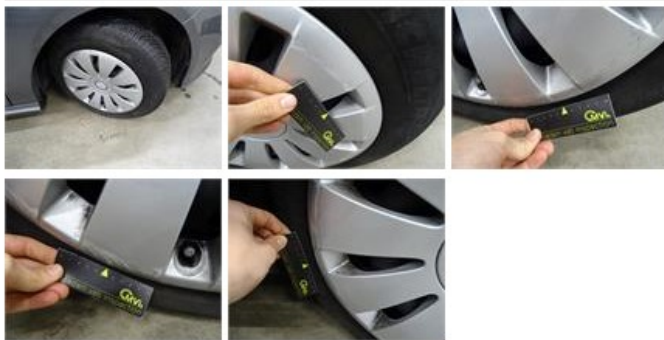
Wheel cover F R, Scratch(es), E - Replace 30,00

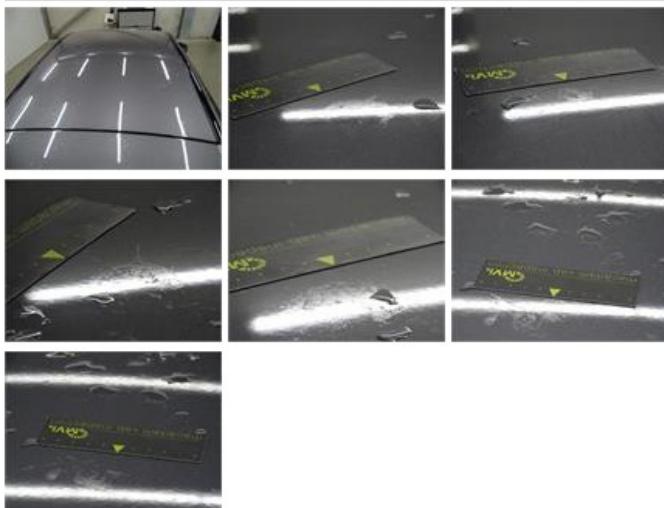
Roof, Chemical pollution, LI - Repair and paint (complete) 481,50
