BMW X5: PQ5532			
Vinnumber:	WBAKS610700N61880	Versionname:	3.0 XDRIVE40D 4WD AUTO
First Registrationdate:	10/02/2016	Fiscalpower:	
Expertise Mileage:	132875	Power Kw:	230
Bodytype:		Body color:	Silver
Gearbox:	Automatic	Paint type:	Metalic
Transmission:	4 Weel	Rims summer:	Aluminium
Fueltype:	Diesel	Oil level:	OK
Battery functioning:	Yes	Parking lot:	2314
Number of doors:	5		
Number of seats:	5		
Number head rests:	5		
Rims summer:	Aluminium		
Category:	Passenger Car		
Oil level:	OK

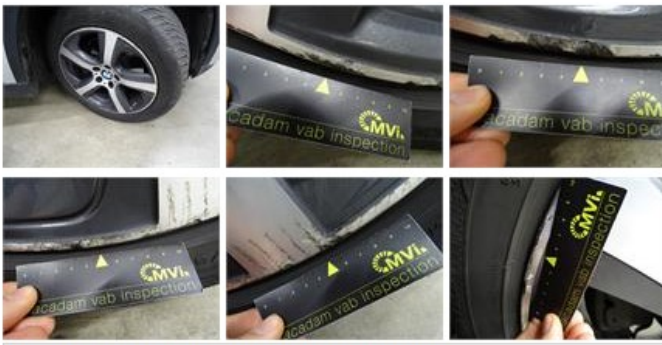
Total cost ex VAT	4179,73
Alloy rim F R polished, Scratch(es), LI - Repair and paint (complete)	95,00

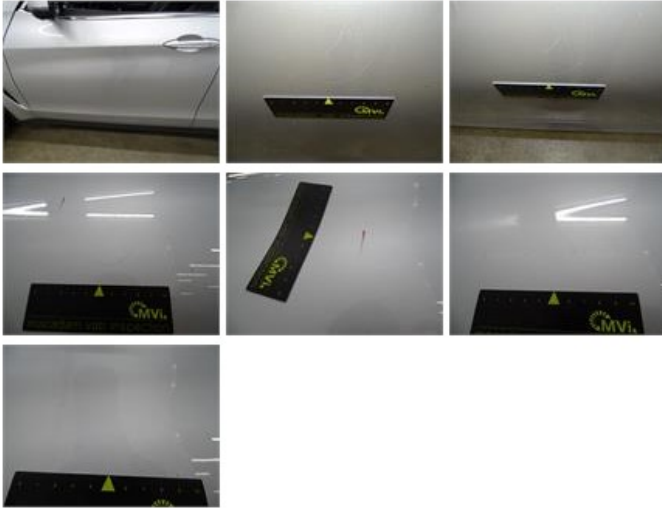
Door F L, Scratch(es), LI - Repair and paint (complete) 382,02

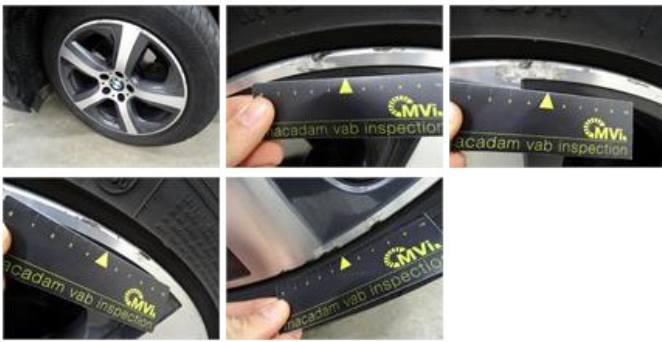
Alloy rim F L polished, Scratch(es), LI - Repair and paint (complete) 95,00

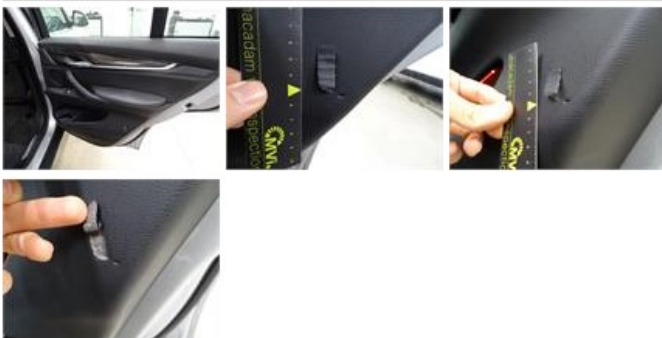
Door panel R R, Tear, E - Replace 132,00

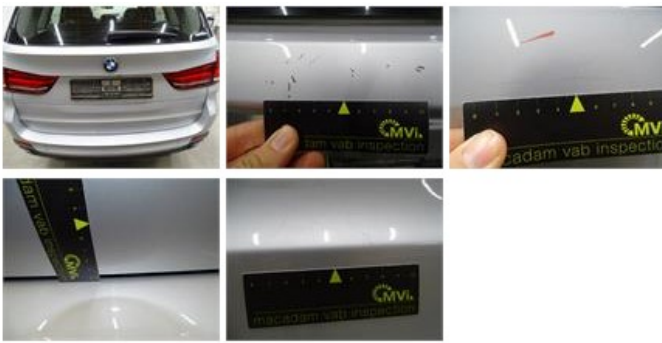
Tailgate, Scratch(es), LI - Repair and paint (complete) 362,02

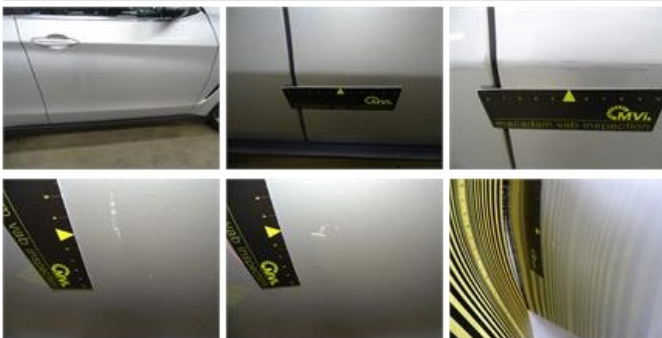
Door F R, Dent(s) and scratch(es), LI - Repair and paint (complete) 382,02

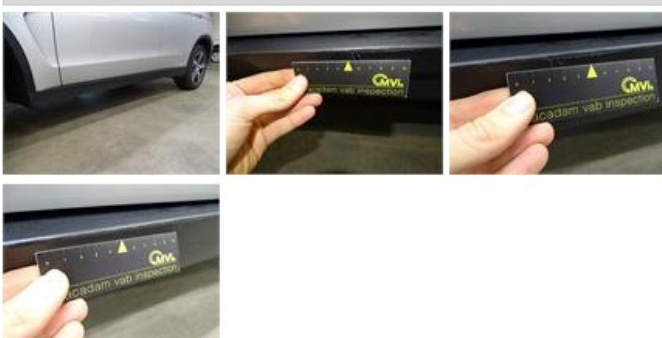
Sill outer L, Scratch(es), It - Spot repair 115,56

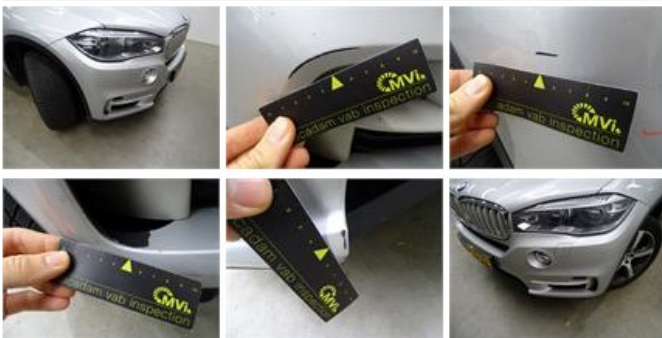
Bumper F, Scratch(es), LI - Repair and paint (complete) 254,16

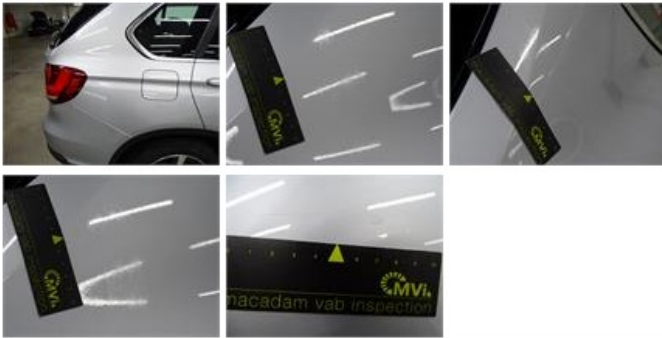
Wing R R, Chemical polution, LI - Repair and paint (complete) 369,84

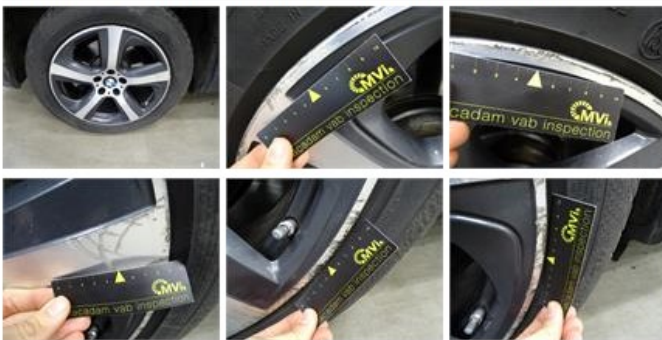
Alloy rim R R polished, Scratch(es), LI - Repair and paint (complete) 95,00

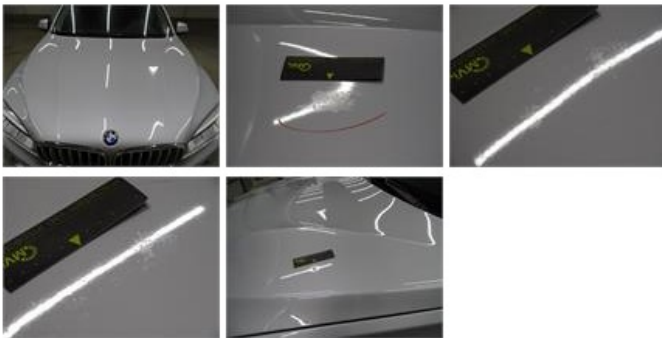
Bonnet, Chemical polution, LI - Repair and paint (complete) 348,09

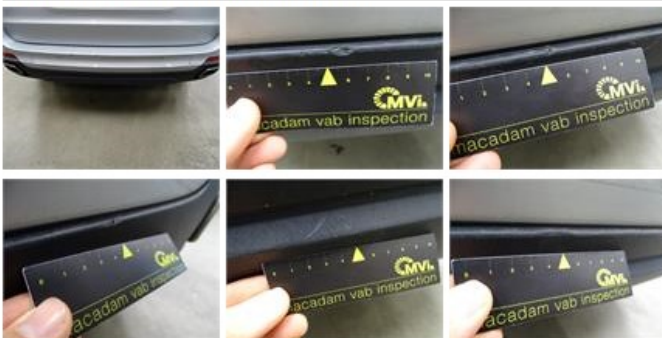
Bumper cover R M, Scratch(es), Smart repair 110,64

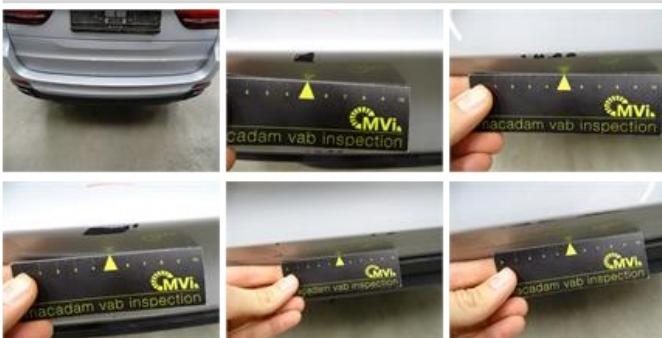
Bumper R, Scratch(es), LI - Repair and paint (complete) 254,16

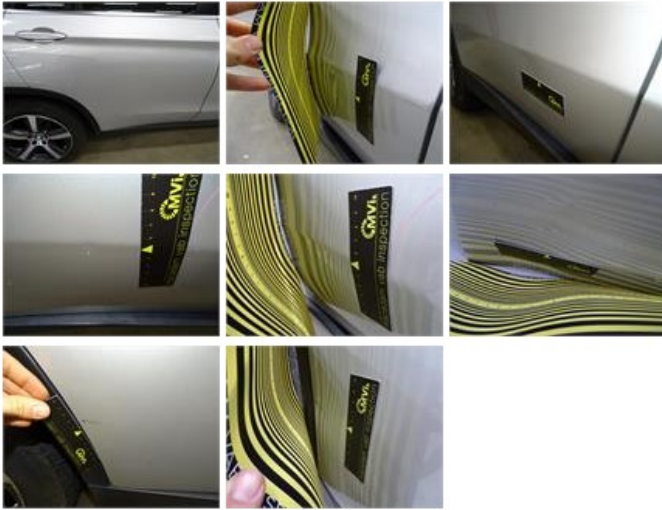
Door R R, Dent(s) and scratch(es), LI - Repair and paint (complete)

430,02

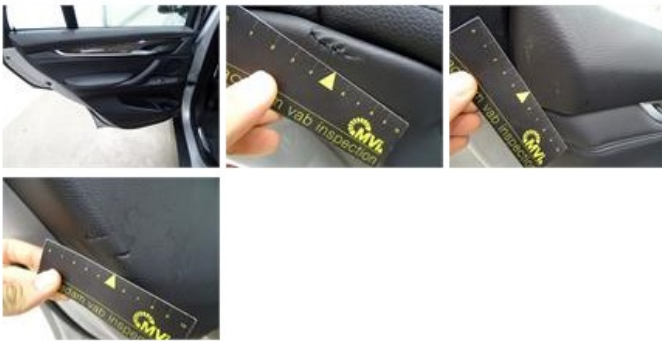
Door panel R L, Tear, E - Replace

132,00

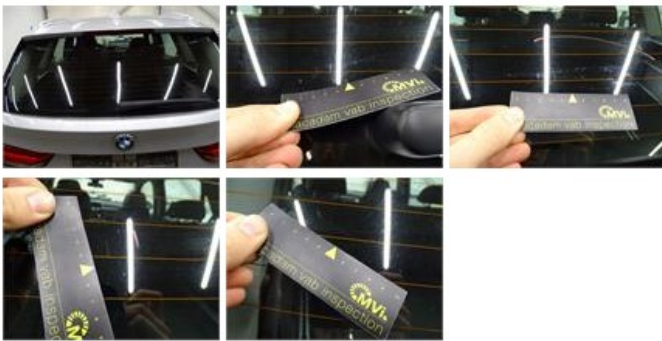
Rear window, Scratch(es), E - Replace

420,00
