AUDI A6: 1HYU794

Limited Technical Inspection

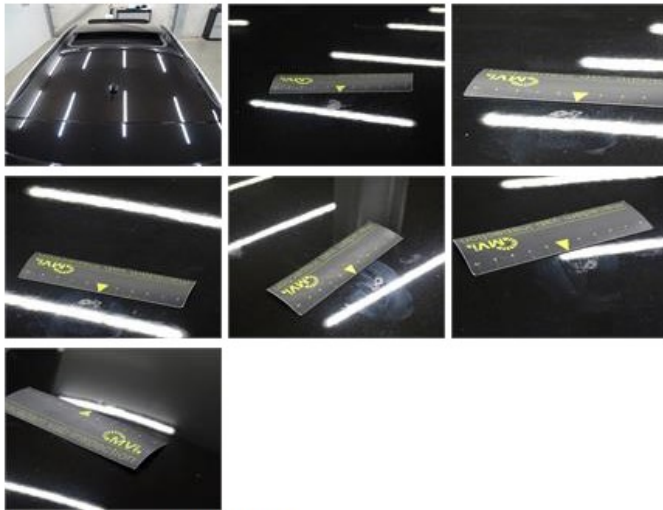
Roof, Chemical pollution, LI - Repair and paint (complete) 577,80

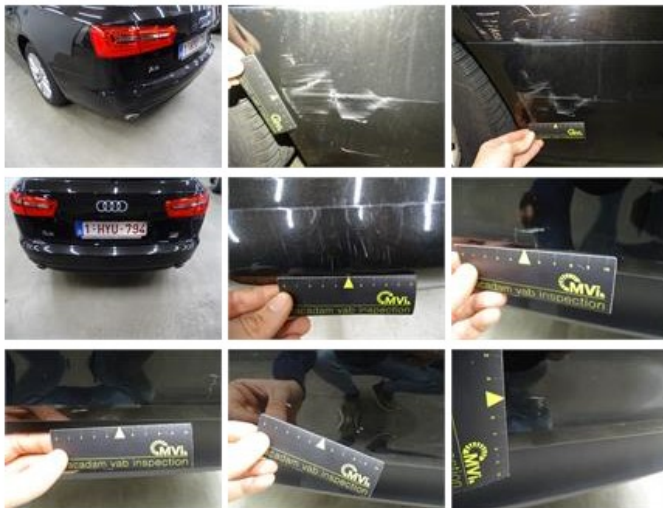
Bumper R, Scratch(es), LI - Repair and paint (complete) 254,16

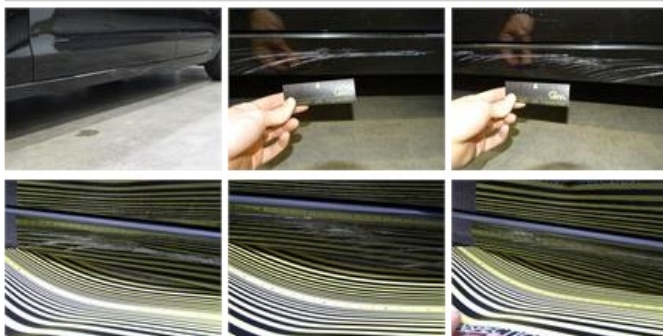
Sill outer L, Dent(s) and scratch(es), LI - Repair and paint (complete) 372,60

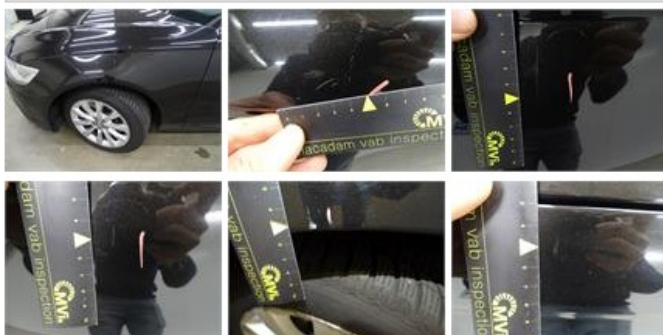
Wing F L, Scratch(es), LI - Repair and paint (complete) 264,21

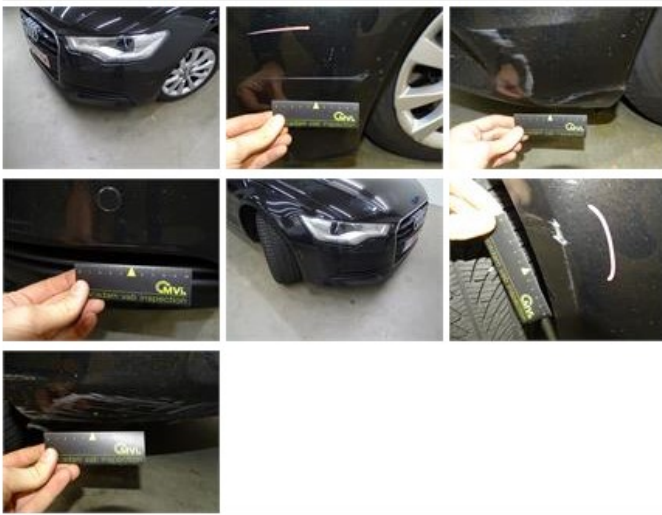
Bumper F, Scratch(es), LI - Repair and paint (complete) 254,16

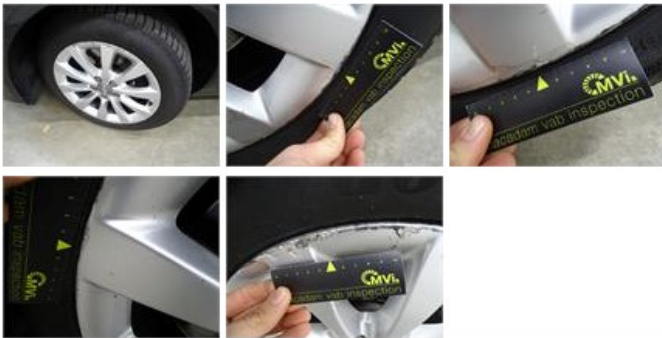
Alloy rim F L, Scratch(es), LI - Repair and paint (complete) 95,00

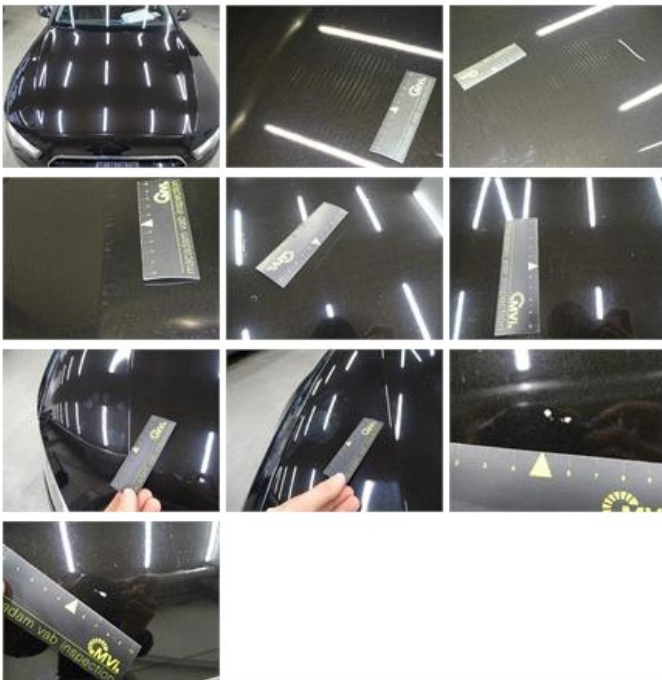
Bonnet, Scratch(es), LI - Repair and paint (complete) 348,09

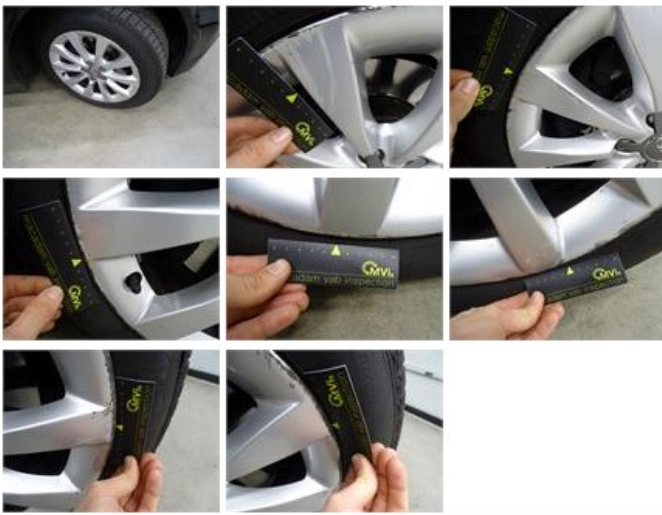
Alloy rim F R, Scratch(es), LI - Repair and paint (complete) 95,00

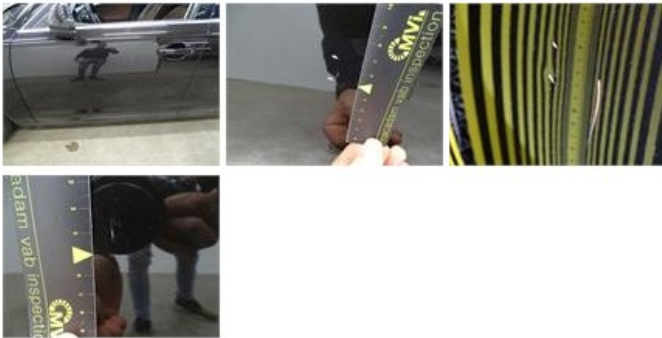
Door F L, Dent(s) and scratch(es), LI - Repair and paint (complete)

382,02
