**BMW 2 ACTIVE TOURER: 1KHS005**

**Limited Technical Inspection**

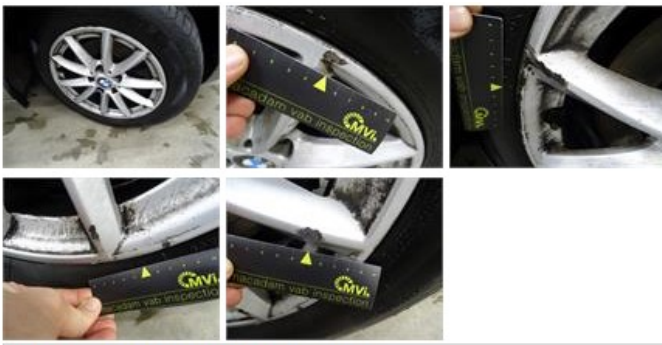
<b>Total cost ex VAT</b>	<b>675,15</b>
<b>Alloy rim F R, Scratch(es), LI - Repair and paint (complete)</b>	<b>95,00</b>

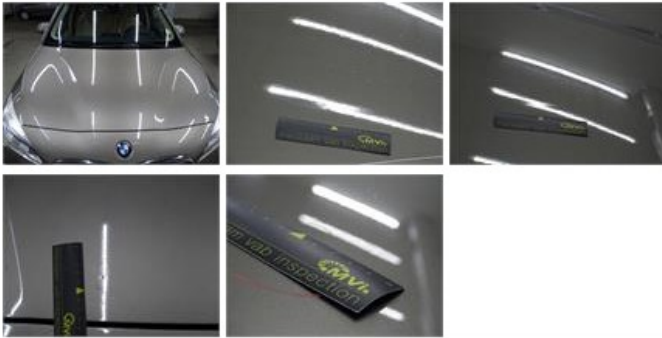
Bonnet, Bad repair, Acceptable 0,00

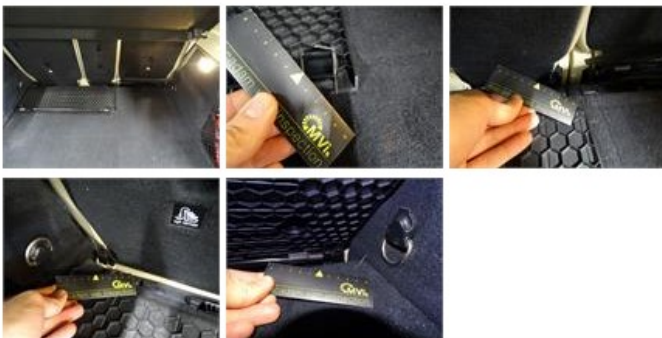
Boot cover, Broken, E - Replace 50,00
