**VOLKSWAGEN Crafter 35 LWB HR: 1BVW065**

**Limited Technical Inspection**

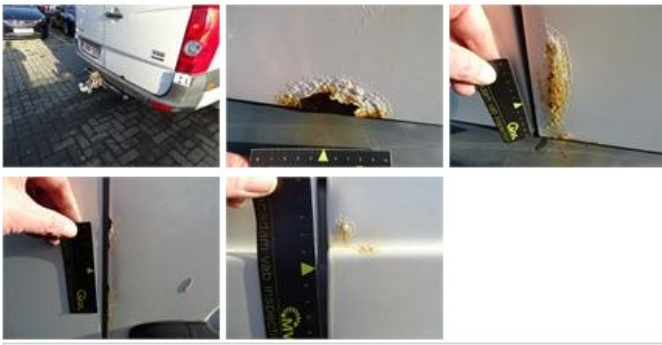
Wing(s), Rust, LI - Repair and paint (complete)

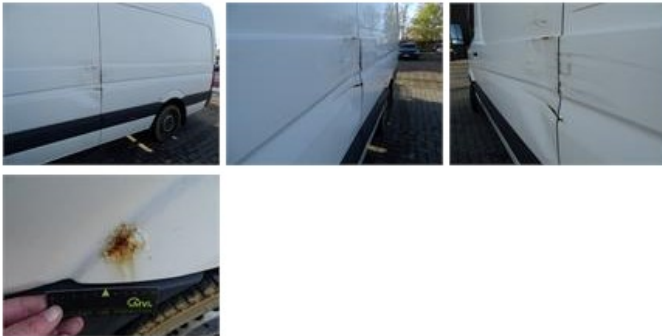
Wing R L, Dent(s) and scratch(es), LI - Repair and paint (complete)
