VOLVO V60: 1HSV784

Limited Technical Inspection

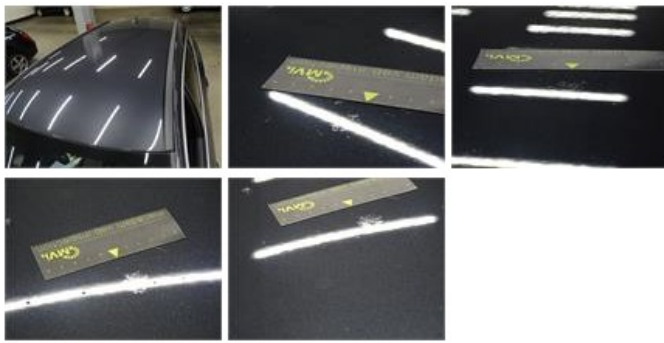
Total cost ex VAT	2984,64
Roof, Chemical polution, LI - Repair and paint (complete)	481,50

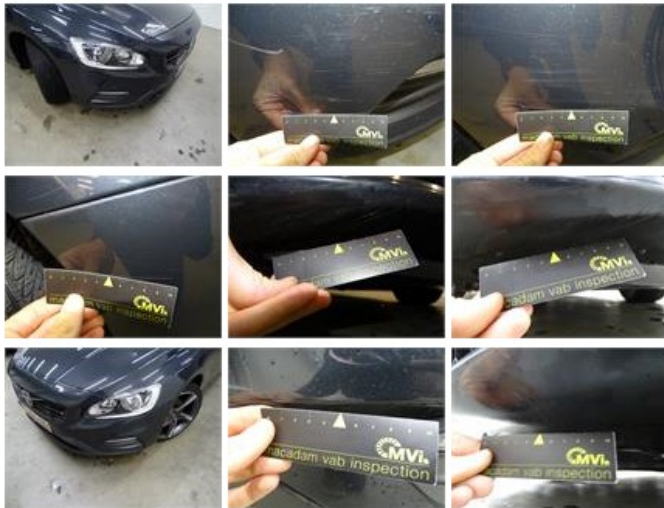
Bumper F, Scratch(es), LI - Repair and paint (complete) 211,80

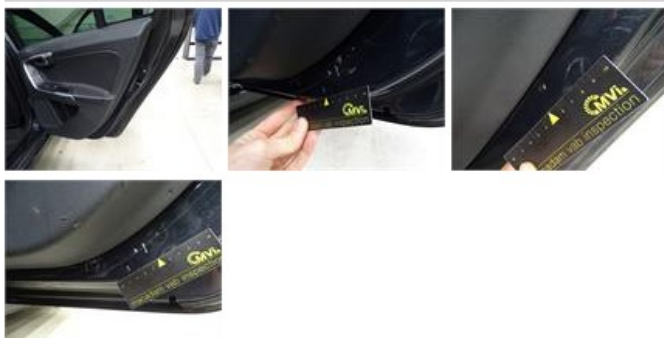
Door frame R R, Dent(s), It - Spot repair 115,56

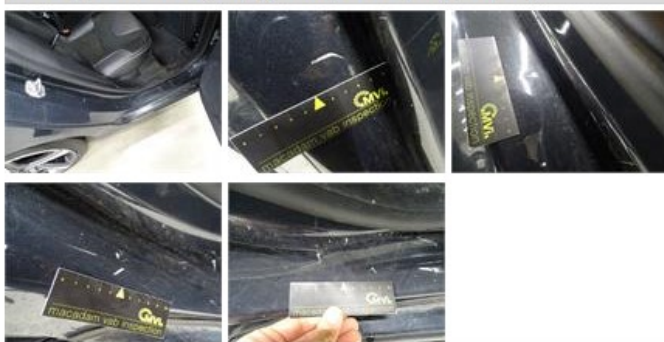
Rocker panel inner R R, Dent(s), LI - Repair and paint (complete) 115,56

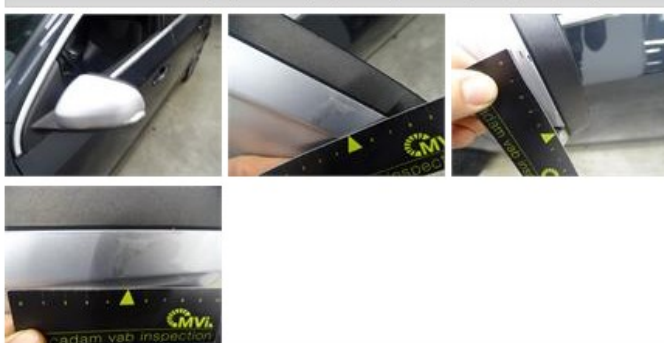
Rearview mirror housing L, Scratch(es), LI - Repair and paint (complete) 115,56

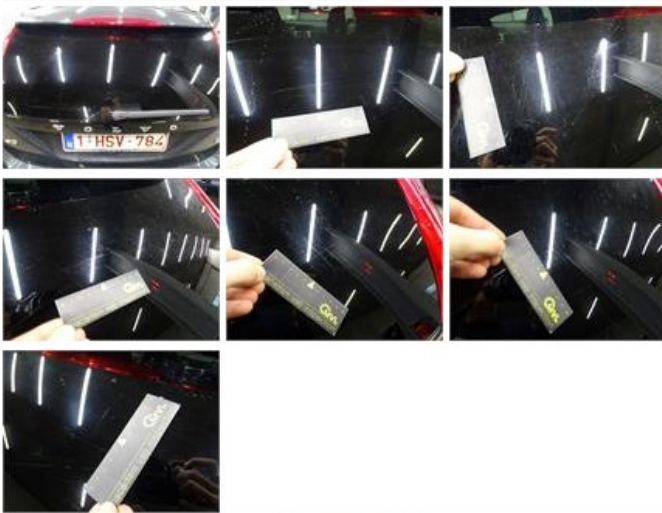
Rear window, Scratch(es), F - Replace 0,00

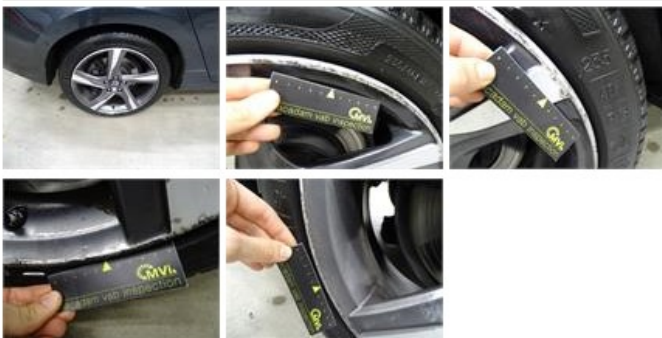
Alloy rim R R polished, Scratch(es), LI - Repair and paint (complete) 95,00

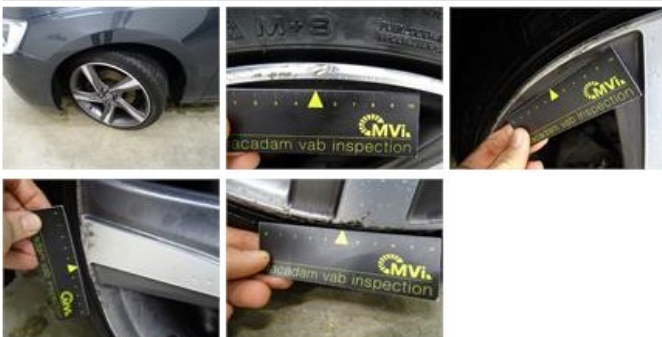
Alloy rim F L polished, Scratch(es), LI - Repair and paint (complete) 95,00

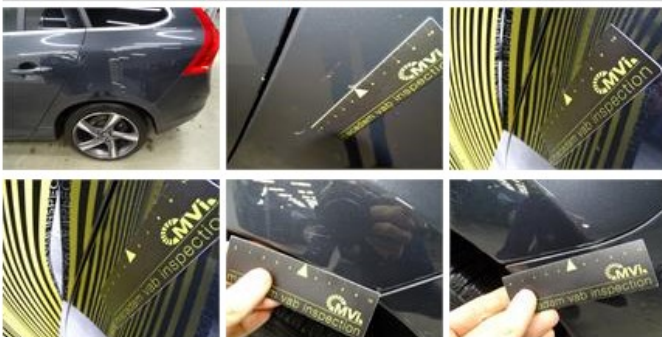
Wing R L, Dent(s) and scratch(es), LI - Repair and paint (complete) 308,20

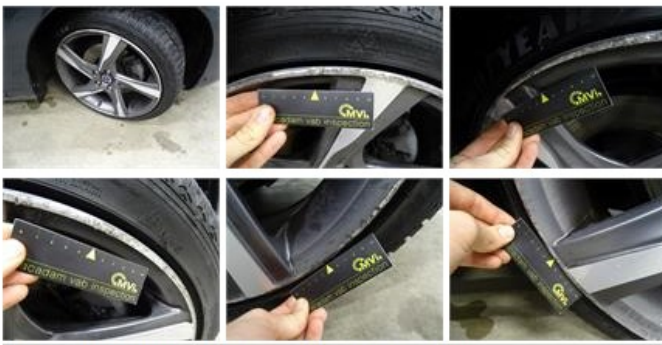
Alloy rim F R polished, Scratch(es), LI - Repair and paint (complete) 95,00

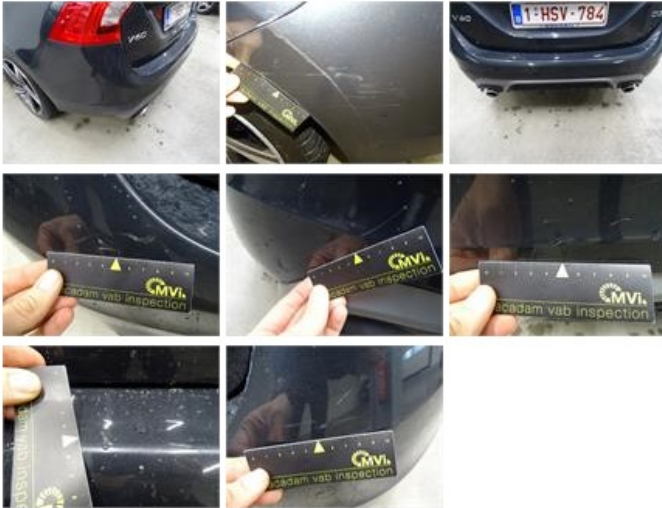
Bumper R, Scratch(es), LI - Repair and paint (complete) 211,80

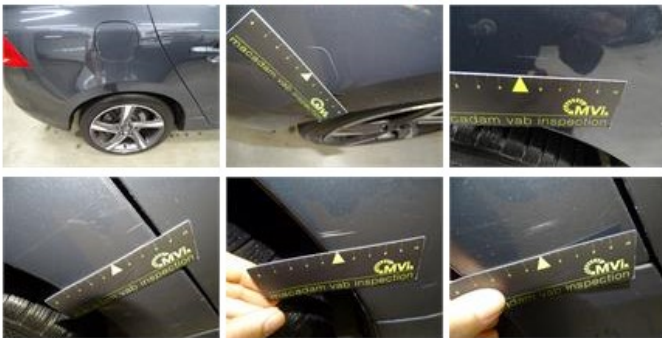
Wing R R, Scratch(es), LI - Repair and paint (complete) 308,20

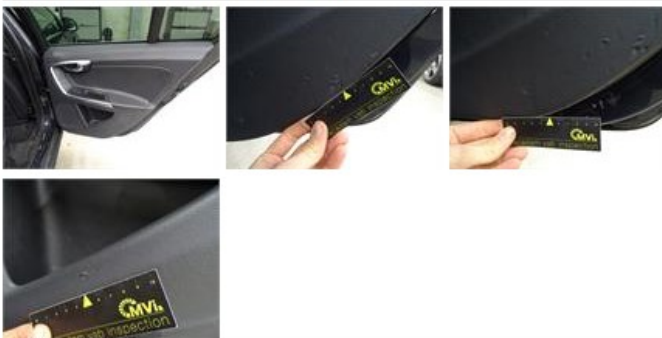
Door panel R R, Scratch(es), Smart repair 110,64

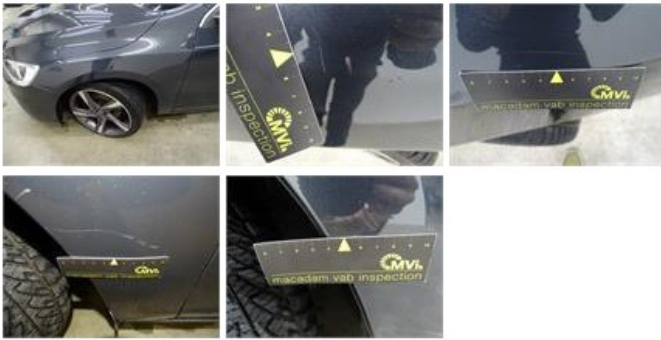
Wing F L, Scratch(es), LI - Repair and paint (complete)

220,18

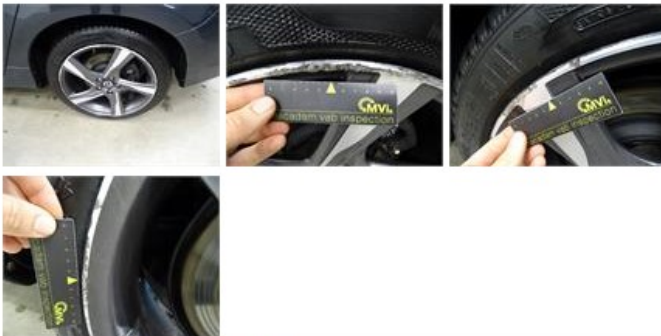
Alloy rim R L polished, Scratch(es), LI - Repair and paint (complete)

95,00

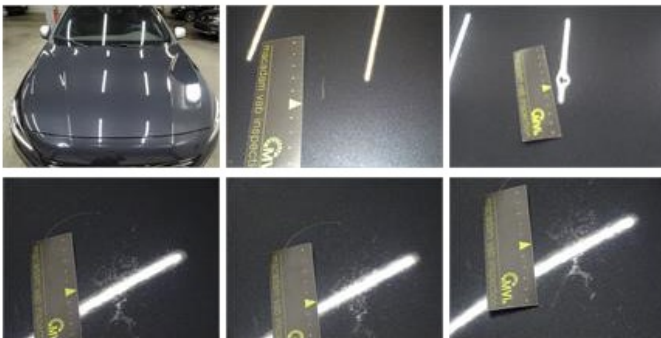
Bonnet, Dent(s) and scratch(es), LI - Repair and paint (complete)

290,08
