VOLKSWAGEN GOLF VII: 1JAC750

Vinnumber:	WVWZZZAUZFW036243	Versionname:	1.6 TDI 77KW BMT TRENDLINE
First Registrationdate:	13/11/2014	Fiscalpower:	
Expertise Mileage:	118487	Power Kw:	77
Bodytype:		Body color:	Grey
Gearbox:	MAN 5 VIT	Paint type:	Metalic
Transmission:	Front	Rims summer:	Steel
Fueltype:	Diesel	Oil level:	OK
Battery functioning:	Yes	Parking lot:	3122
Number of doors:	5		
Number of seats:	5		
Number head rests:	5		
Rims summer:	Steel		
Category:	Passenger Car		
Oil level:	OK		
Registration Certificate Car (BE):	Yes

Limited Technical Inspection

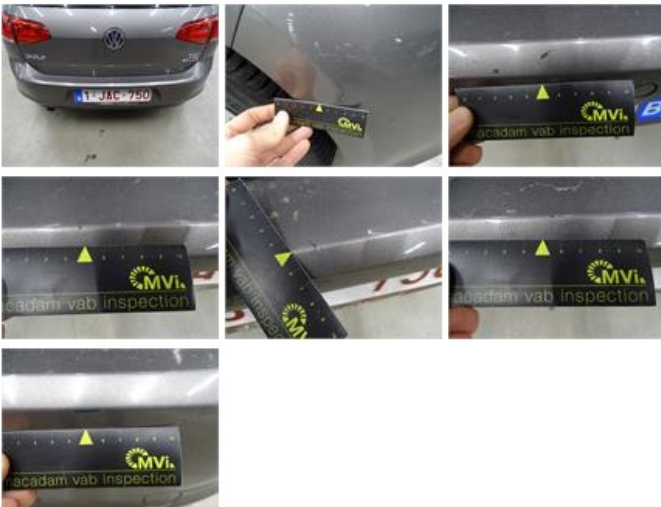
Wing R L, Dent(s) and scratch(es), LI - Repair and paint (complete)

308,20
