**OPEL Zafira: 1HPG996**

**Limited Technical Inspection**

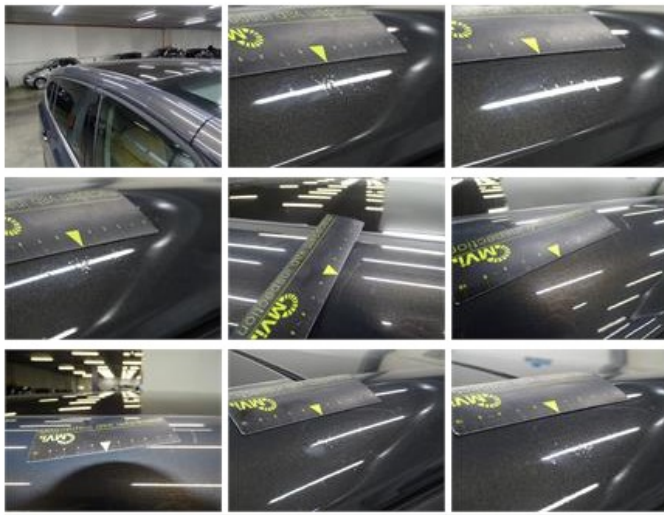
<b>Total cost ex VAT</b>	<b>2649,86</b>
<b>Roof pillar R, Chemical polution, LI - Repair and paint (complete)</b>	<b>220,18</b>

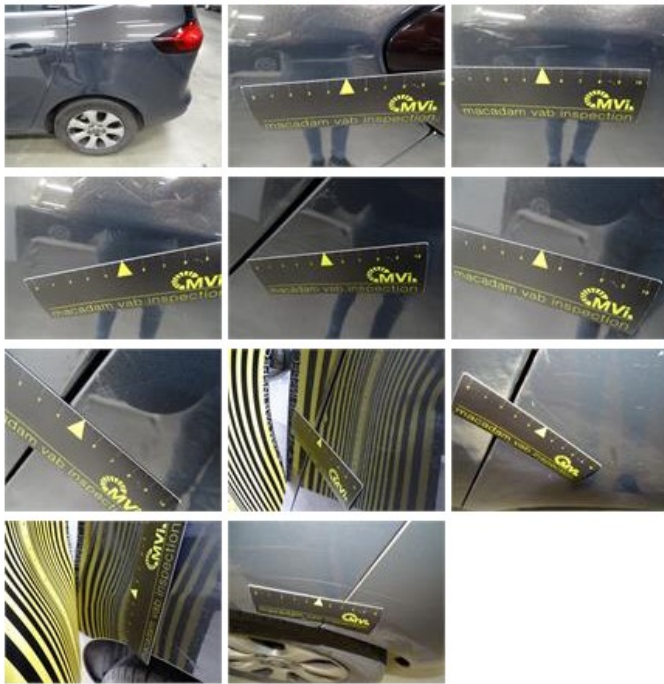
Wing R L, Dent(s) and scratch(es), LI - Repair and paint (complete)

308,20

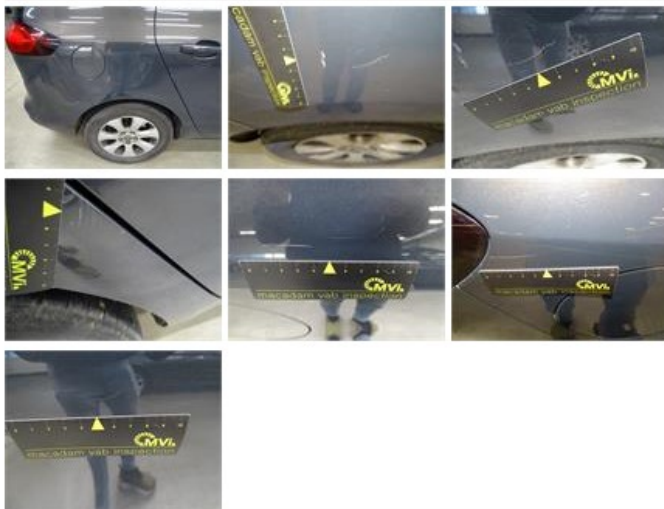
Wing R R, Scratch(es), LI - Repair and paint (complete)

308,20

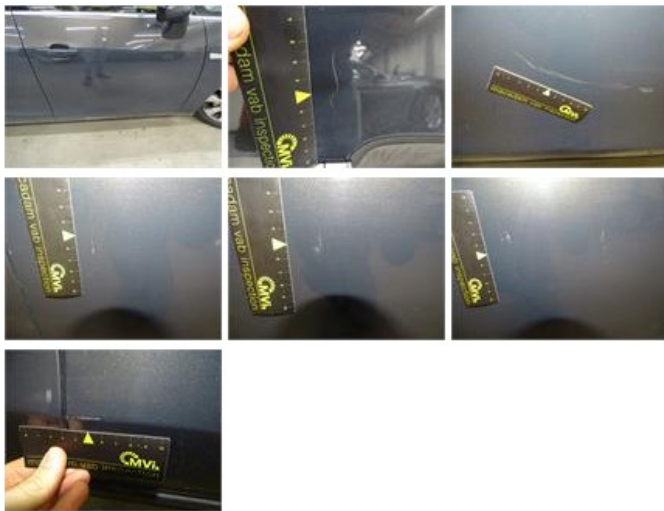
Door F R, Scratch(es), LI - Repair and paint (complete)

318,35

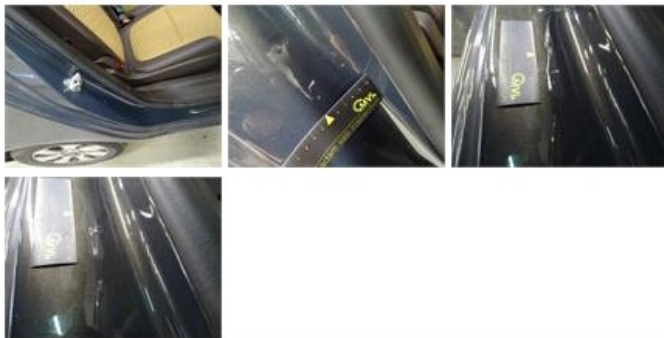
Rocker panel inner R R, Dent(s), LI - Repair and paint (complete)

115,56

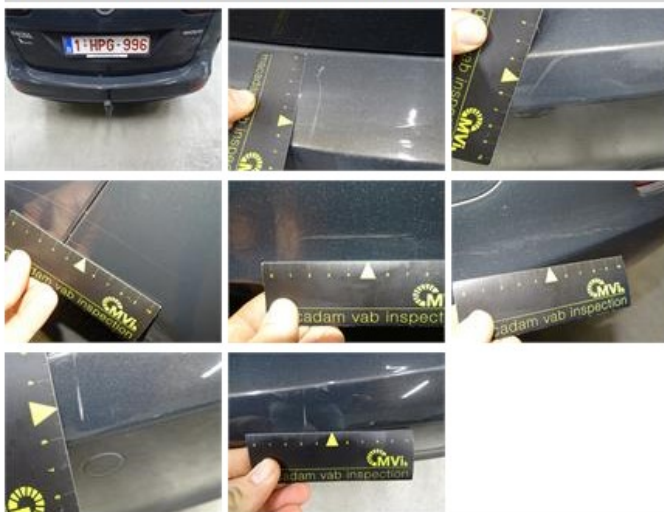
Bumper R, Scratch(es), LI - Repair and paint (complete)

211,80

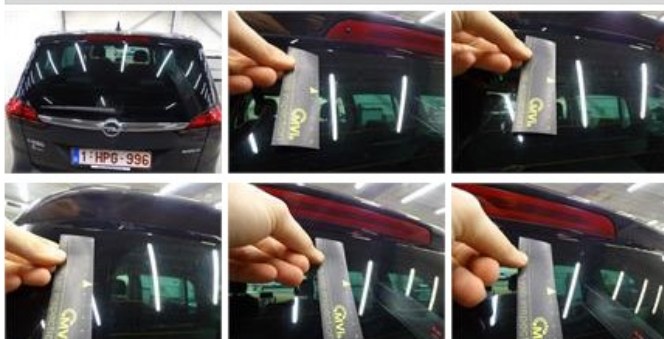
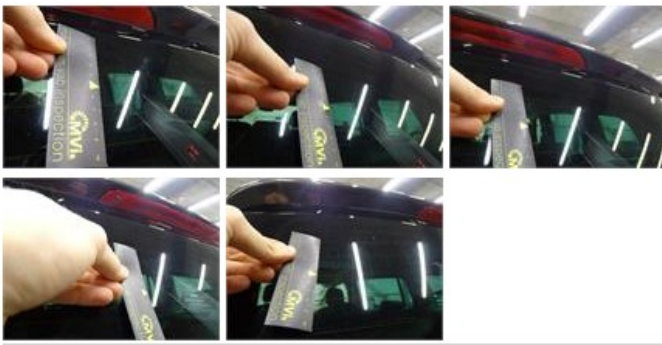
Rear window, Scratch(es), E - Replace

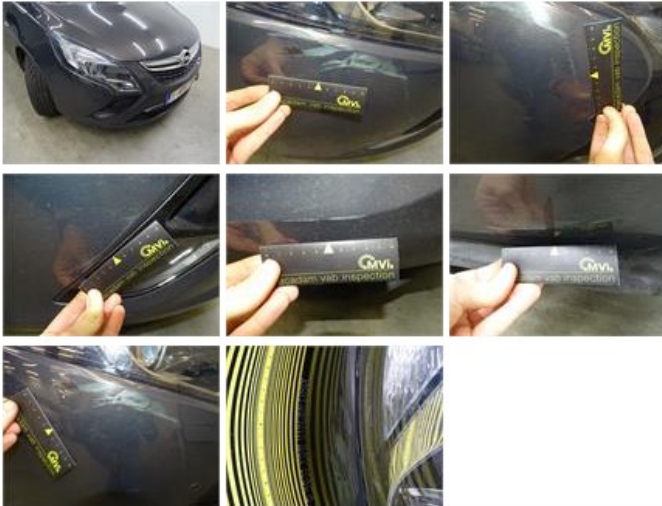
Bumper F, Scratch(es), LI - Repair and paint (complete) 211,80

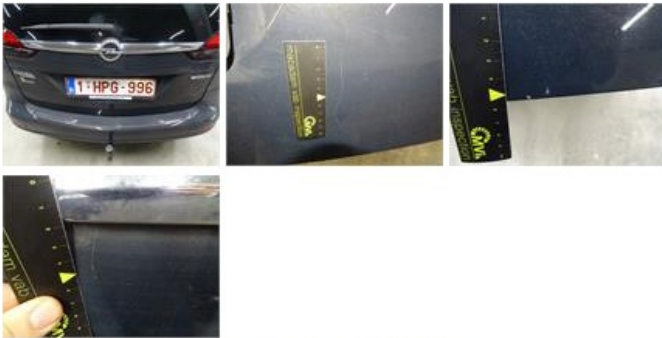
Tailgate, Scratch(es), LI - Repair and paint (complete) 301,68

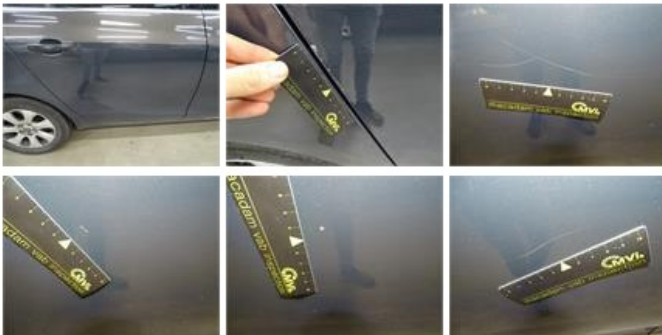
Door R R, Scratch(es), LI - Repair and paint (complete) 318,35
