SKODA OCTAVIA COMBI: 1KND896

Limited Technical Inspection

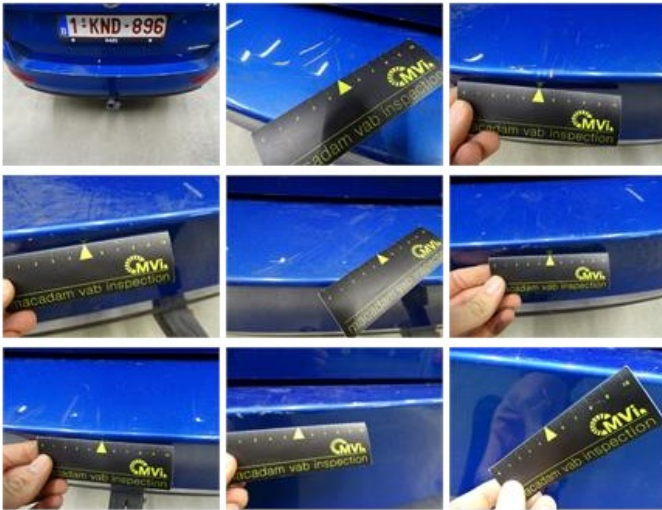
Bumper R, Scratch(es), LI - Repair and paint (complete) 211,80

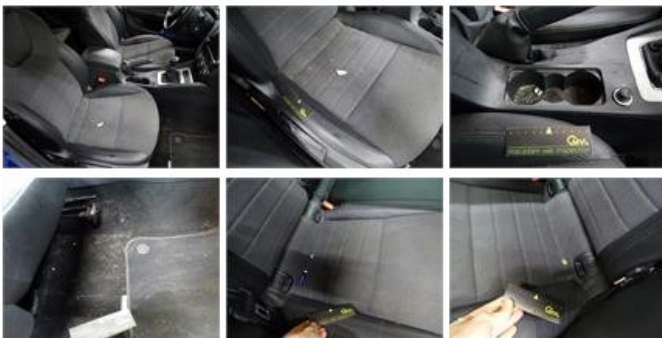
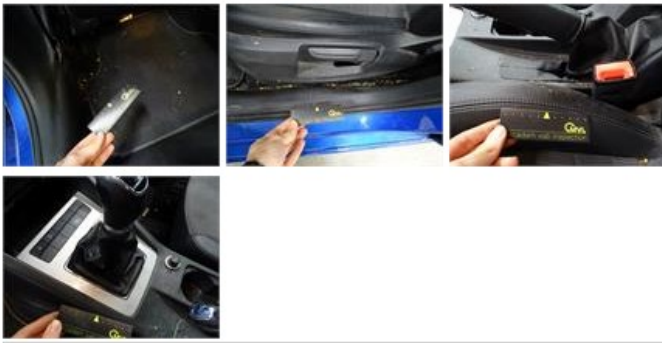
Interior, Dirty, Cleaning 50,00

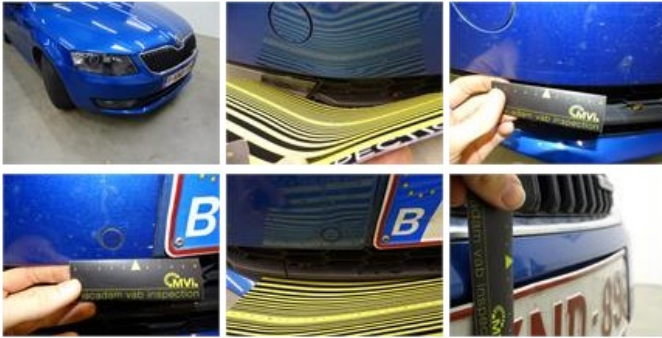
Bumper F, Dent(s) and scratch(es), LI - Repair and paint (complete) 211,80
