**MERCEDES E BREAK: 1LKL900**

**Limited Technical Inspection**

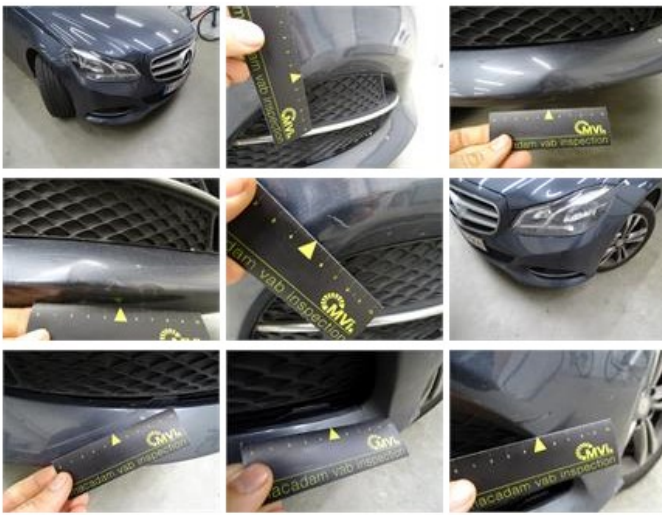
Bumper F, Dent(s) and scratch(es), LI - Repair and paint (complete) 254,16

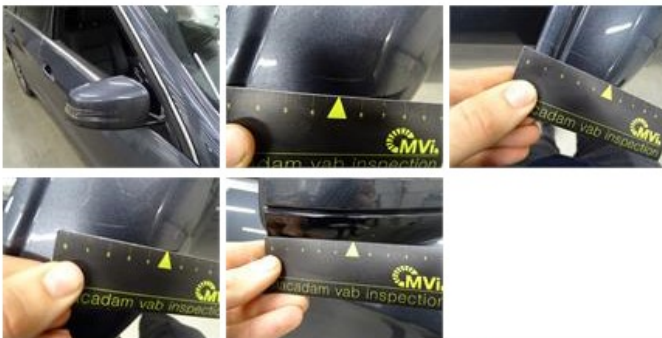
Rearview mirror housing R, Scratch(es), LI - Repair and paint (complete) 115,56

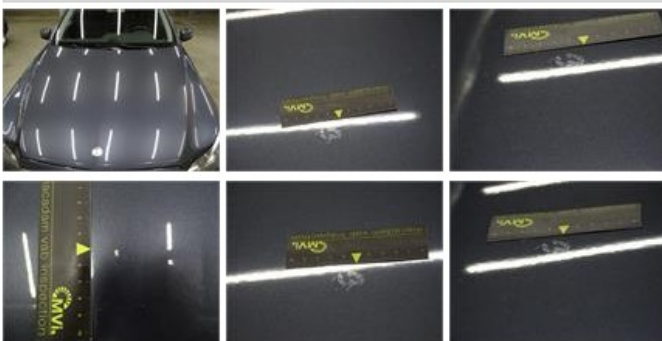
Bonnet, Chemical polution, LI - Repair and paint (complete) 348,09

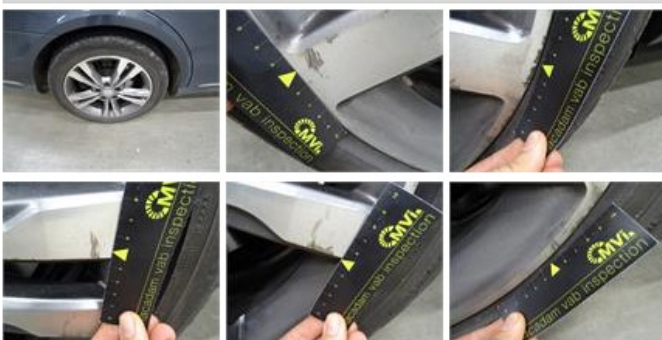
Alloy rim R R polished, Scratch(es), LI - Repair and paint (complete) 95,00
