RENAULT MEGANE BERLINE: 1LSJ169

Limited Technical Inspection

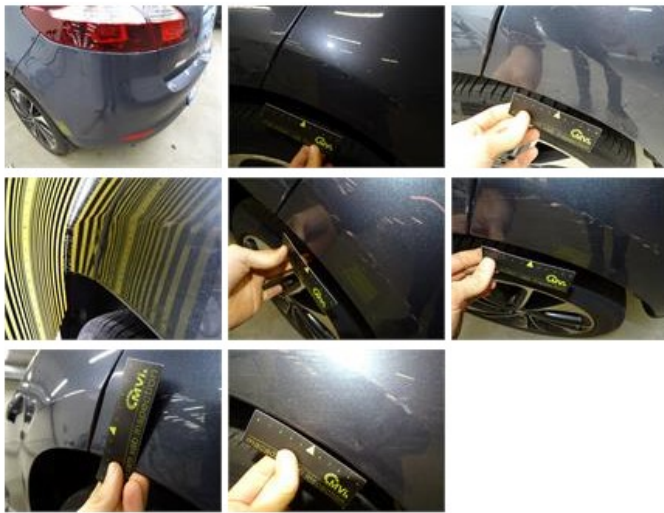
Total cost ex VAT	1576,58
Bumper R, Scratch(es), LI - Repair and paint (complete)	211,80

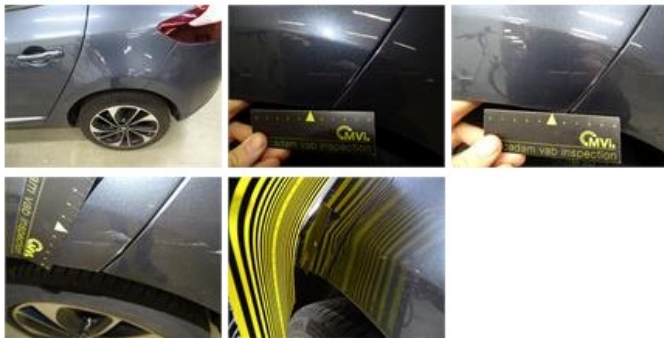
Wing R L, Dent(s) and scratch(es), LI - Repair and paint (complete)

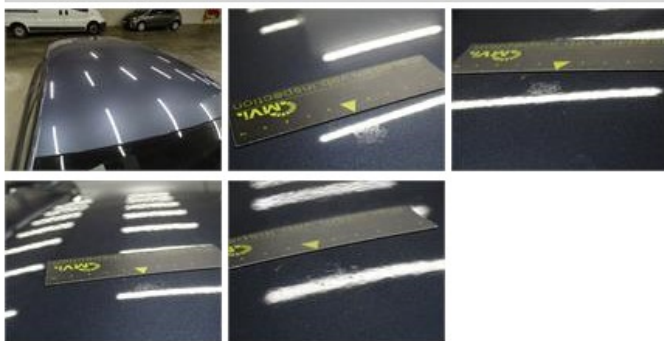
Roof, Chemical polution, LI - Repair and paint (complete)

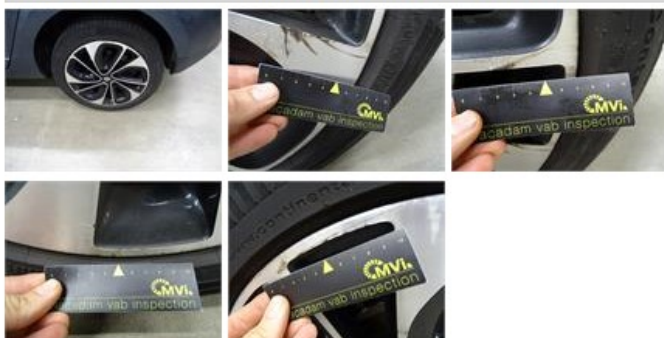
Alloy rim R L polished, Scratch(es), LI - Repair and paint (complete)

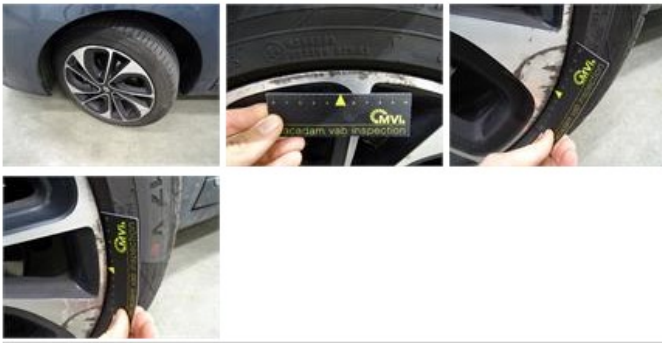
Alloy rim F L polished, Scratch(es), LI - Repair and paint (complete)

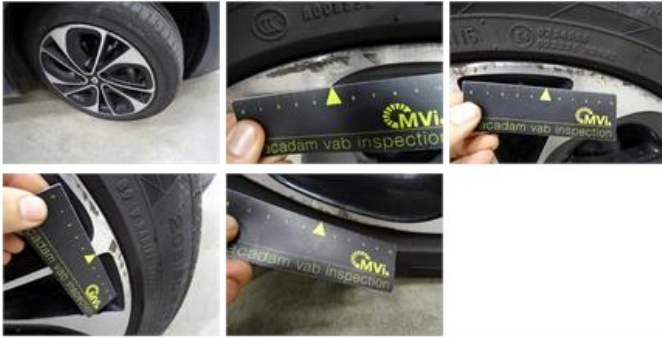
Alloy rim F R polished, Scratch(es), LI - Repair and paint (complete) 95,00

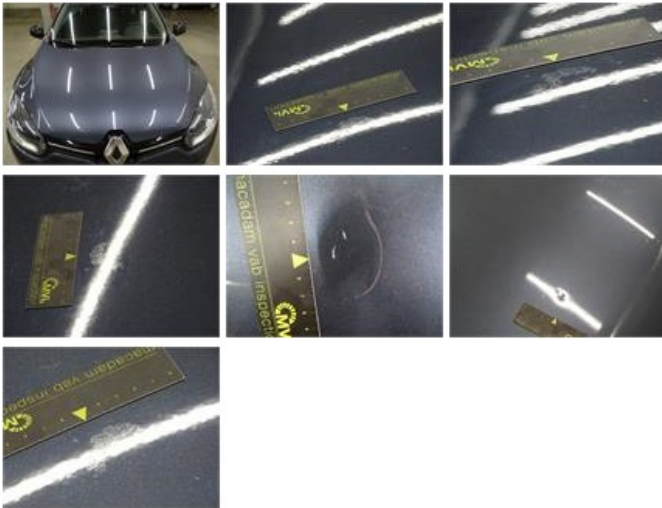
Bonnet, Chemical polution, LI - Repair and paint (complete) 290,08
