SSANGYONG KORANDO: 1PBA321

Limited Technical Inspection

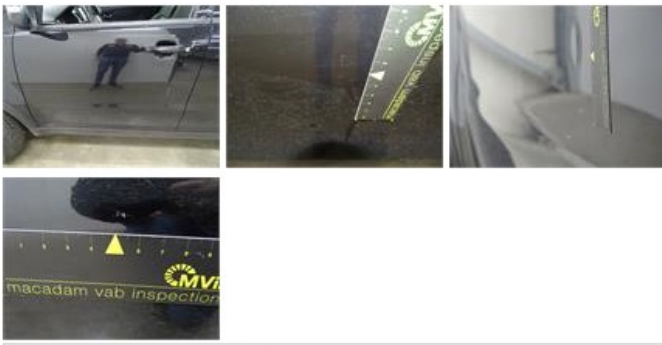
Total cost ex VAT	1948,62
Door F L, Dent(s) and scratch(es), LI - Repair and paint (complete)	382,02

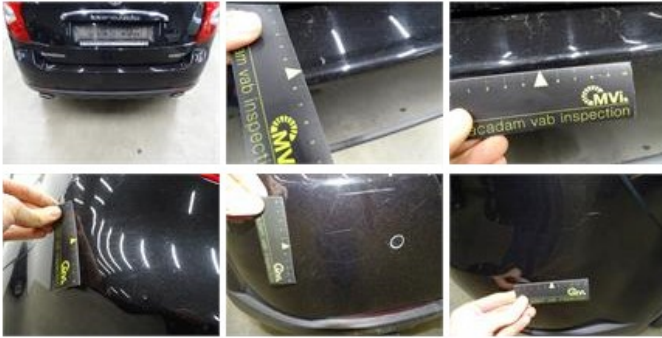
Bumper R, Scratch(es), LI - Repair and paint (complete) 254,16

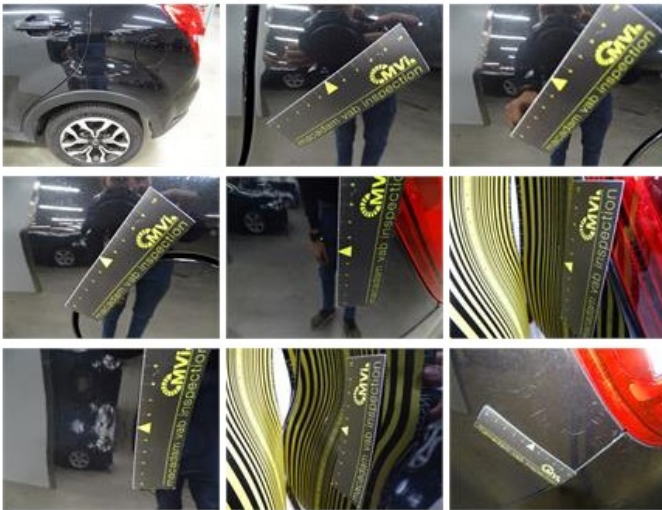
Wing R L, Dent(s) and scratch(es), LI - Repair and paint (complete) 369,84

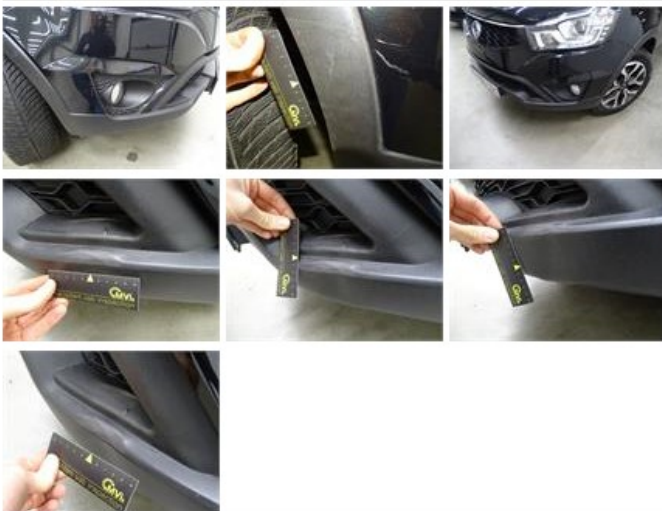
Bumper F M, Dent(s) and scratch(es), Smart repair 110,64

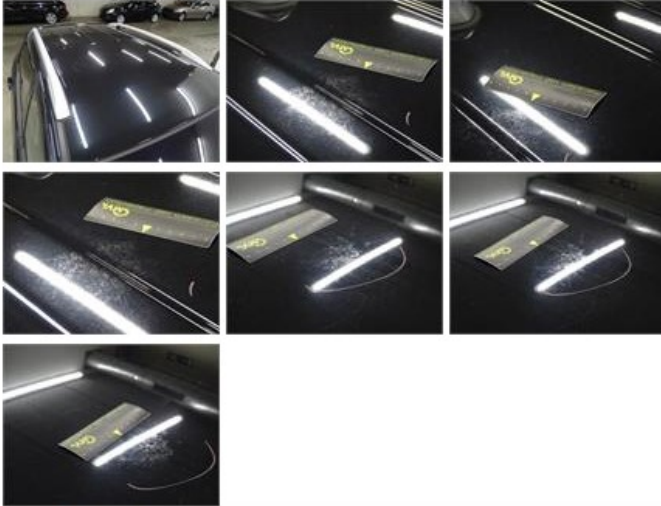
Wing trim R R, Scratch(es), Acceptable	0,00
<i>No pictures to display</i>	
Bonnet, Chemical polution, 67 - Polish	0,00
<i>No pictures to display</i>	
Wing F L, Scratch(es), Acceptable	0,00
<i>No pictures to display</i>	
Door R L, Scratch(es), Acceptable	0,00
<i>No pictures to display</i>	
Roof, Chemical polution, LI - Repair and paint (complete)	577,80
