VOLVO V60: 1LRS558			
Vinnumber:	YV1FW74C1G1307509	Versionname:	2.0 D2 KINETIC
First Registrationdate:	17/11/2015	Fiscalpower:	
Expertise Mileage:	77530	Power Kw:	88
Bodytype:		Body color:	Grey
Gearbox:	MAN 6 VIT	Paint type:	Metalic
Transmission:	Front	Rims summer:	Aluminium
Fueltype:	Diesel	Oil level:	OK
Battery functioning:	Yes	Parking lot:	2413
Number of doors:	5		
Number of seats:	5		
Number head rests:	5		
Rims summer:	Aluminium		
Category:	Passenger Car		
Oil level:	OK		
Registration Certificate Car (BE):	Yes

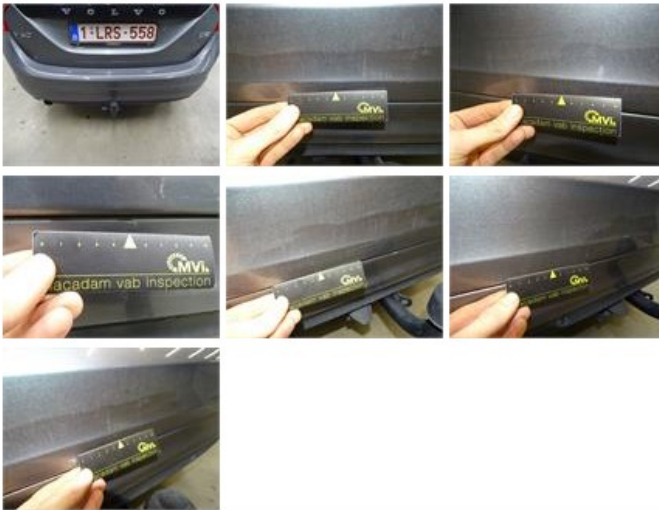
Bumper R, Scratch(es), LI - Repair and paint (complete)

211,80

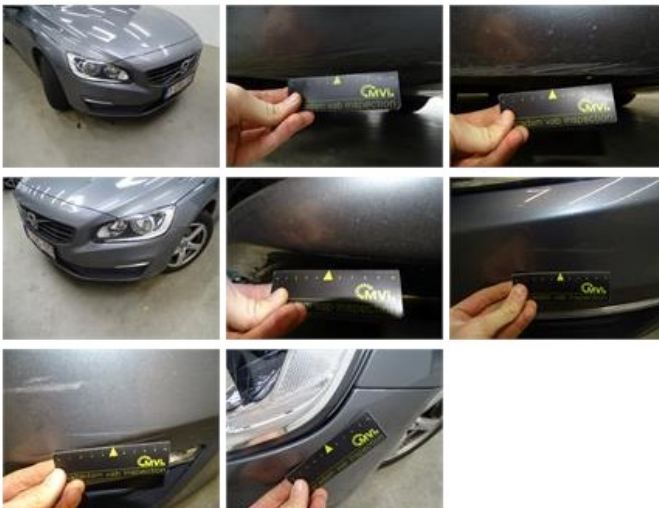
Bumper F, Scratch(es), LI - Repair and paint (complete)

211,80
