FORD Fiesta: 1ETY919

Limited Technical Inspection

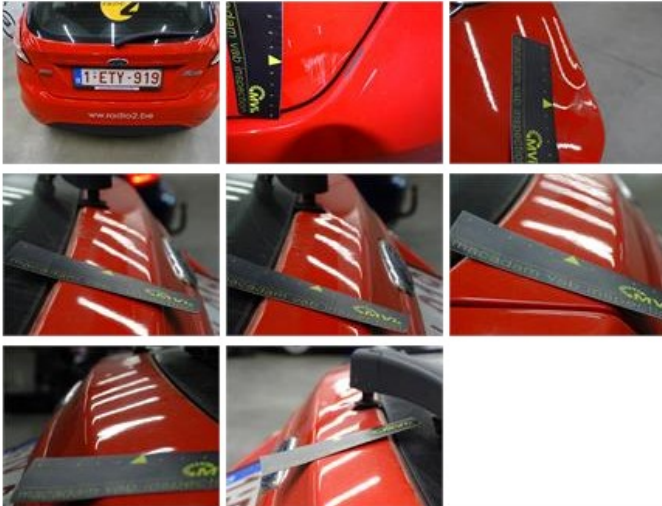
Tailgate, Dent(s) and scratch(es), LI - Repair and paint (complete) 0,00

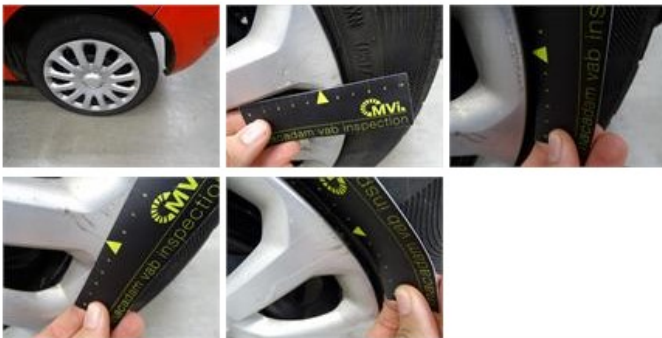
Wheel cover R L, Scratch(es), E - Replace 0,00

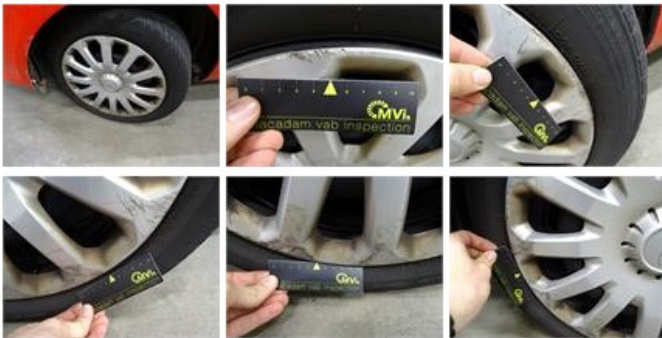
Wheel cover F L, Scratch(es), E - Replace 0,00

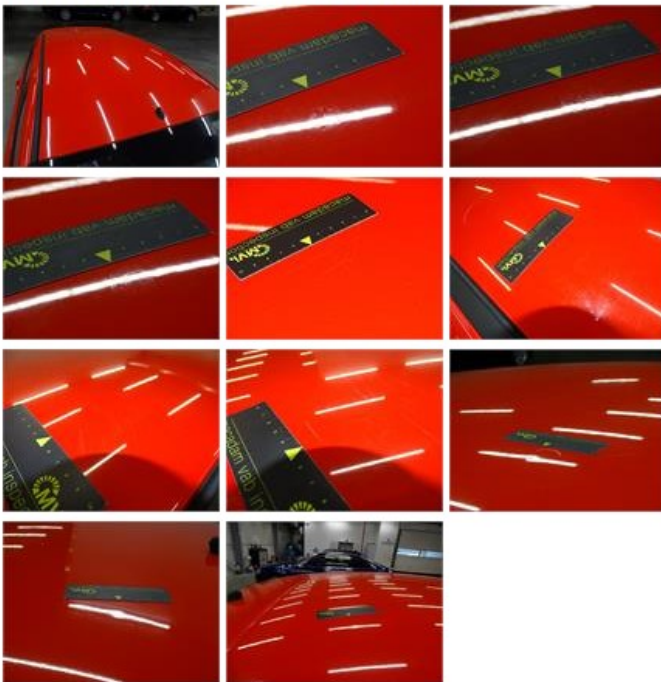
Roof, Chemical polution, LI - Repair and paint (complete)

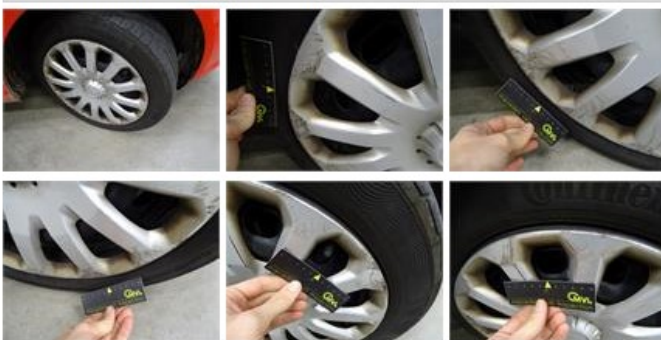
Wheel cover F R, Scratch(es), E - Replace

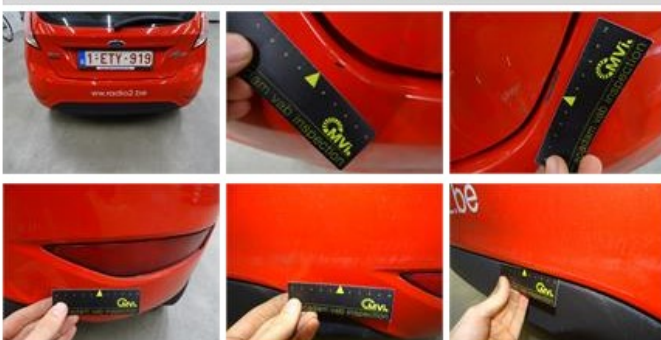
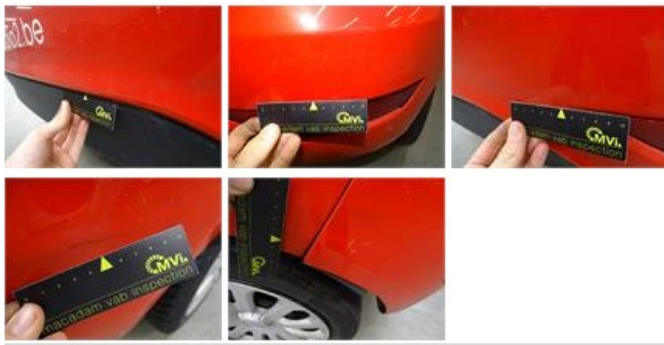
Bumper R, Scratch(es), LI - Repair and paint (complete)

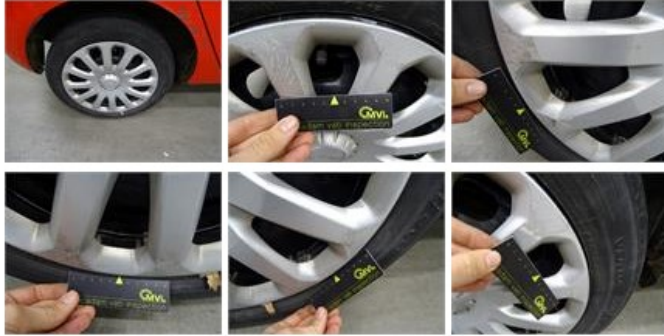
Wheel cover R R, Scratch(es), E - Replace 0,00
