RENAULT Trafic: 1FCE273

Limited Technical Inspection

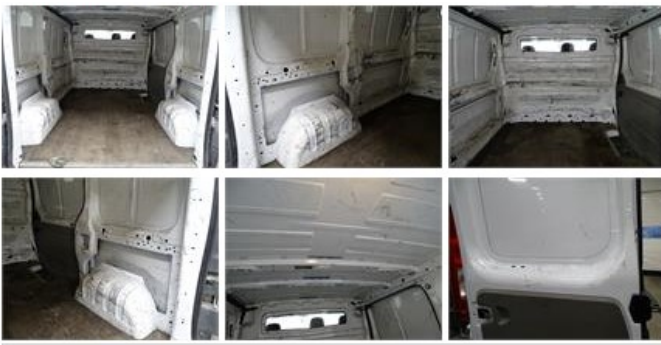
Interior, Damaged, Acceptable 0,00
