**VOLKSWAGEN Touran: 1JAL720**

**Limited Technical Inspection**

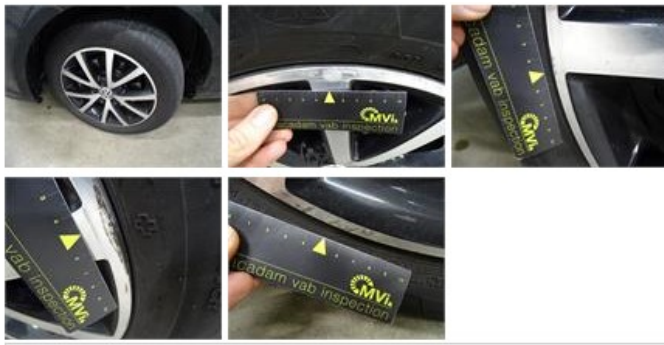
Total cost ex VAT	2835,61
Door R L, Dent(s) and scratch(es), Acceptable	0,00
<i>No pictures to display</i>	
Alloy rim F L polished, Scratch(es), LI - Repair and paint (complete)	95,00

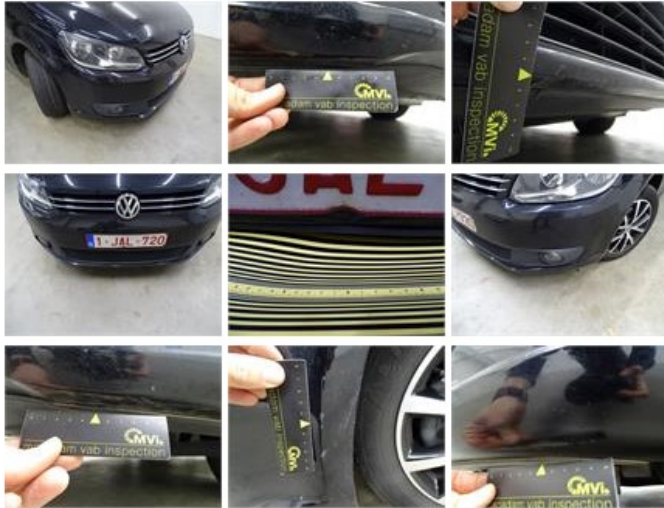
Bumper F, Dent(s) and scratch(es), LI - Repair and paint (complete) 211,80

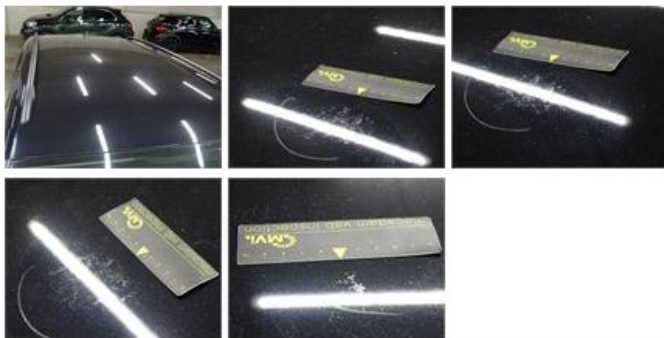
Roof, Chemical polution, LI - Repair and paint (complete) 481,50

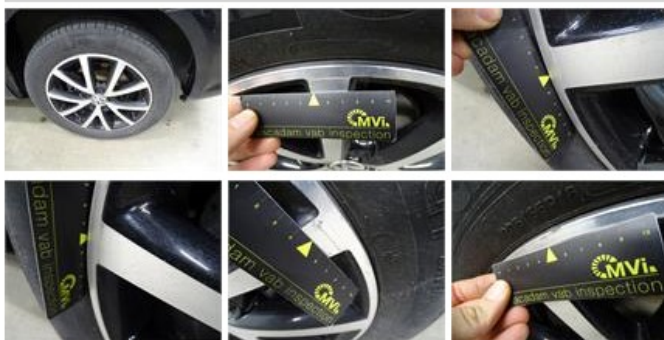
Alloy rim R L polished, Scratch(es), LI - Repair and paint (complete) 95,00

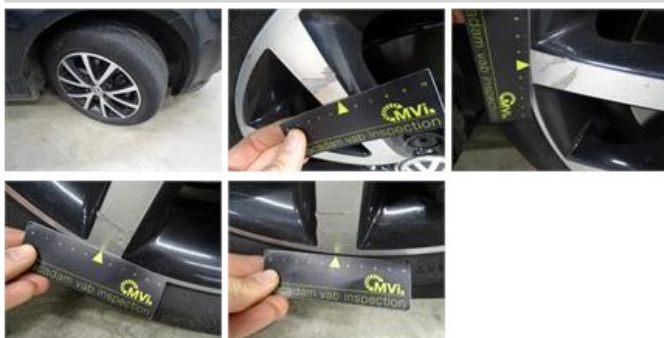
Alloy rim F R polished, Scratch(es), LI - Repair and paint (complete) 95,00

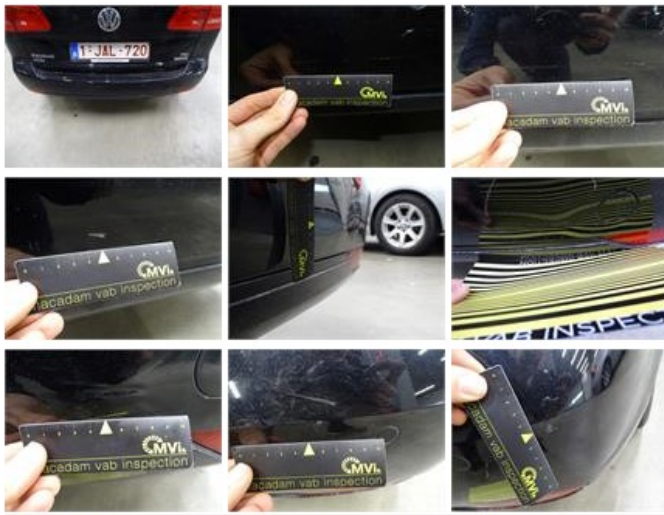
Bumper R, Dent(s) and scratch(es), LI - Repair and paint (complete) 211,80

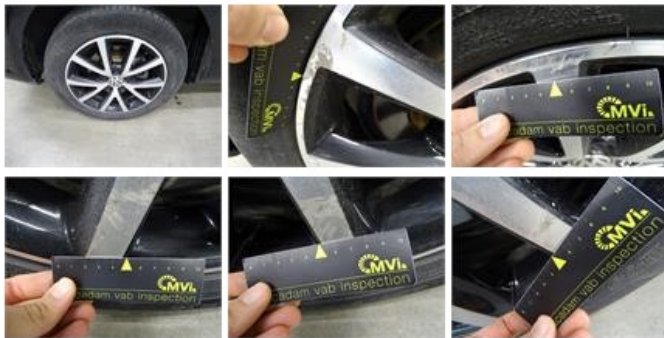
Alloy rim R R polished, Scratch(es), LI - Repair and paint (complete)

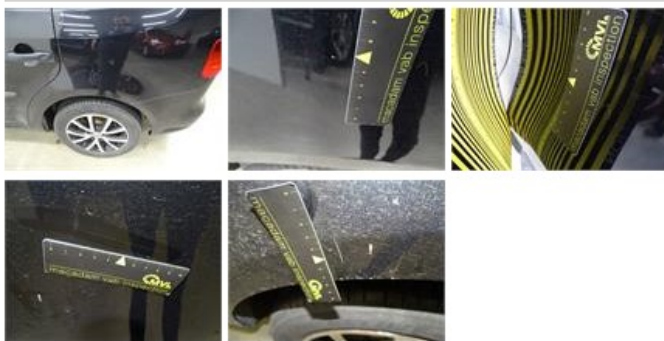
Wing R L, Dent(s) and scratch(es), LI - Repair and paint (complete)

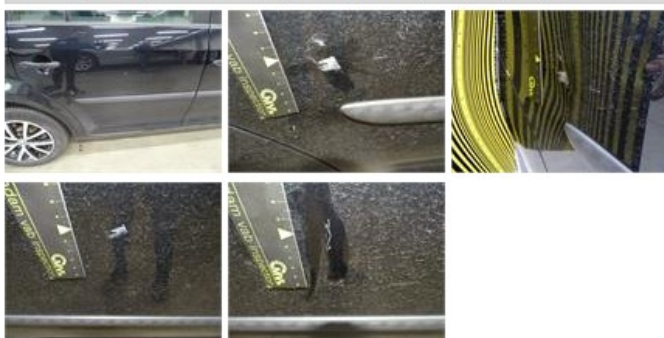
Door R R, Dent(s) and scratch(es), LI - Repair and paint (complete)

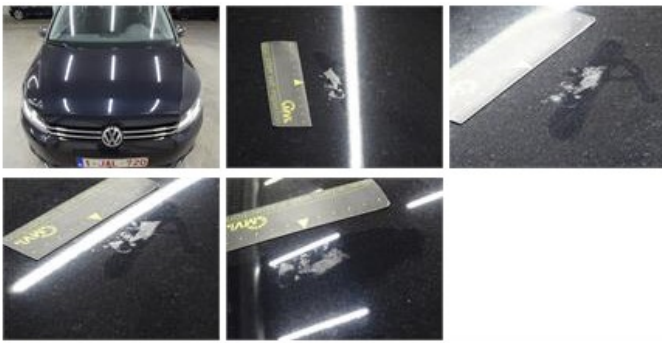
Bonnet, Chemical polution, LI - Repair and paint (complete)

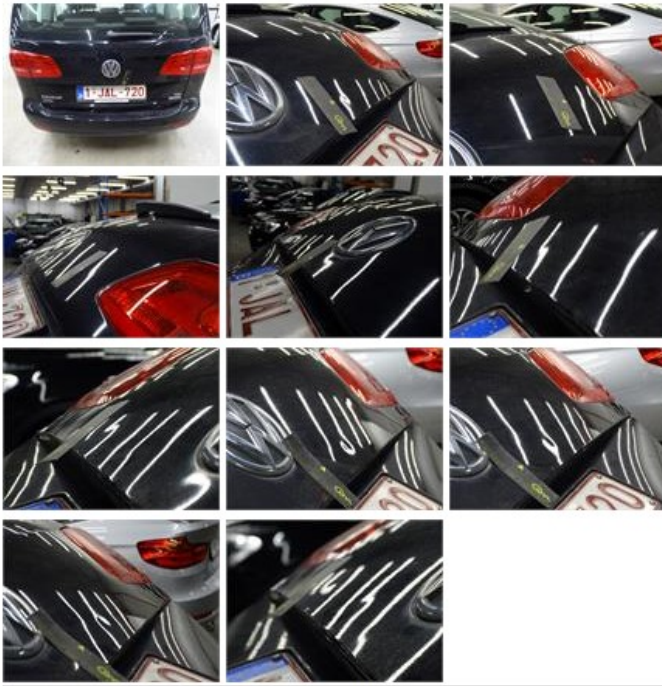
Tailgate, Dent(s), LI - Repair and paint (complete) 301,68

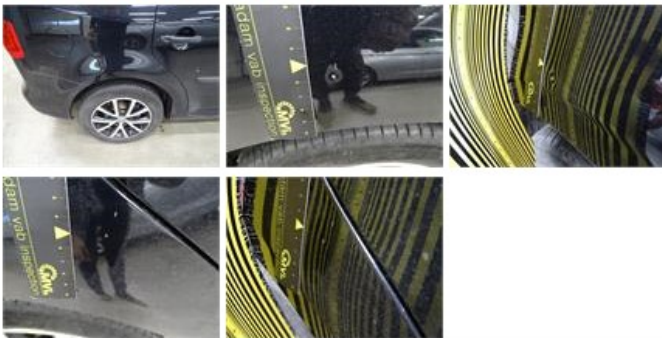
Wing R R, Dent(s) and scratch(es), LI - Repair and paint (complete) 308,20
