OPEL INSIGNIA SPORTS TOURER: 1LJY360

Limited Technical Inspection

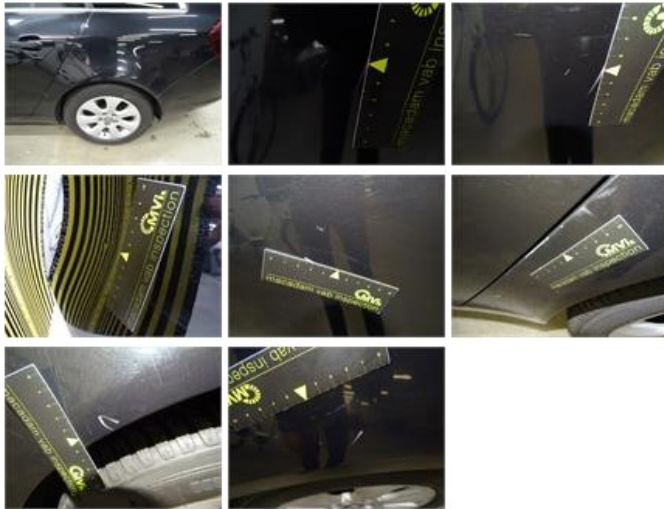
Wing R L, Dent(s) and scratch(es), LI - Repair and paint (complete)

308,20

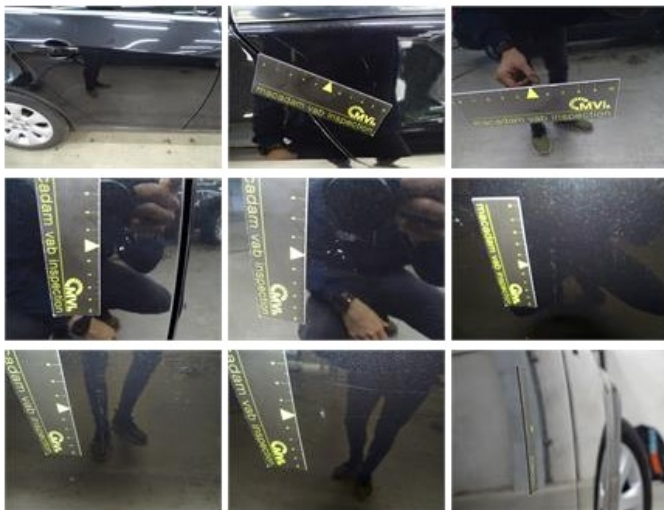
Door R R, Dent(s) and scratch(es), LI - Repair and paint (complete)

318,35

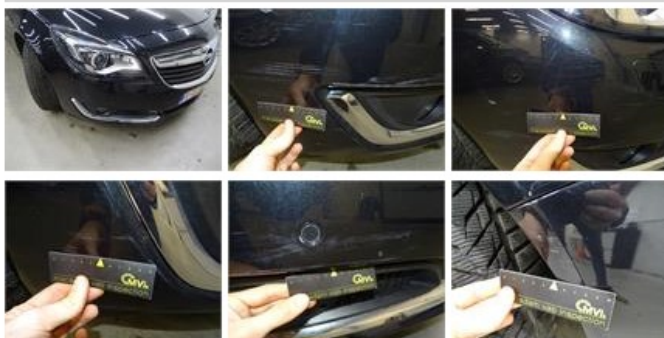
Bumper F, Scratch(es), LI - Repair and paint (complete)

211,80

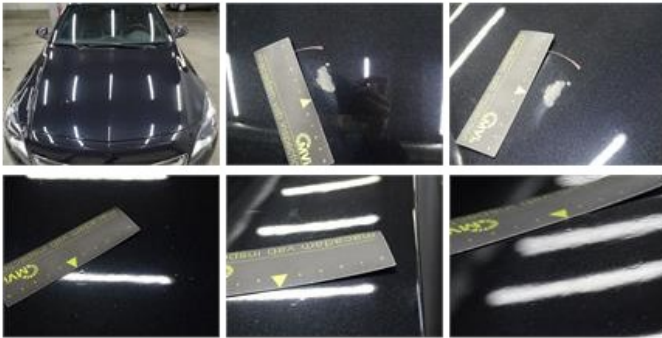
Bonnet, Bad repair, Acceptable 0,00

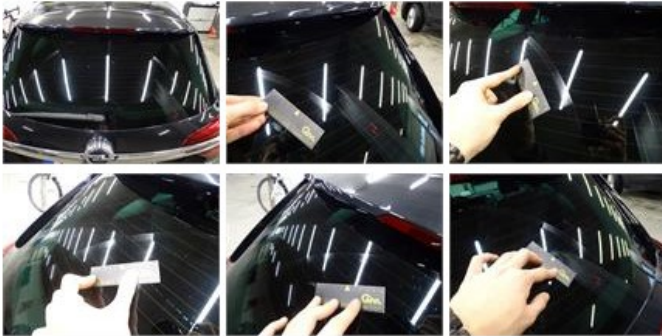
Rear window, Scratch(es), E - Replace 370,00

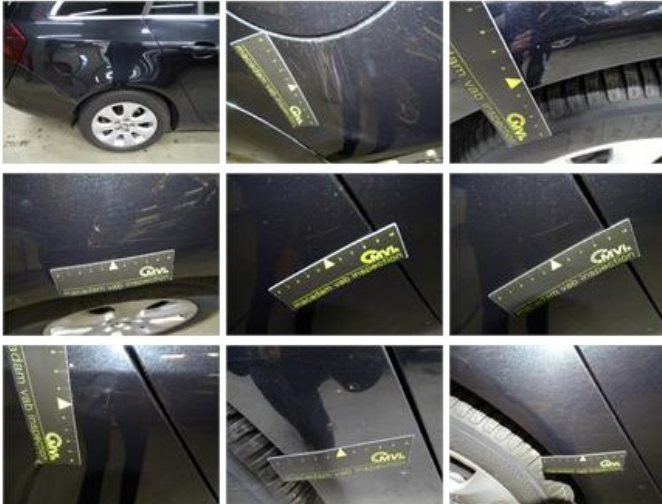
Wing R R, Scratch(es), LI - Repair and paint (complete) 308,20

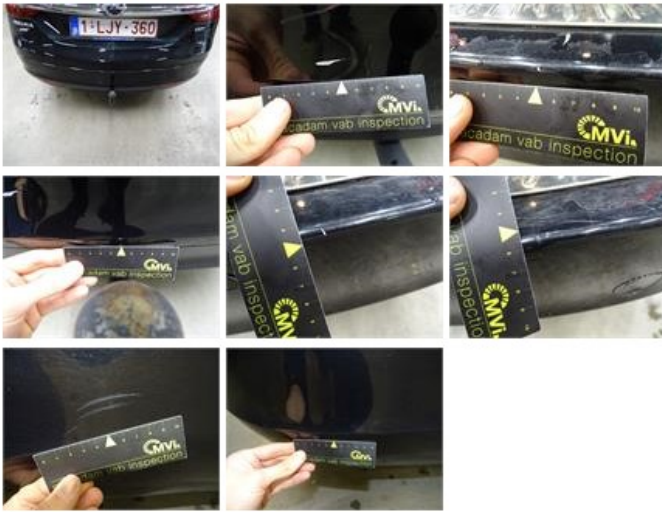
Bumper R, Scratch(es), LI - Repair and paint (complete)

211,80
