SKODA Superb: 1FWJ258

Limited Technical Inspection

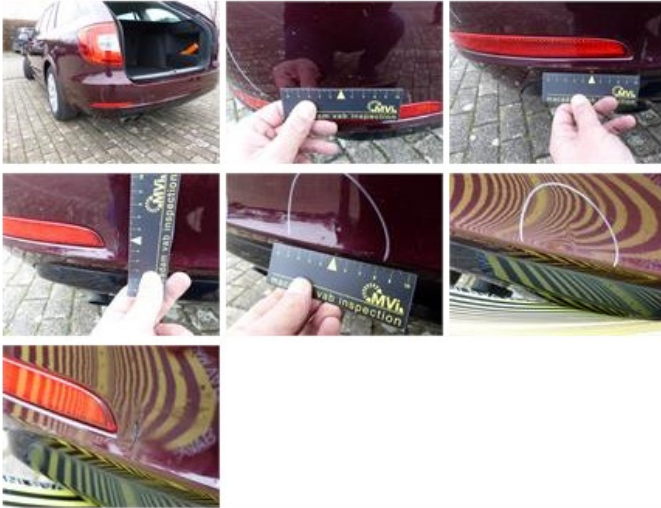
Bumper corner R L, Dent(s) and scratch(es), It - Spot repair 115,56
