SKODA Octavia: 1GF286

Limited Technical Inspection

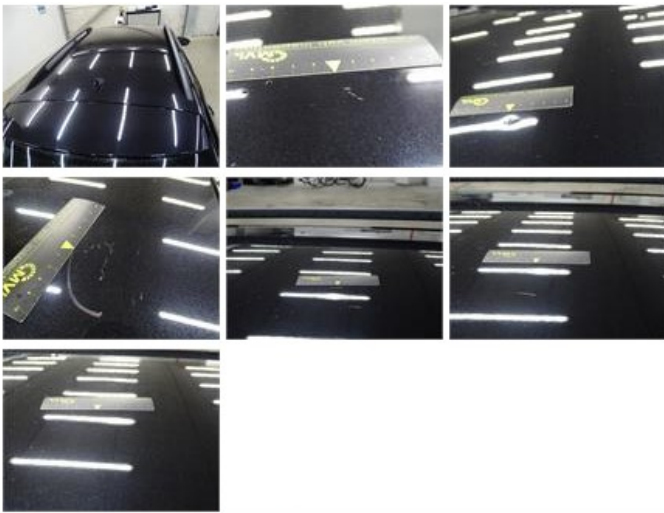
Total cost ex VAT	2450,46
Wing F L, Scratch(es), Acceptable	0,00
<i>No pictures to display</i>	
Roof, Dent(s) and scratch(es), LI - Repair and paint (complete)	481,50

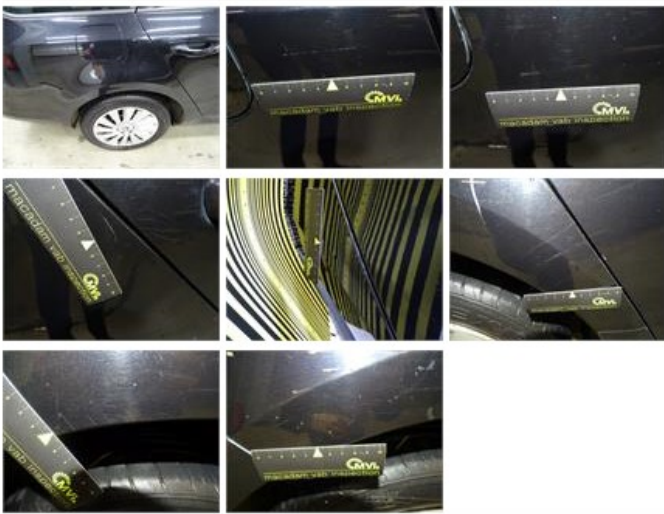
Wing R R, Dent(s) and scratch(es), LI - Repair and paint (complete) 308,20

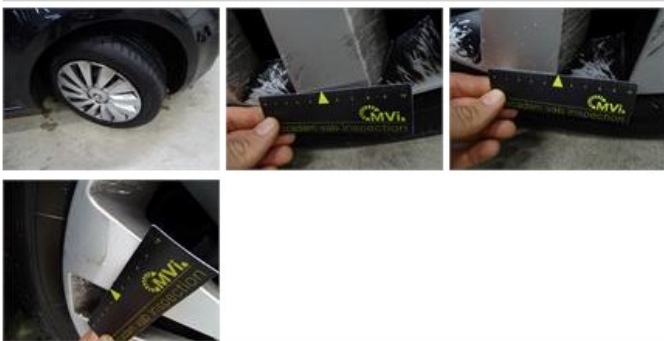
Wheel cover F R, Scratch(es), E - Replace 30,00

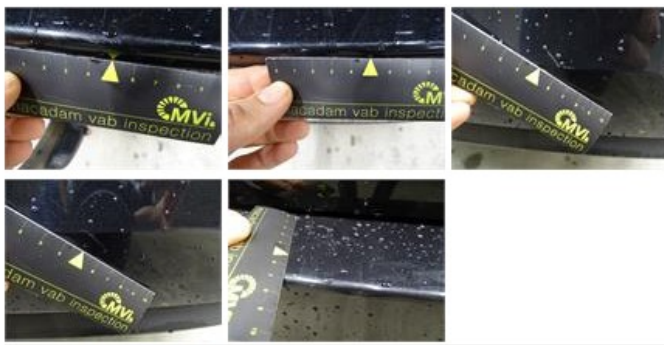
Bumper R, Scratch(es), LI - Repair and paint (complete) 211,80

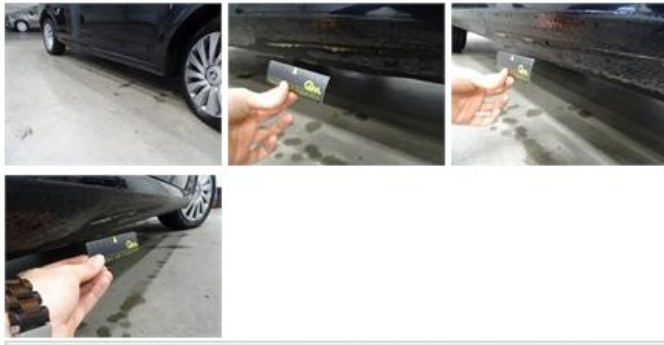
Sill outer R, Dent(s) and scratch(es), LI - Repair and paint (complete) 358,50

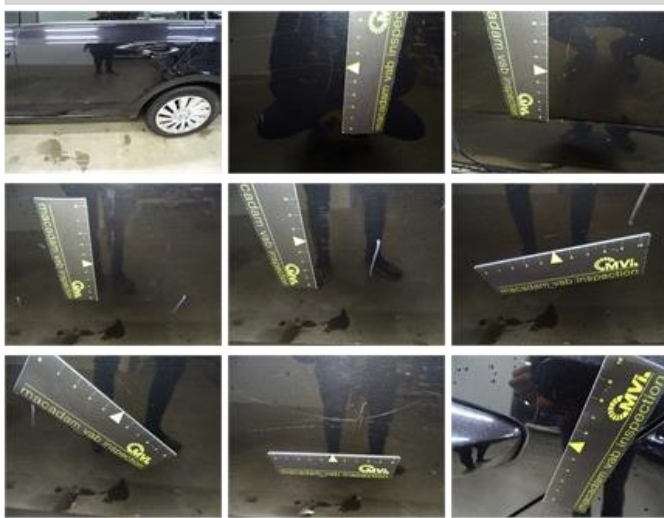
Door R L, Scratch(es), LI - Repair and paint (complete) 318,35

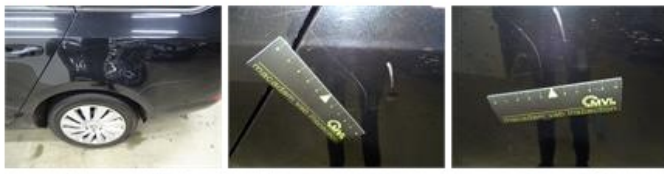
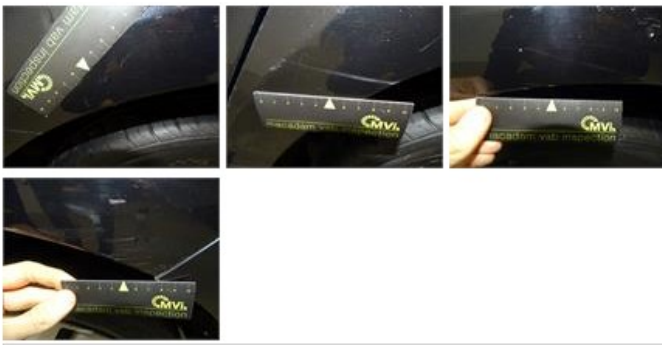
Wing R L, Scratch(es), LI - Repair and paint (complete) 308,20

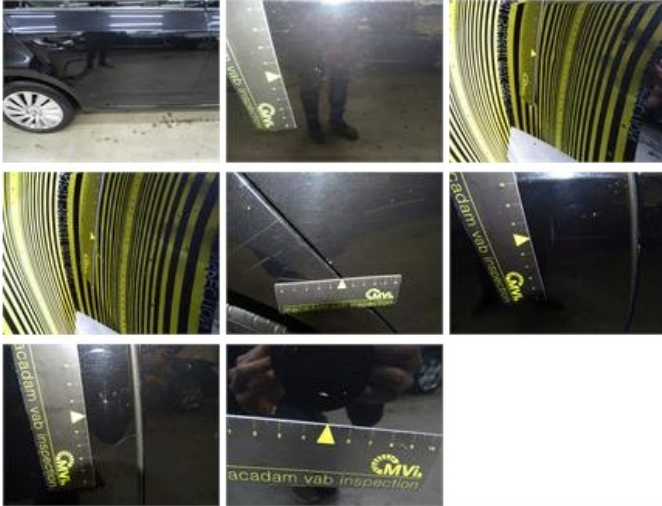
Door R R, Dent(s) and scratch(es), LI - Repair and paint (complete) 318,35

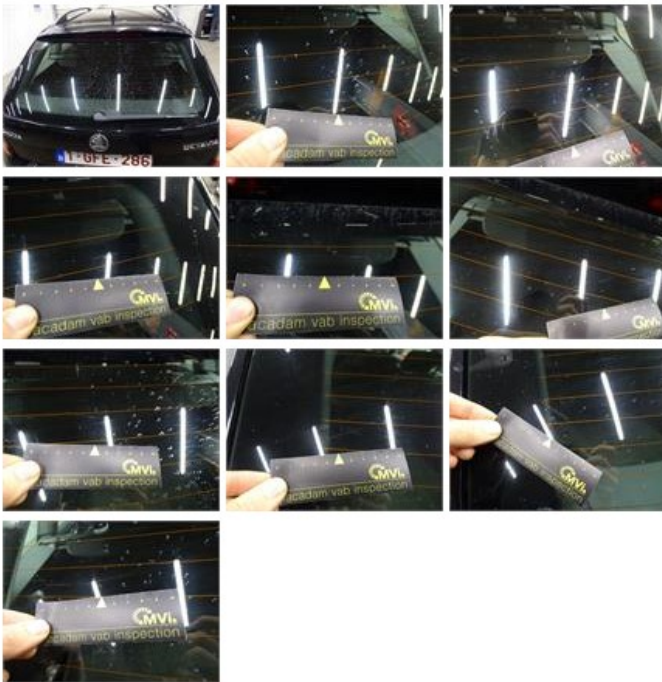
Rear window, Scratch(es), E - Replace 0,00
