MINI : 1PEN919			
Vinnumber:	WMWXN110203851814	Versionname:	1.5 ONE D
First Registrationdate:	17/06/2016	Fiscalpower:	
Expertise Mileage:	43349	Power Kw:	70
Bodytype:		Body color:	Black
Gearbox:	MAN 6 VIT	Paint type:	Metalic
Transmission:	Front	Rims summer:	Aluminium
Fueltype:	Diesel	Oil level:	OK
Battery functioning:	Yes	Parking lot:	2622
Number of doors:	3		
Number of seats:	4		
Number head rests:	4		
Rims summer:	Aluminium		
Category:	Passenger Car		
Oil level:	OK		
Registration Certificate Car (BE):	Yes

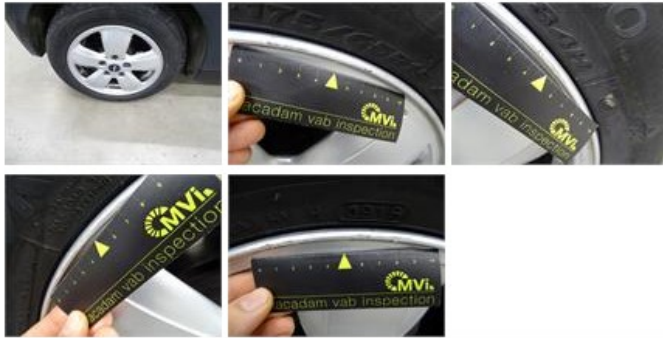
Alloy rim R R, Scratch(es), LI - Repair and paint (complete) 95,00

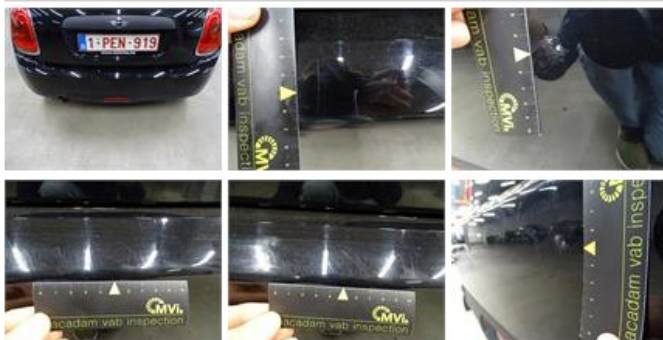
Bumper R, Dent(s) and scratch(es), LI - Repair and paint (complete) 211,80

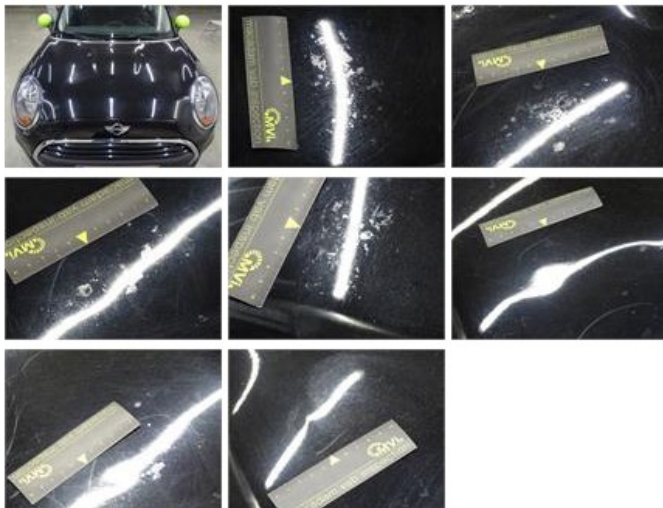
Bonnet, Chemical polution, LI - Repair and paint (complete) 314,08

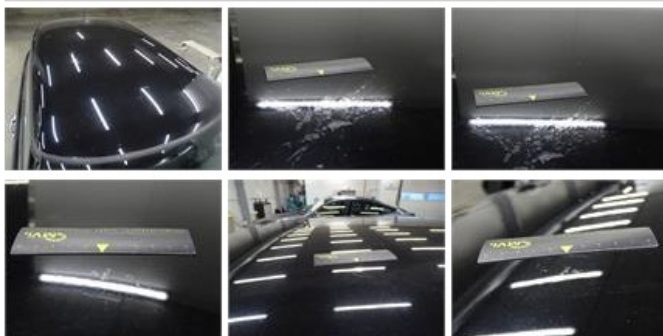
Roof, Chemical polution, LI - Repair and paint (complete) 481,50

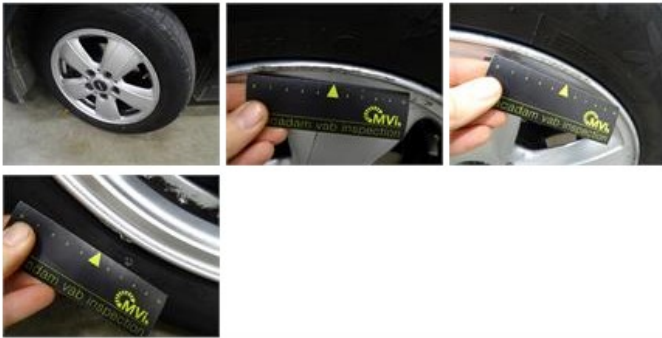
Alloy rim F L, Scratch(es), LI - Repair and paint (complete)

95,00

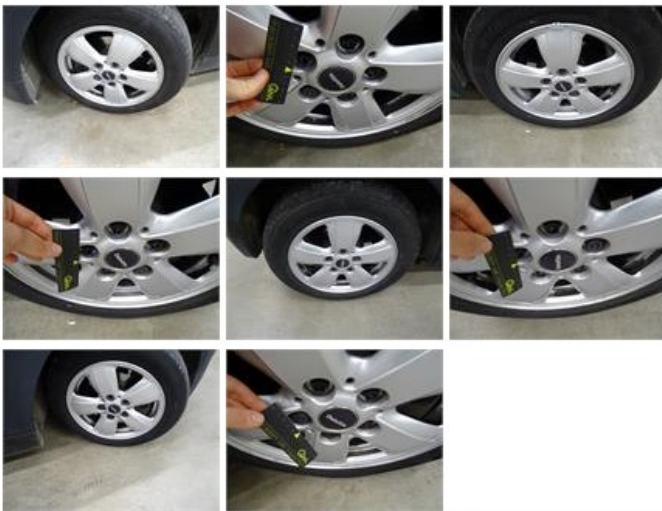
Wheel hub cap F L, Not original part, Acceptable

0,00

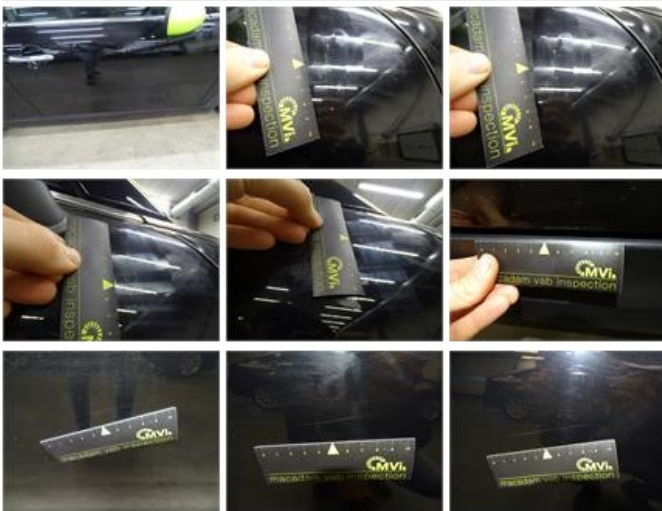
Door F R, Chemical pollution, LI - Repair and paint (complete)

318,35

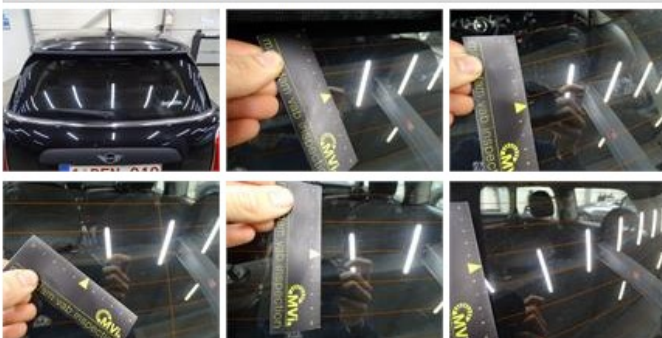
Rear window, Scratch(es), E - Replace

370,00

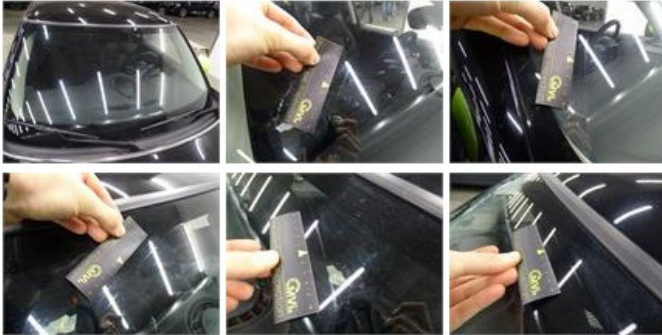
Windscreen, Scratch(es), E - Replace 487,20

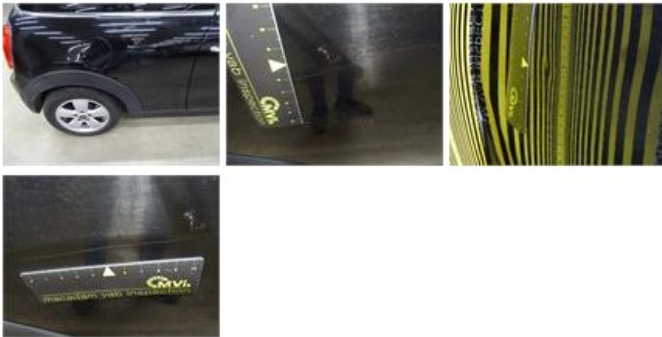
Wing R R, Dent(s) and scratch(es), LI - Repair and paint (complete) 308,20
