AUDI A1 SPORTBACK: 1LUA591

Limited Technical Inspection

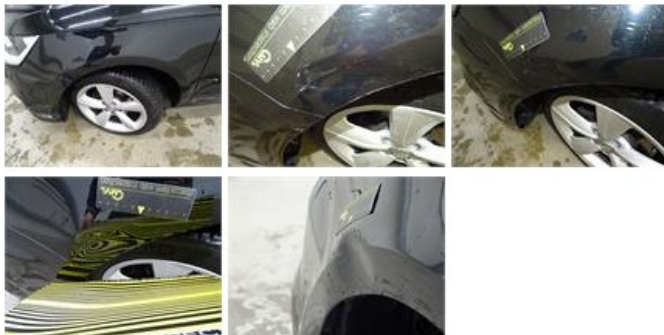
Wing F L, Dent(s) and scratch(es), LI - Repair and paint (complete)

176,14

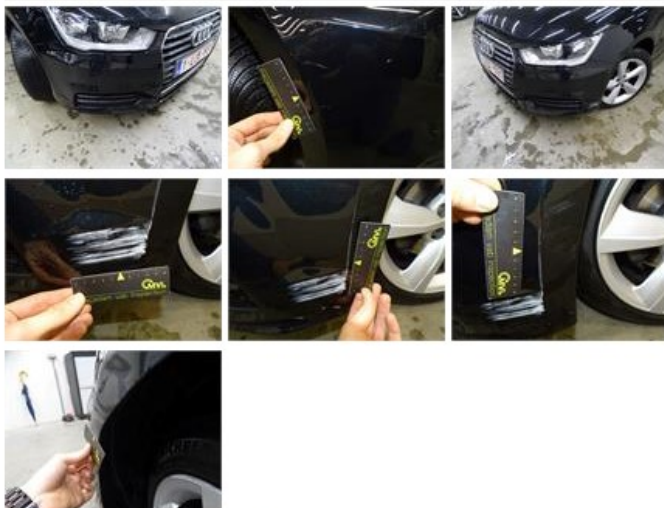
Bumper F, Dent(s) and scratch(es), LI - Repair and paint (complete)

169,44

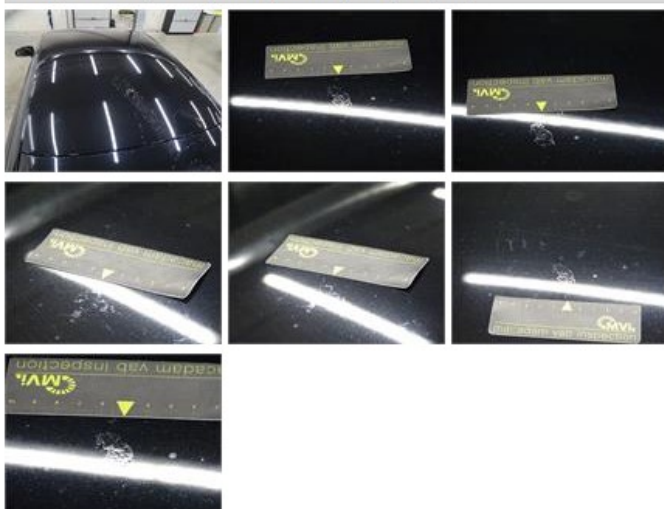
Roof, Chemical pollution, LI - Repair and paint (complete)

0,00

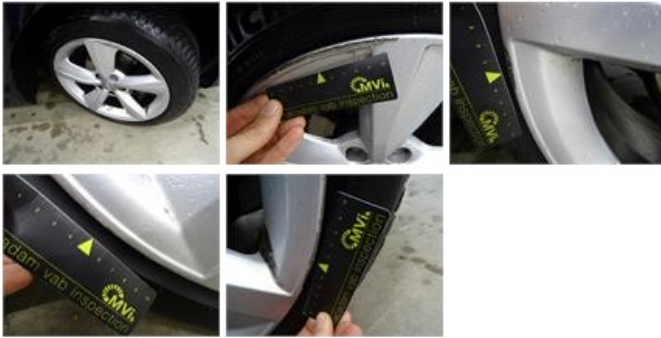
Alloy rim F R, Scratch(es), LI - Repair and paint (complete) 95,00

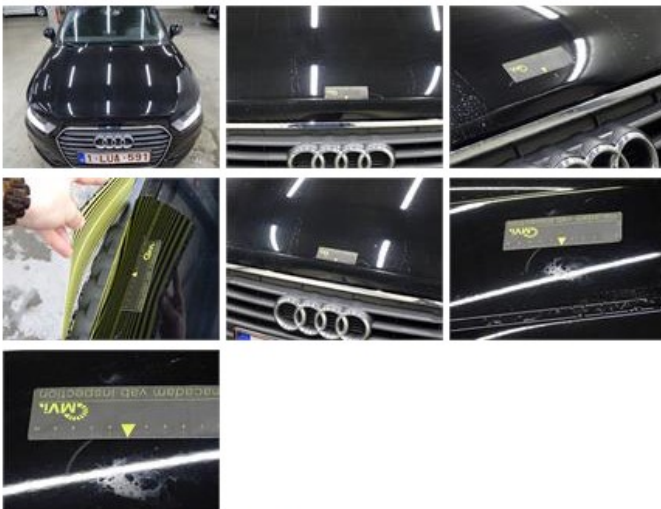
Bonnet, Deformed / Strained, LI - Repair and paint (complete) 232,06

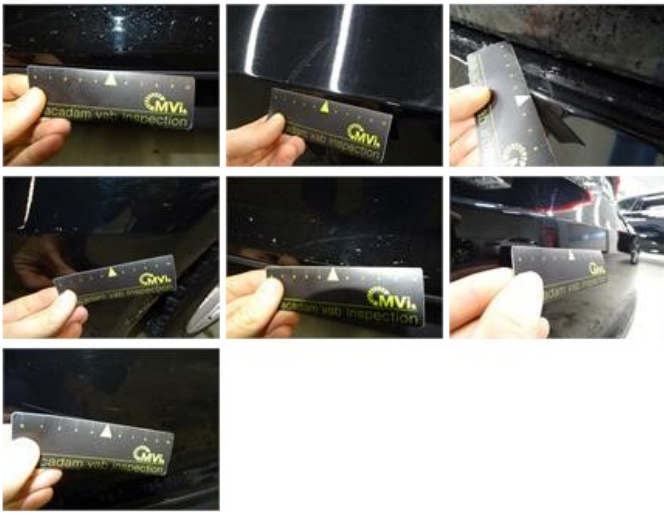
Bumper R, Scratch(es), LI - Repair and paint (complete) 169,44
