AUDI A3: 1GDH568

Limited Technical Inspection

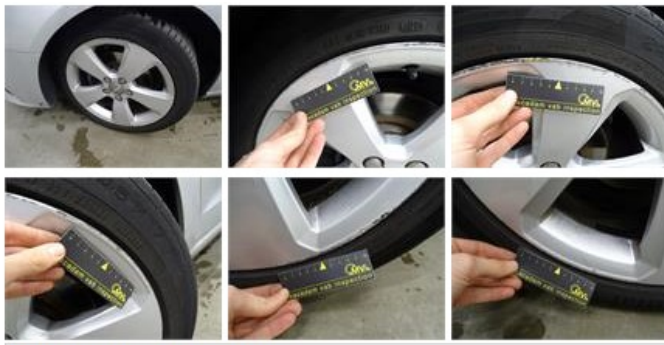
Total cost ex VAT	1229,28
Alloy rim F L, Scratch(es), LI - Repair and paint (complete)	95,00

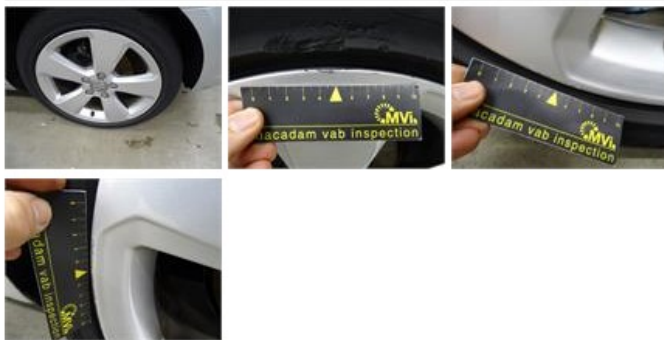
Alloy rim R L, Scratch(es), LI - Repair and paint (complete)

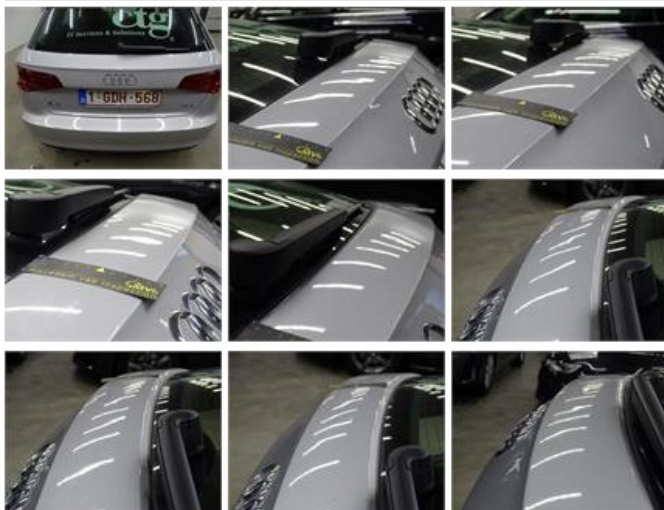
Tailgate, Deformed / Strained, LI - Repair and paint (complete)

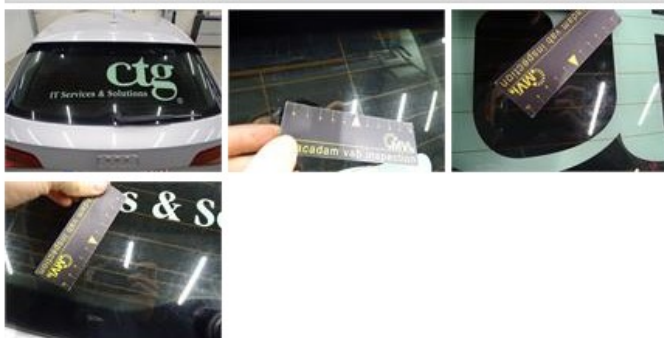
Rear window, Scratch(es), Acceptable

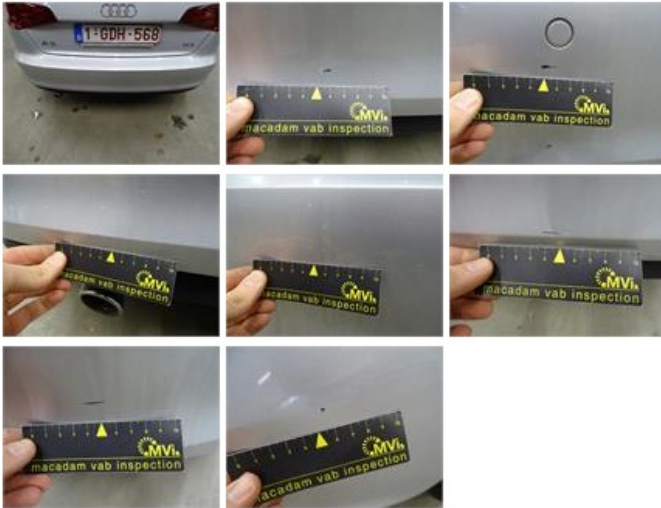
Bumper R, Scratch(es), LI - Repair and paint (complete) 211,80

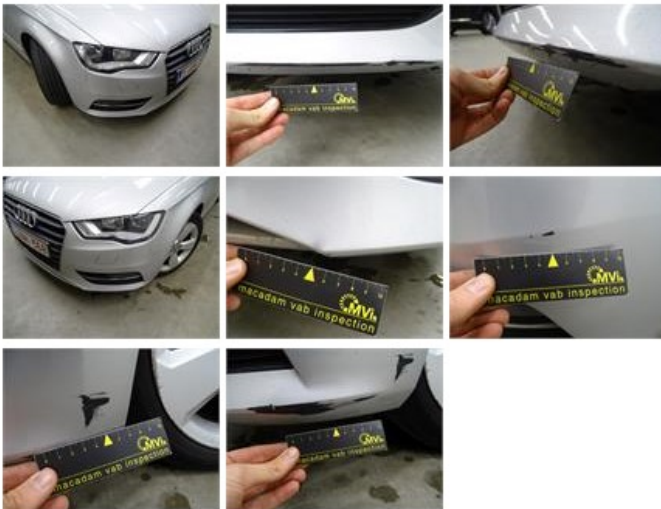
Bumper F, Dent(s) and scratch(es), LI - Repair and paint (complete) 211,80

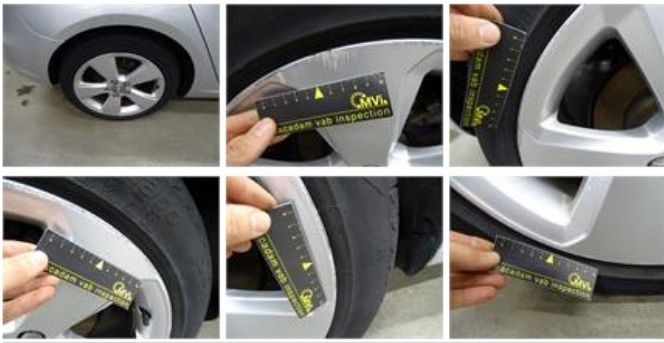
Alloy rim R R, Scratch(es), LI - Repair and paint (complete) 95,00

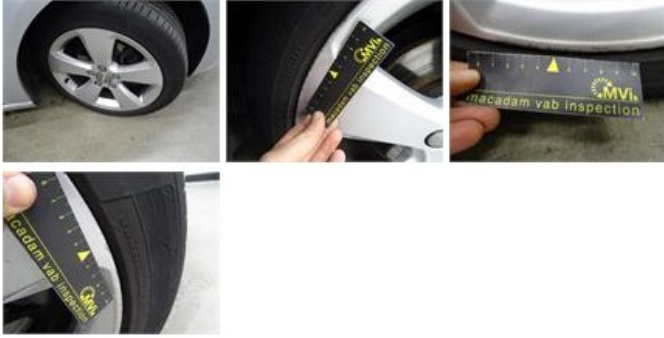
Alloy rim F R, Scratch(es), LI - Repair and paint (complete)
