BMW 1 HATCH: 1RED984

Limited Technical Inspection

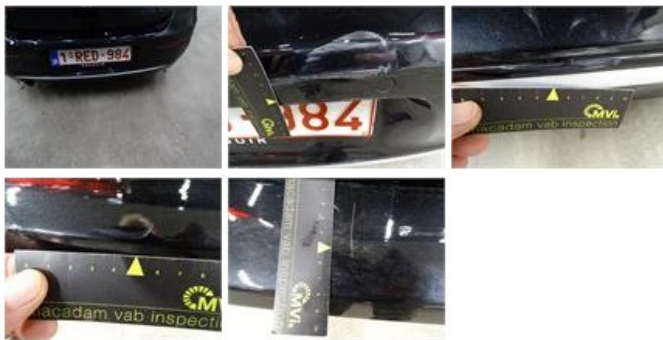
Total cost ex VAT	1798,30
Bumper R, Scratch(es), LI - Repair and paint (complete)	211,80

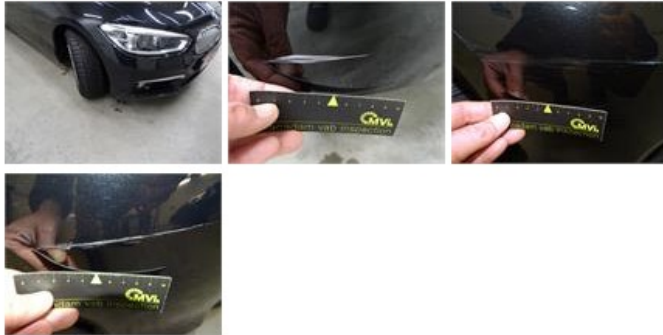
Bumper F, Scratch(es), LI - Repair and paint (complete)

211,80
