**BMW 1 HATCH: 1TCS259**

**Limited Technical Inspection**

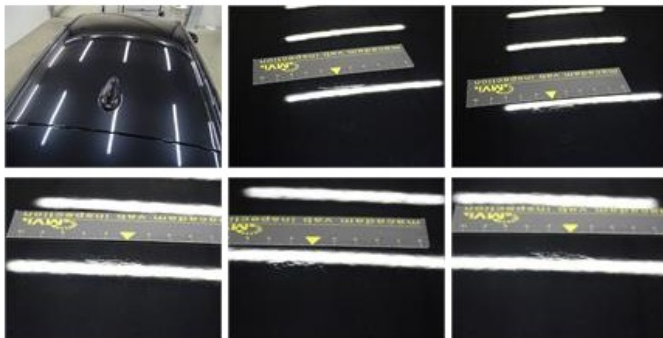
Roof, Chemical polution, LI - Repair and paint (complete)

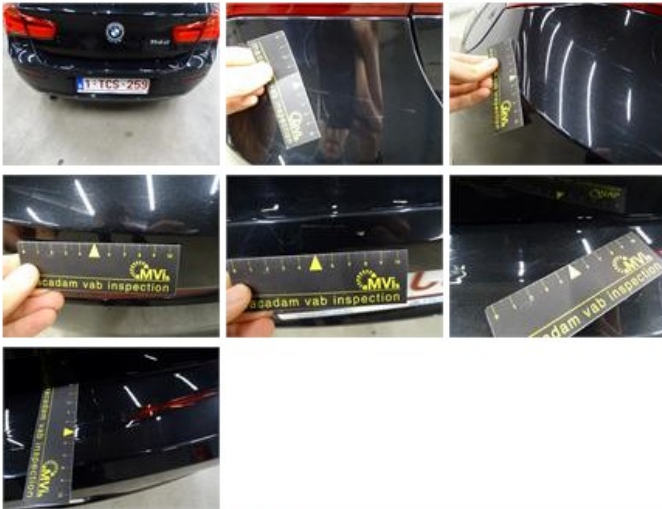
Bumper R, Scratch(es), LI - Repair and paint (complete) 211,80

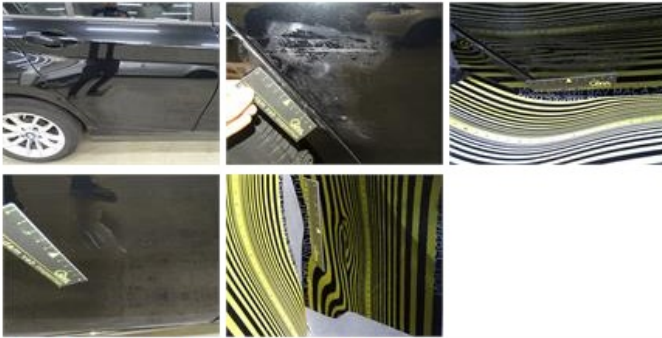
Door R R, Dent(s) and scratch(es), LI - Repair and paint (complete) 366,35

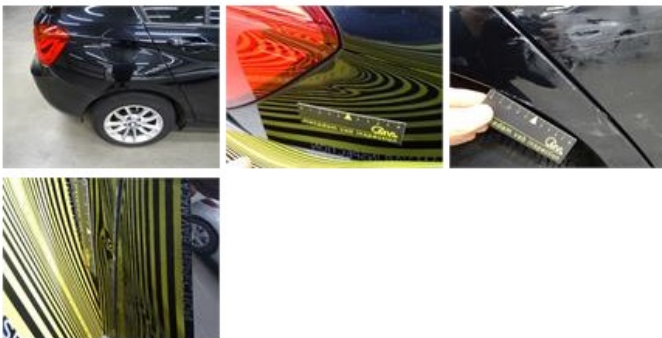
Wing R R, Dent(s) and scratch(es), LI - Repair and paint (complete) 308,20

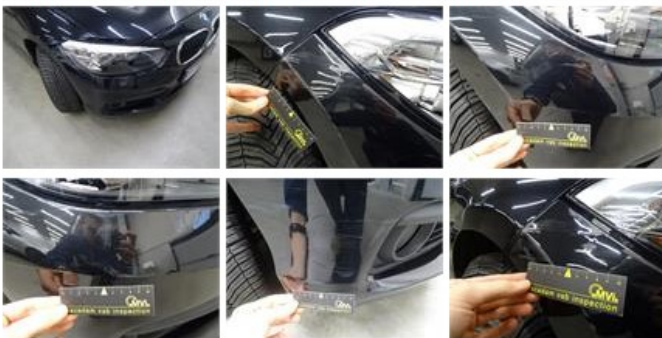
Bumper F, Dent(s) and scratch(es), LI - Repair and paint (complete) 211,80

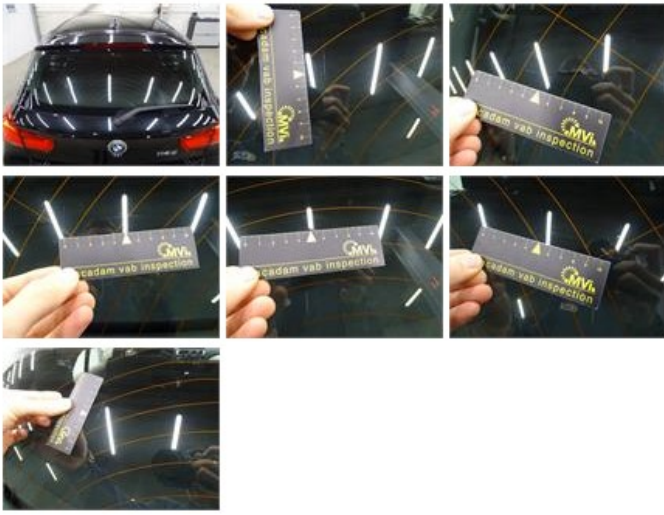
Rear window, Scratch(es), E - Replace 370,00
