**BMW 3: 1HXH647**

**Limited Technical Inspection**

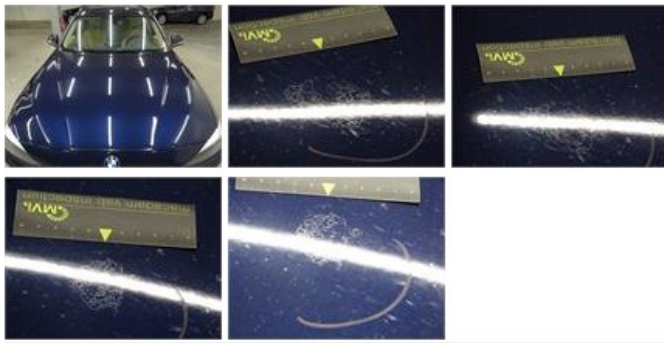
<b>Total cost ex VAT</b>	<b>3142,84</b>
<b>Wing F R, Scratch(es), Acceptable</b>	<b>0,00</b>
<i>No pictures to display</i>	
<b>Bonnet, Chemical polution, LI - Repair and paint (complete)</b>	<b>290,08</b>

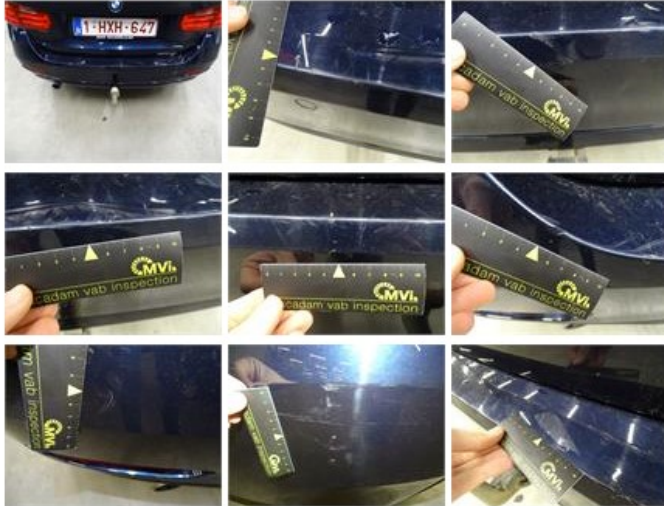
Bumper R, Scratch(es), LI - Repair and paint (complete)

211,80

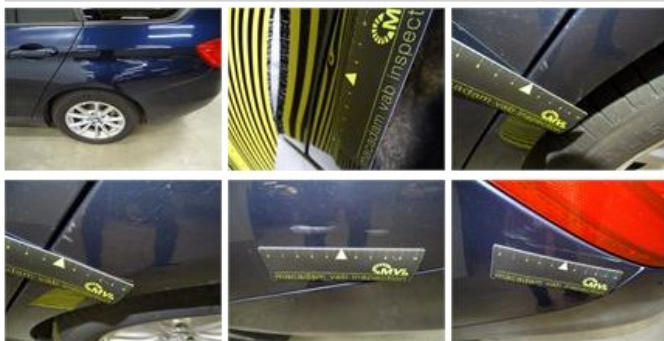
Wing R L, Dent(s) and scratch(es), LI - Repair and paint (complete)

308,20

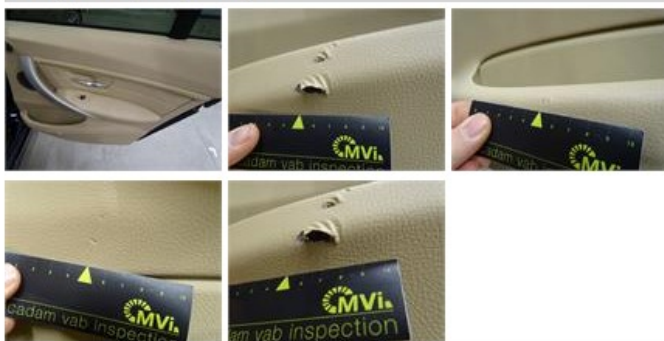
Door panel R R, Tear, E - Replace

114,00

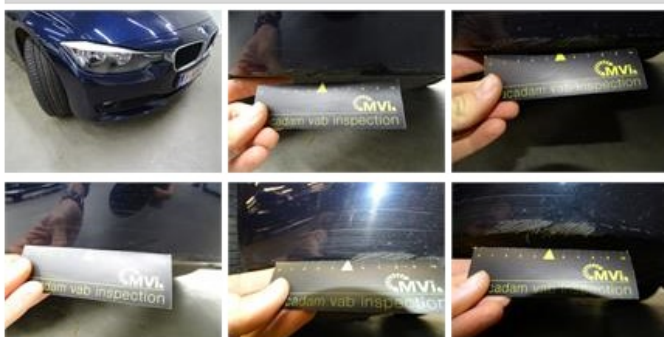
Bumper F, Scratch(es), LI - Repair and paint (complete)

211,80

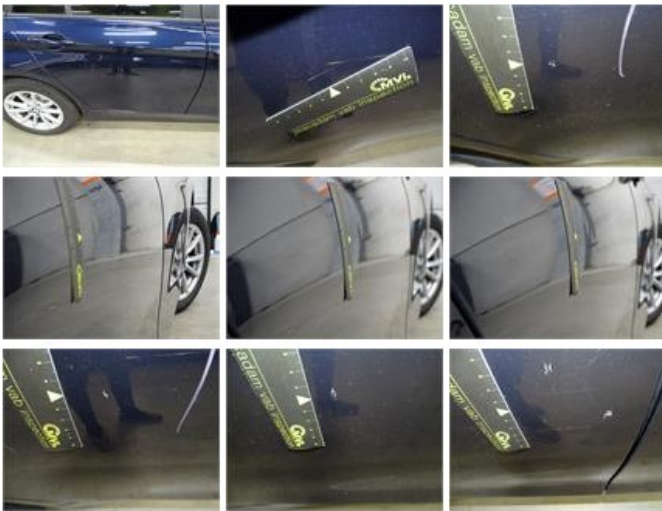
Door R R, Dent(s) and scratch(es), LI - Repair and paint (complete) 318,35

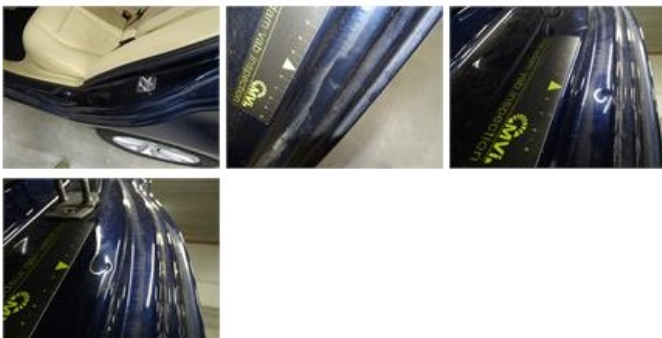
Rocker panel inner R L, Dent(s), LI - Repair and paint (complete) 115,56

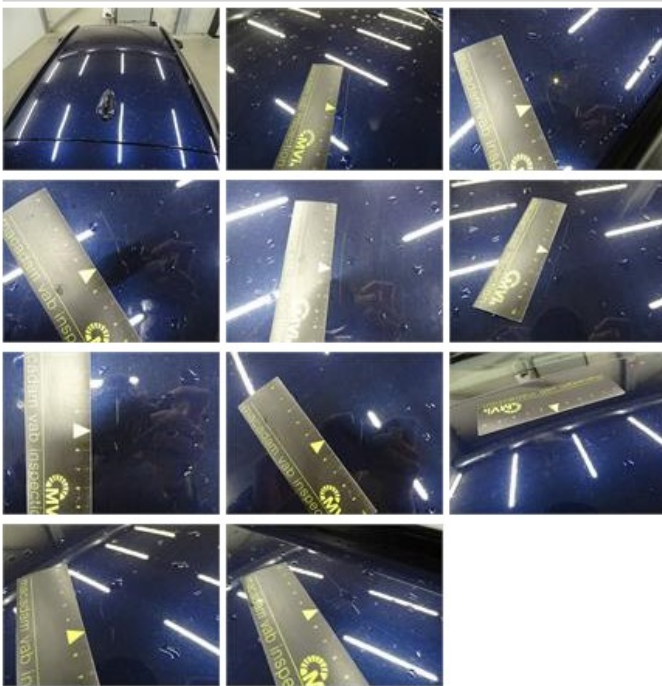
Roof, Scratch(es), LI - Repair and paint (complete) 481,50

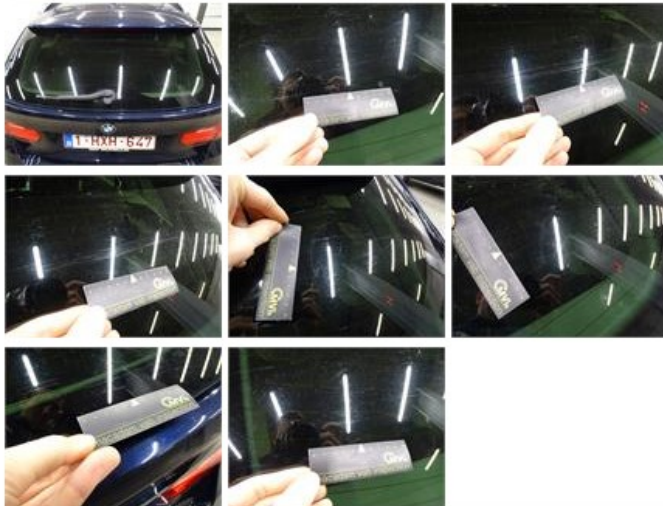
Rear window, Scratch(es), E - Replace

370,00

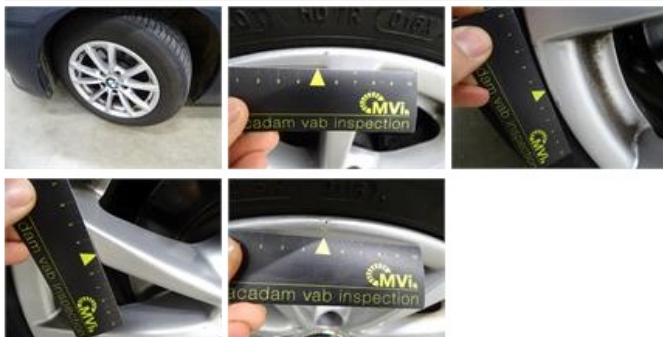
Alloy rim F L, Scratch(es), LI - Repair and paint (complete)

95,00

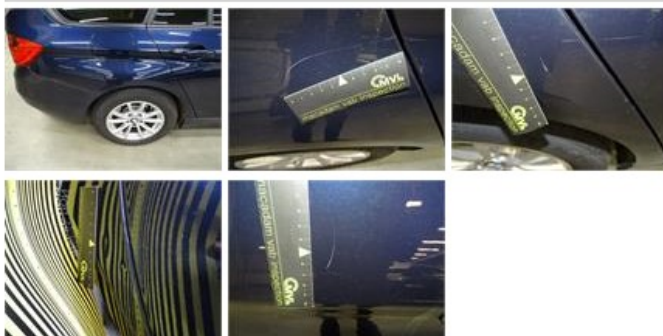
Wing R R, Dent(s) and scratch(es), LI - Repair and paint (complete)

308,20

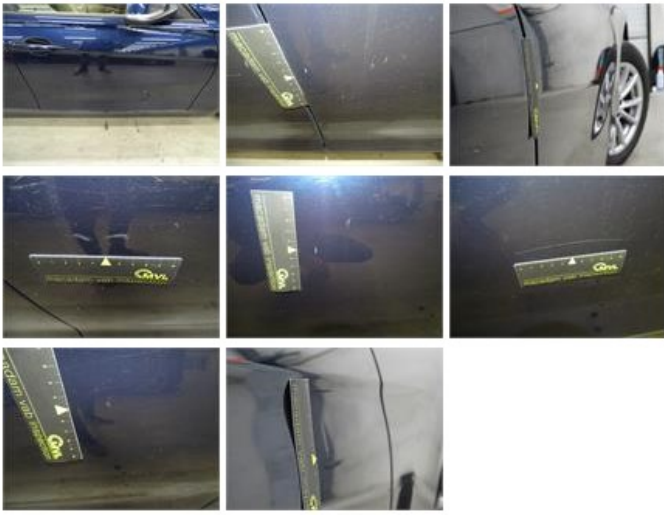
Door F R, Dent(s) and scratch(es), LI - Repair and paint (complete)

318,35
