BMW 3 TOURING: 1KDY578

Limited Technical Inspection

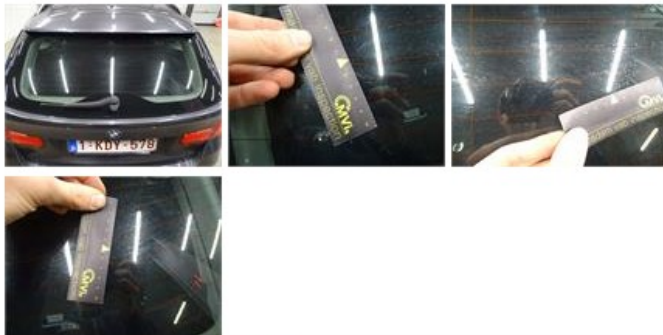
Rear window, Scratch(es), Acceptable

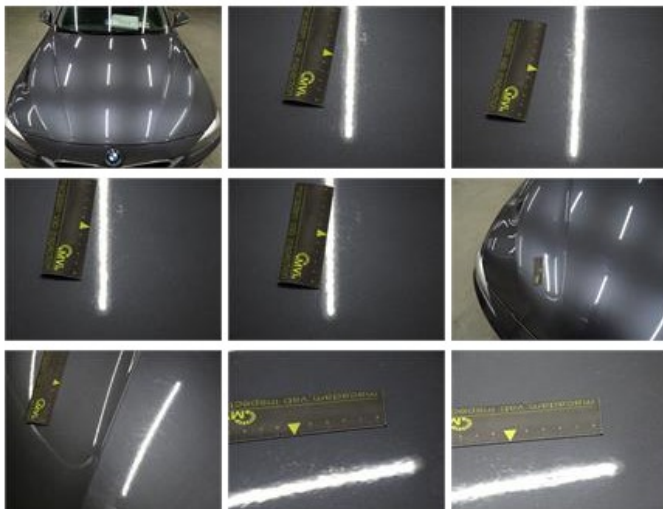
Bonnet, Chemical pollution, LI - Repair and paint (complete)
