**PEUGEOT 5008: 1LAB653**

Vinnumber:	<b>VF30EBHZTFS143084</b>	Versionname:	<b>1.6 BLUEHDI S&amp;S 88KW AUTO ALLURE</b>
First Registrationdate:	<b>30/07/2015</b>	Fiscalpower:	
Expertise Mileage:	<b>163723</b>	Power Kw:	<b>88</b>
Bodytype:		Body color:	<b>Grey</b>
Gearbox:	<b>Automatic</b>	Paint type:	<b>Metalic</b>
Transmission:	<b>Front</b>	Rims summer:	<b>Aluminium</b>
Fueltype:	<b>Diesel</b>	Oil level:	<b>OK</b>
Battery functioning:	<b>Yes</b>	Parking lot:	<b>3504</b>
Number of doors:	<b>5</b>		
Number of seats:	<b>7</b>		
Number head rests:	<b>7</b>		
Rims summer:	<b>Aluminium</b>		
Category:	<b>Passenger Car</b>		
Oil level:	<b>OK</b>		
Registration Certificate Car (BE):	<b>Yes</b>

**Limited Technical Inspection**

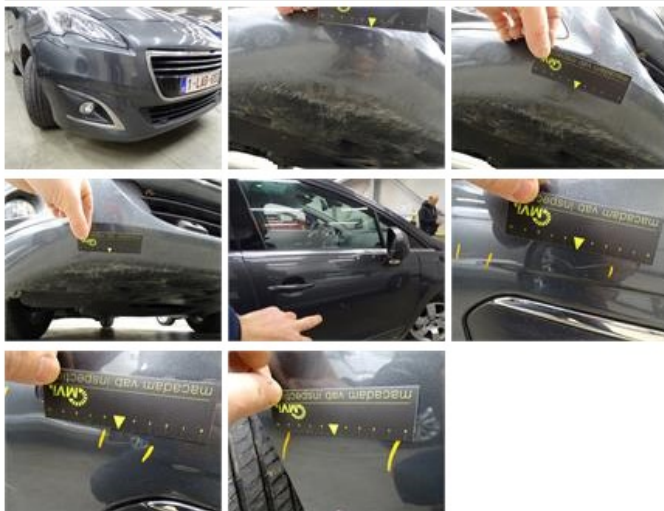
Bumper F, Scratch(es), LI - Repair and paint (complete) 211,80

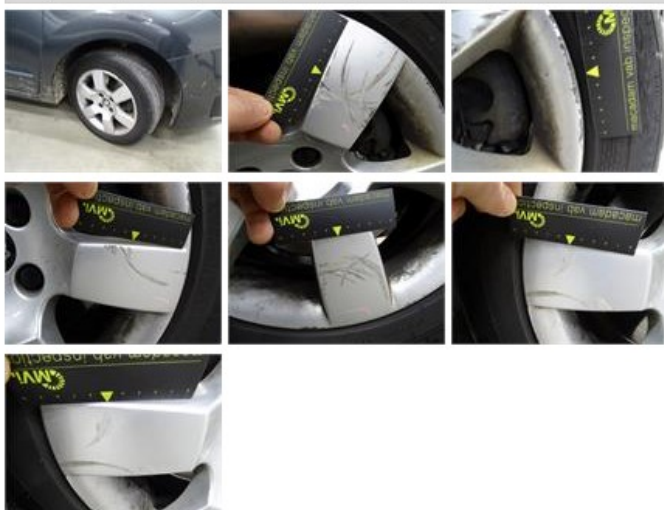
Alloy rim F R, Scratch(es), LI - Repair and paint (complete) 95,00

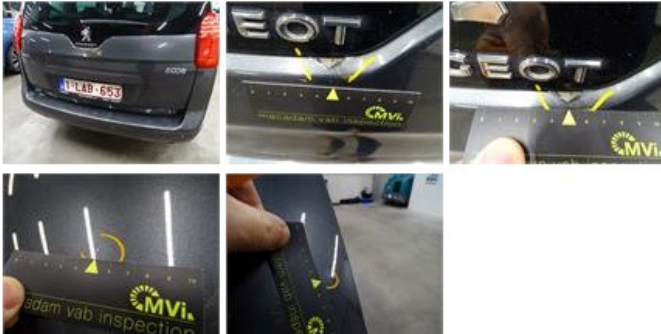
Tailgate, Bad repair, LI - Repair and paint (complete) 0,00
