RENAULT CLIO: 1LPG928

| Vinnumber: | VF15R0J0A54118296 | Versionname: | 1.5 ENERGY DCI 90E EXPRESSION |

Limited Technical Inspection

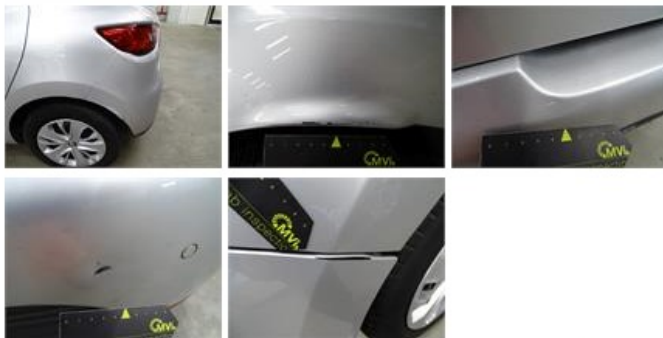
Bumper R, Crack, Le - Replace and paint

535,20
