OPEL Insignia: 1HXS453

Limited Technical Inspection

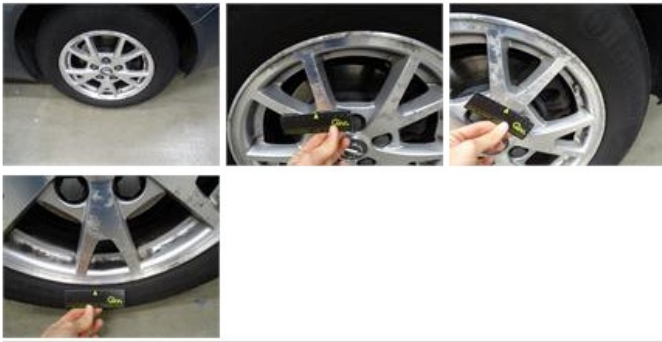
Alloy rim R L polished, Rust, Acceptable 0,00

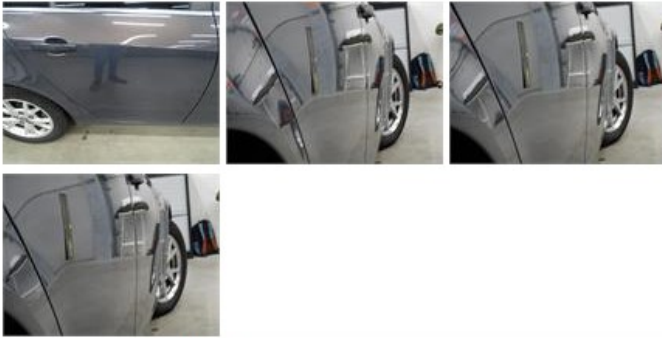
Door R R, Bad repair, Acceptable 0,00

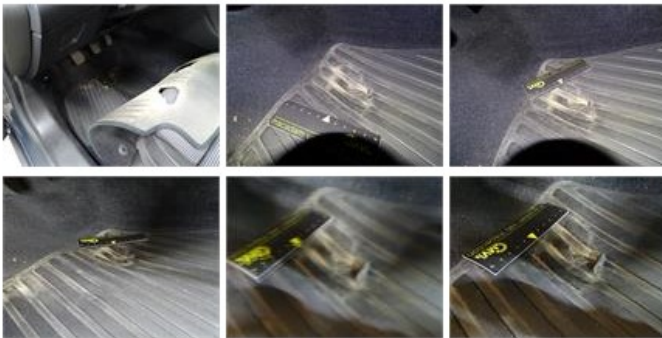
Floor covering F L, Hole, Smart repair 64,32

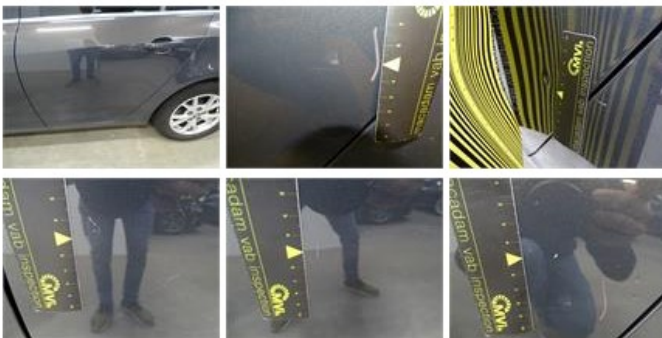
Door R L, Dent(s) and scratch(es), LI - Repair and paint (complete) 318,35

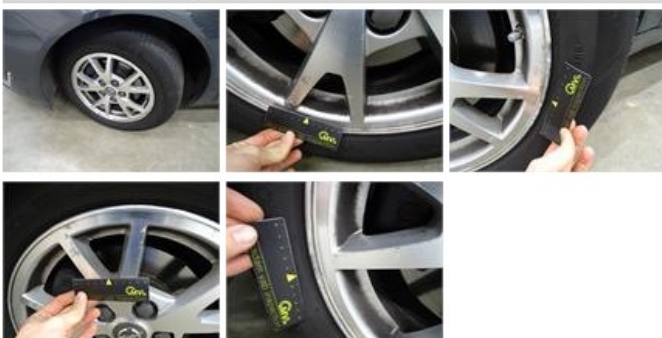
Alloy rim F L polished, Rust, Acceptable 0,00

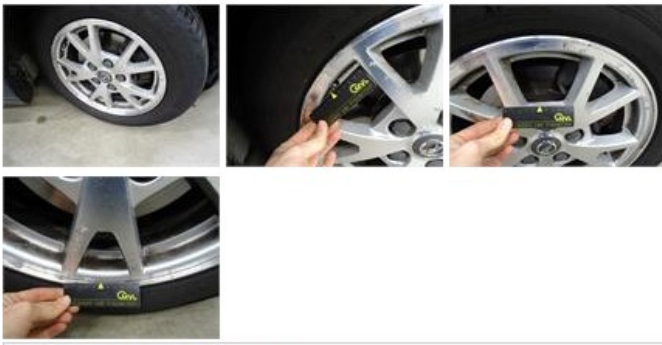
Alloy rim F R polished, Rust, Acceptable 0,00

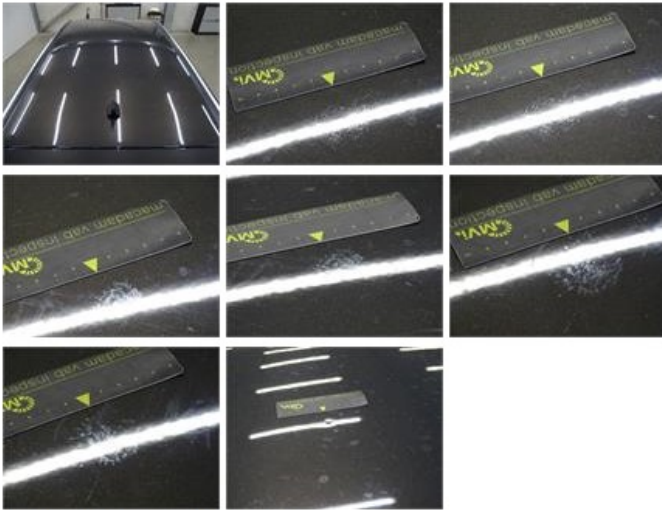
Roof, Chemical polution, LI - Repair and paint (complete) 481,50

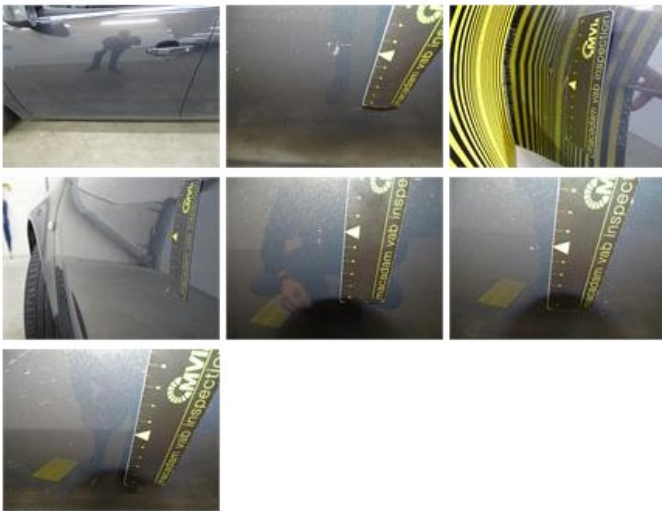
Door F L, Dent(s) and scratch(es), LI - Repair and paint (complete) 318,35
