PEUGEOT 308: 1HLL187

Limited Technical Inspection

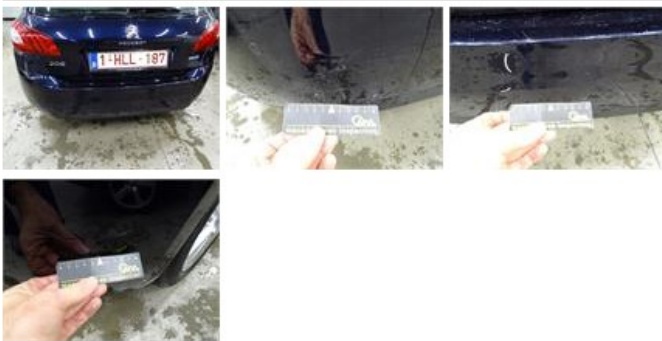
Bumper R, Scratch(es), LI - Repair and paint (complete) 211,80

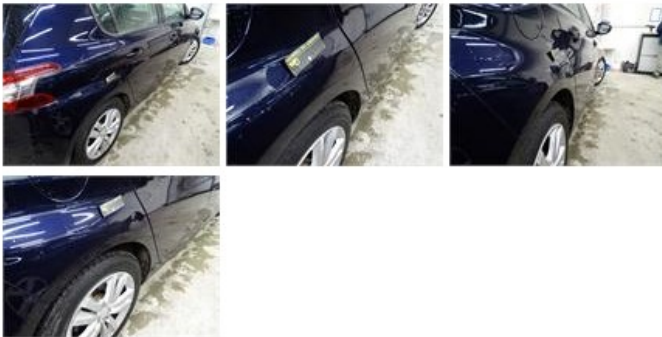
Wing R R, Dent(s), LI - Repair and paint (complete) 356,20
