OPEL ZAFIRA TOURER: 1LRZ269

| Vinnumber: | WOLPE9E36G1032574 | Versionname: | 1.6 CDTI ECOFLEX 100KW S/S COSMO |

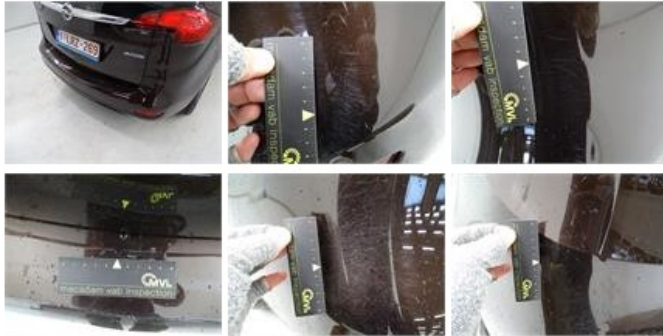
Bumper R, Scratch(es), LI - Repair and paint (complete)

211,80

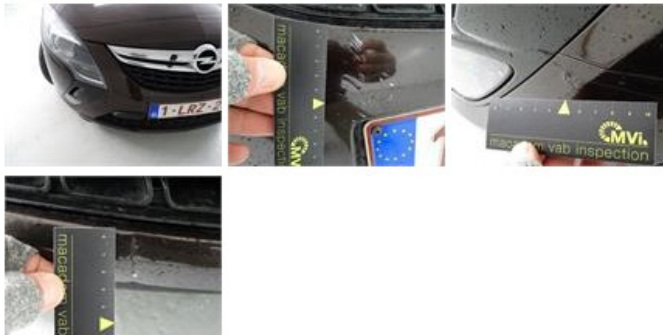
Bumper F, Dent(s) and scratch(es), LI - Repair and paint (complete)

211,80

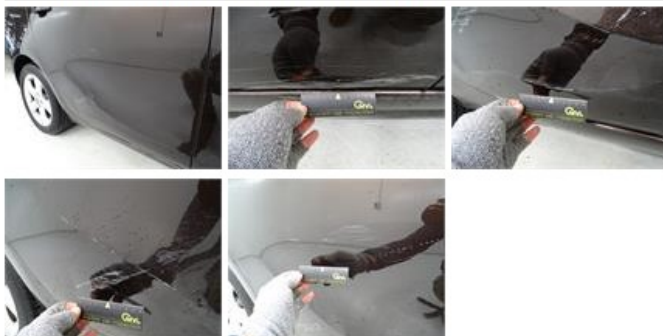
Door R R, Scratch(es), LI - Repair and paint (complete)

318,35
