**MERCEDES C BERLINE: 1KTX819**

**Limited Technical Inspection**

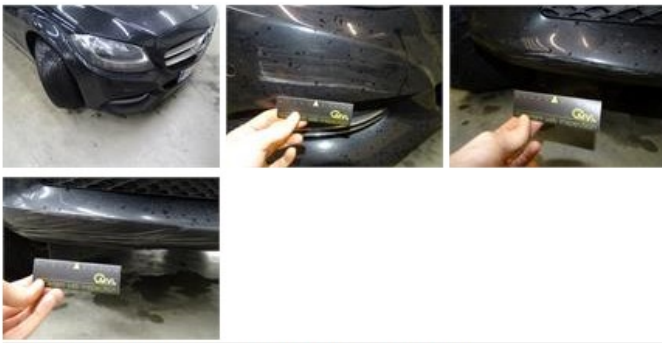
<b>Total cost ex VAT</b>	<b>2123,41</b>
<b>Bumper F, Scratch(es), LI - Repair and paint (complete)</b>	<b>211,80</b>

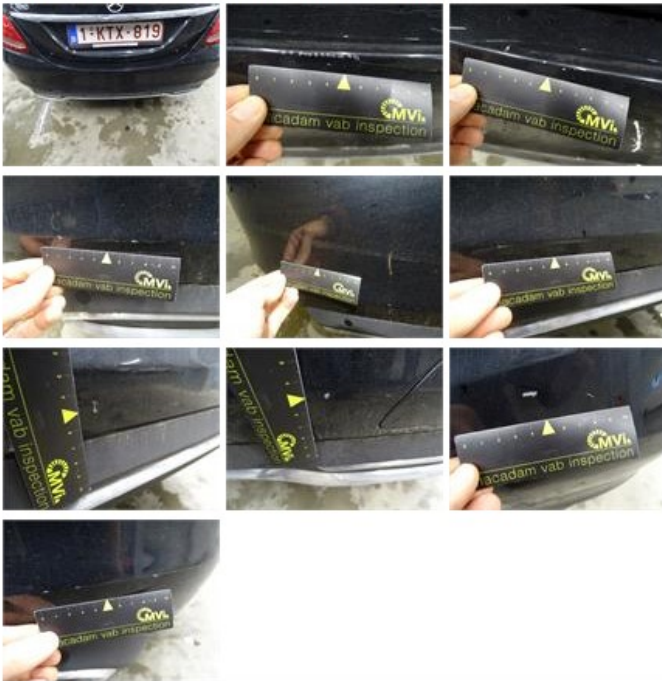
Bumper R, Scratch(es), LI - Repair and paint (complete) 211,80

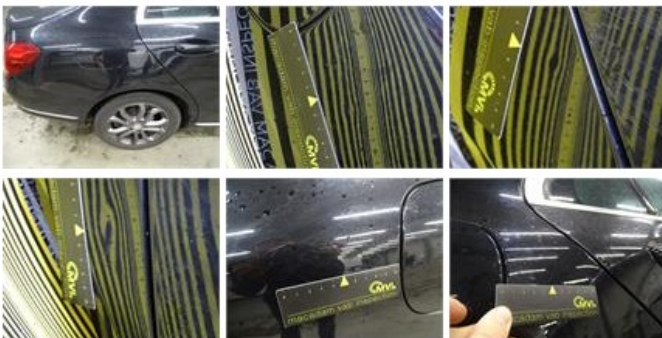
Wing R R, Dent(s) and scratch(es), LI - Repair and paint (complete) 308,20

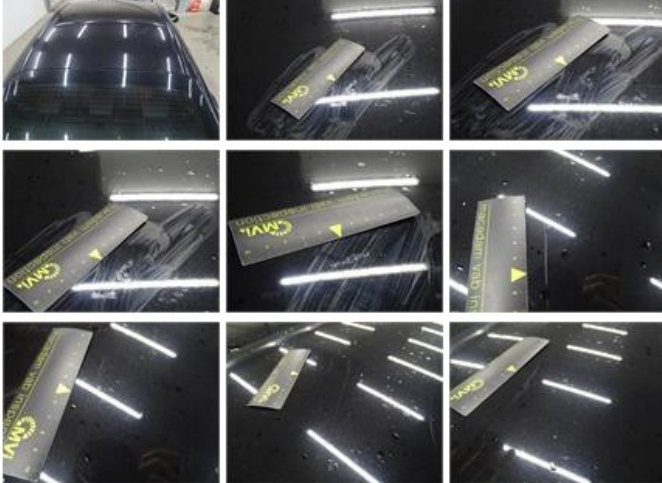
Roof, Chemical polution, LI - Repair and paint (complete) 481,50

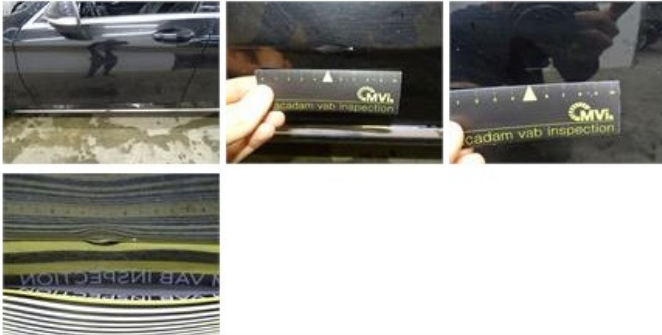
Door F L, Dent(s) and scratch(es), LI - Repair and paint (complete) 318,35

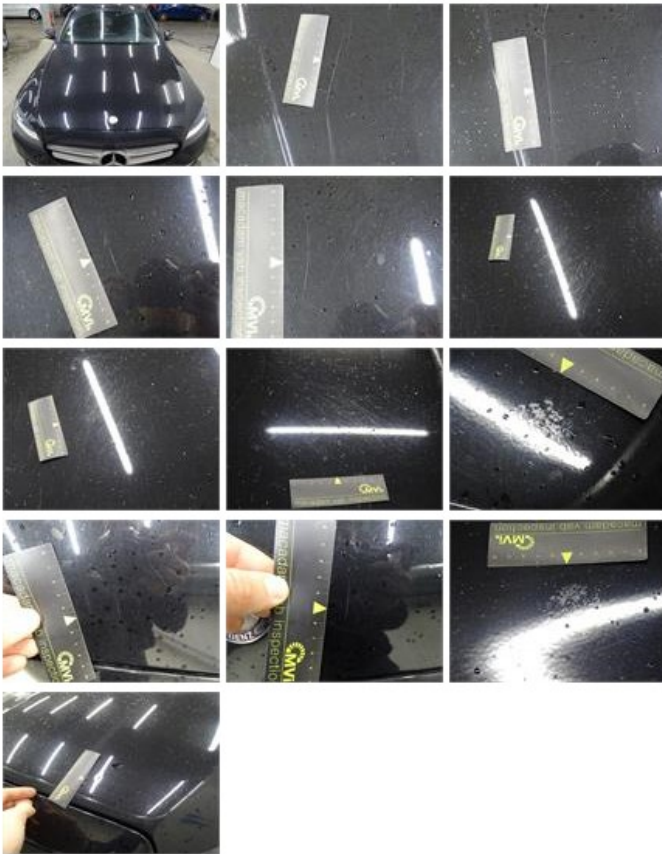
Bonnet, Scratch(es), LI - Repair and paint (complete) 290,08

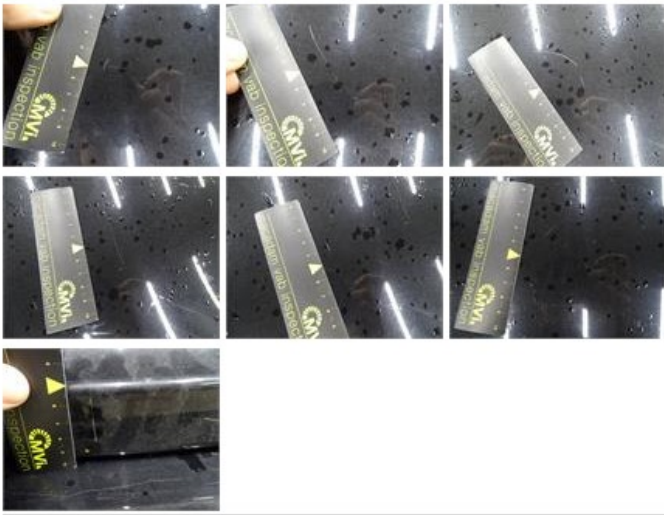
Tailgate, Scratch(es), LI - Repair and paint (complete) 301,68
