**OPEL INSIGNIA: 1KAF602**

**Limited Technical Inspection**

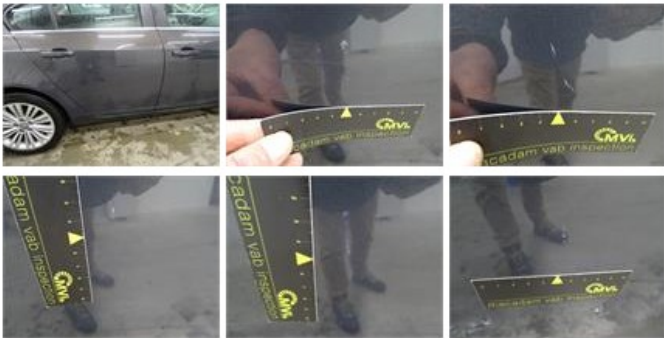
Door R R, Scratch(es), LI - Repair and paint (complete) 318,35
