VOLVO V60: 1LTG914

Limited Technical Inspection

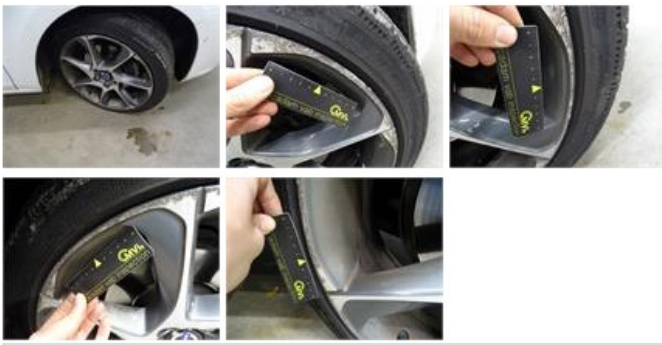
Total cost ex VAT	1412,03
Alloy rim F R polished, Scratch(es), LI - Repair and paint (complete)	95,00

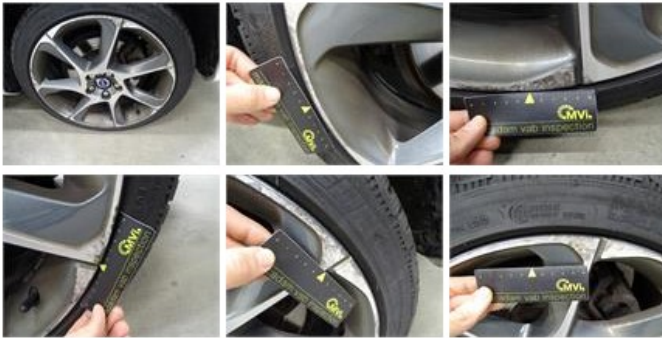
Alloy rim R L polished, Scratch(es), LI - Repair and paint (complete) 95,00

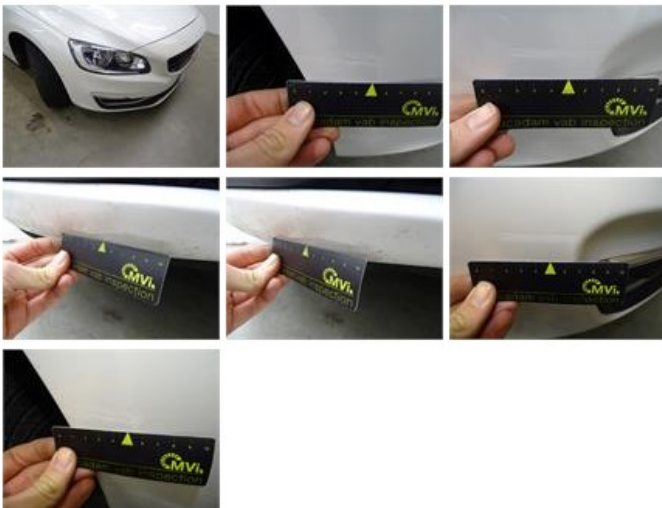
Bumper F, Scratch(es), LI - Repair and paint (complete) 211,80

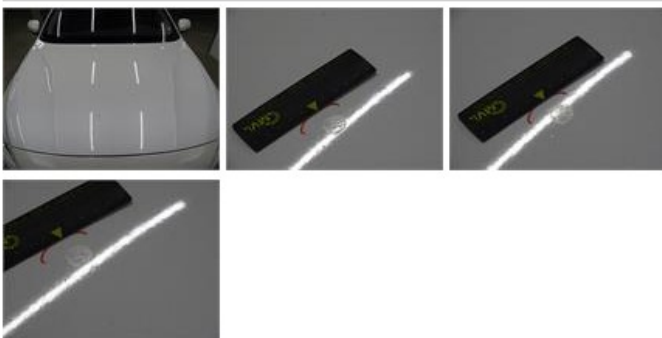
Bonnet, Chemical polution, LI - Repair and paint (complete) 290,08
