<b>BMW X5: HA9209</b>			
Vinnumber:	<b>WBAKS410700H60175</b>	Versionname:	<b>X5 3.0dA xDrive30 258PK Aut.</b>
First Registrationdate:	<b>9/02/2015</b>	Fiscalpower:	
Expertise Mileage:	<b>189058</b>	Power Kw:	<b>190</b>
Bodytype:		Body color:	<b>Dark Brown</b>
Gearbox:	<b>Automatic</b>	Paint type:	<b>Metalic</b>
Transmission:	<b>4 Weel</b>	Rims summer:	<b>Aluminium</b>
Fueltype:	<b>Diesel</b>	Oil level:	<b>OK</b>
Battery functioning:	<b>Yes</b>	Parking lot:	<b>2814</b>
Number of doors:	<b>5</b>		
Number of seats:	<b>5</b>		
Number head rests:	<b>5</b>		
Rims summer:	<b>Aluminium</b>		
Category:	<b>Passenger Car</b>		
Oil level:	<b>OK</b>

<b>Limited Technical Inspection</b>			
Airco functioning	<b>OK</b>	Battery functioning	<b>Yes</b>
Tires wear profile	<b>OK</b>	Power steering	<b>Yes</b>
Idle position	<b>OK</b>	Sound engine	<b>OK</b>
Engine startingtime	<b>OK</b>	Clutch test	<b>OK</b>
Exhaust gass	<b>OK</b>	Wiper fluid level	<b>OK</b>
Handbrake	<b>OK</b>	Transmission	<b>OK</b>
		Lighting	<b>OK</b>
		Wiperblades	<b>OK</b>

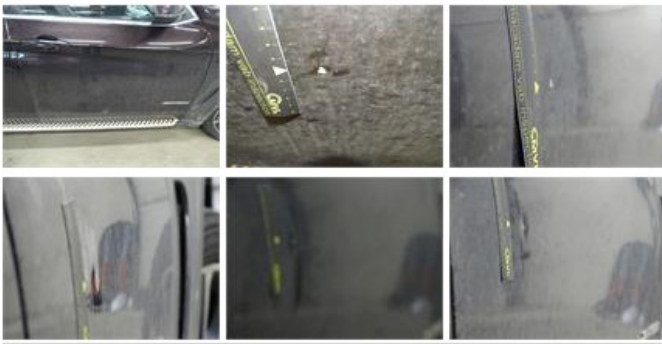
<b>Door F R, Dent(s) and scratch(es), LI - Repair and paint (complete)</b>	<b>382,02</b>
--	---------------

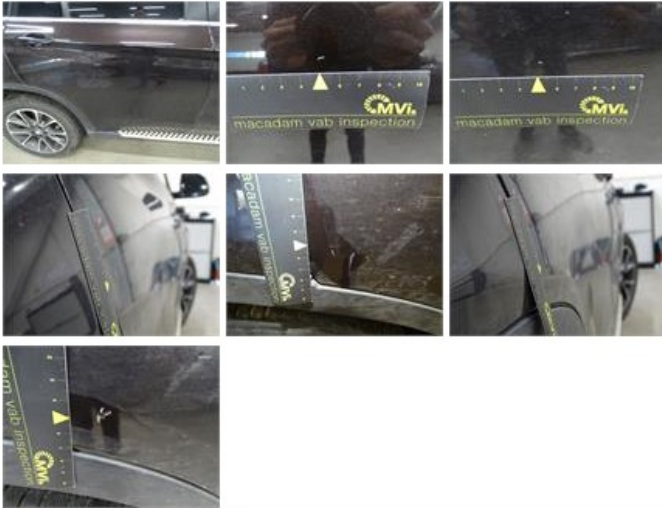
Door R R, Dent(s) and scratch(es), LI - Repair and paint (complete) 382,02

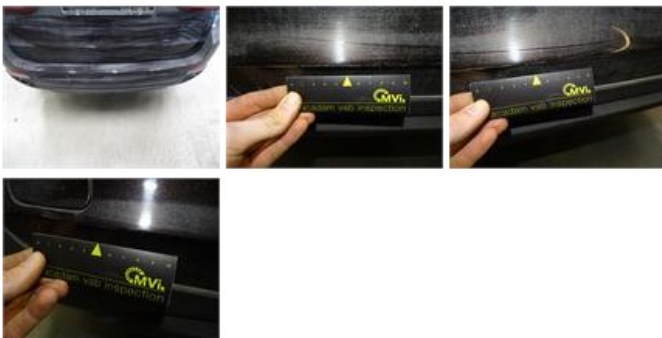
Bumper R, Scratch(es), LI - Repair and paint (complete) 254,16

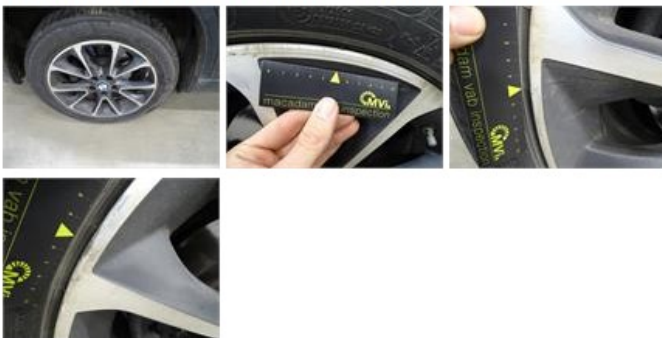
Alloy rim R R polished, Scratch(es), LI - Repair and paint (complete) 95,00

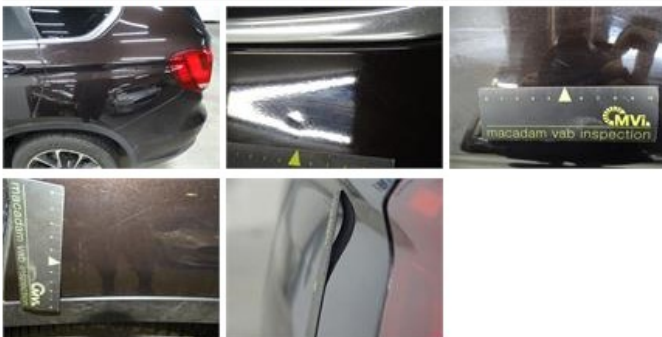
Wing R L, Dent(s), LI - Repair and paint (complete) 369,84

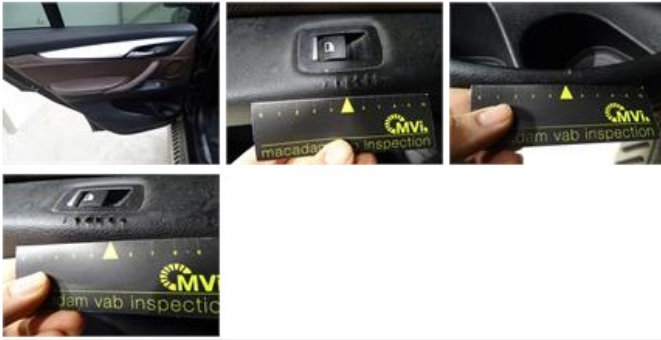
Door panel R L, Tear, Smart repair 110,64

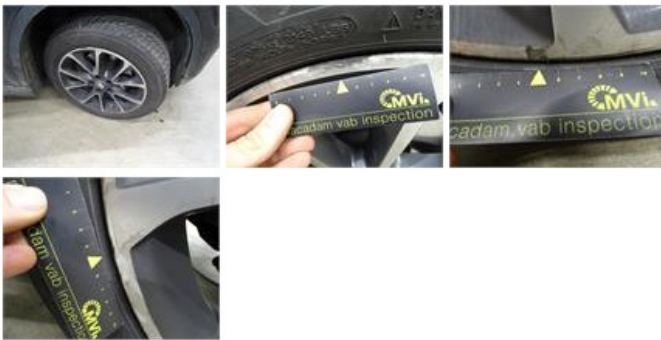
Alloy rim F R polished, Scratch(es), LI - Repair and paint (complete) 95,00

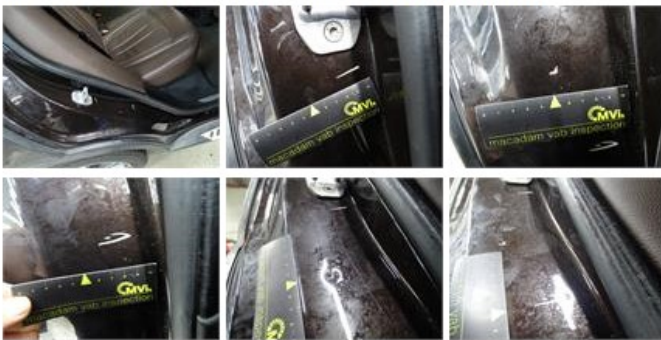
Rocker panel inner R R, Dent(s), LI - Repair and paint (complete) 115,56

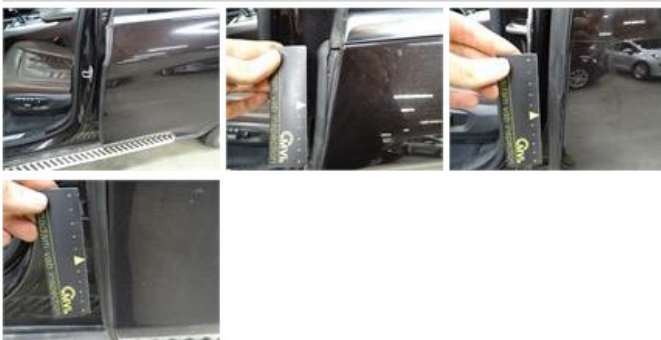
Door seal R L, Deformed / Strained, E - Replace 60,00

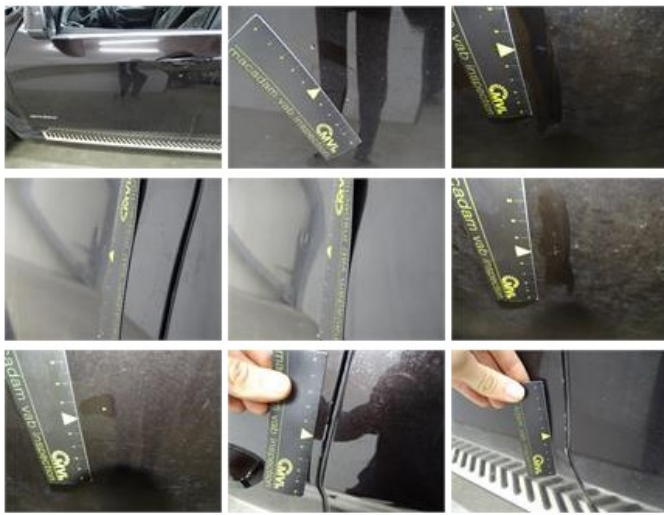
Door F L, Dent(s) and scratch(es), LI - Repair and paint (complete) 382,02

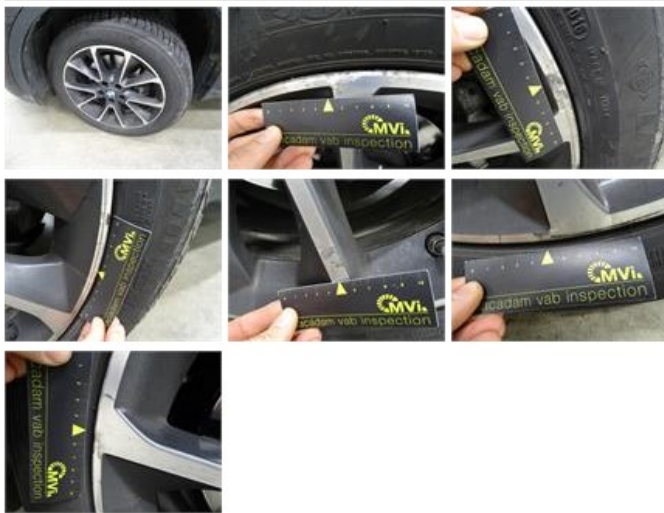
Alloy rim F L polished, Scratch(es), LI - Repair and paint (complete)

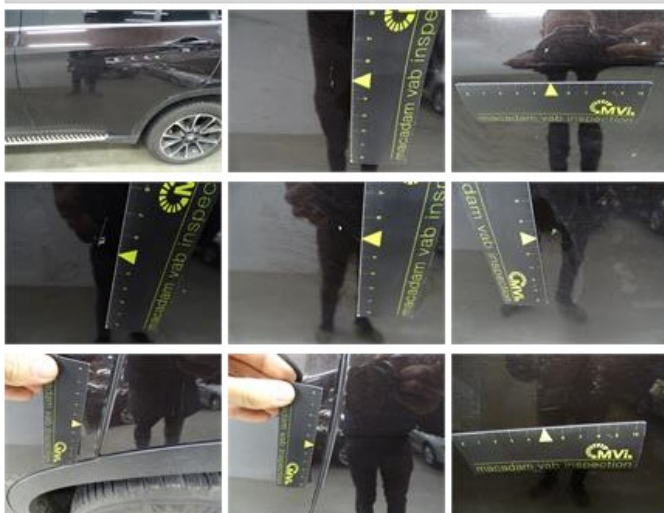
Door R L, Scratch(es), LI - Repair and paint (complete)

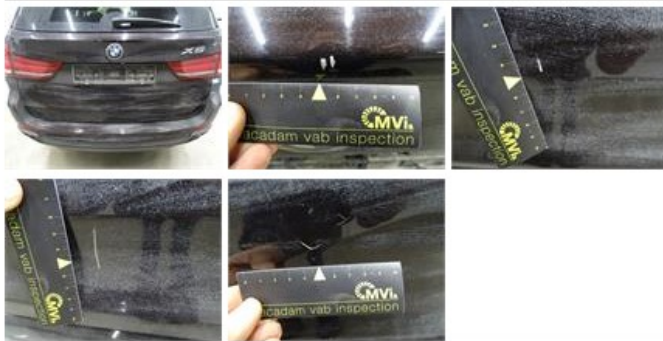
Tailgate, Scratch(es), LI - Repair and paint (complete)

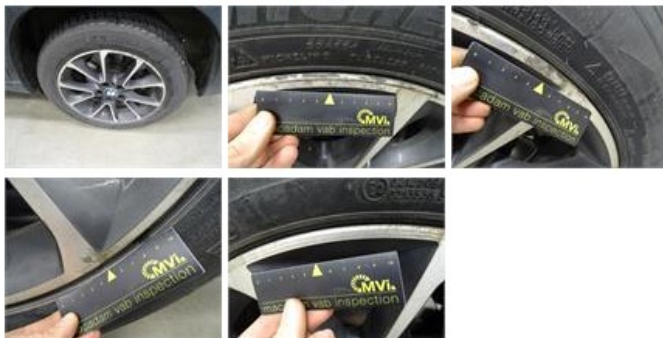
Alloy rim R L polished, Scratch(es), LI - Repair and paint (complete)
