<b>VOLVO V40: 1JEX385</b>			
Vinnumber:	<b>YV1MV8481F2213398</b>	Versionname:	<b>V40 D2 Base 115PK</b>
First Registrationdate:	<b>28/11/2014</b>	Fiscalpower:	
Expertise Mileage:	<b>67559</b>	Power Kw:	<b>84</b>
Bodytype:		Body color:	<b>Black</b>
Gearbox:	<b>MAN 6 VIT</b>	Paint type:	<b>Metalic</b>
Transmission:	<b>Front</b>	Rims summer:	<b>Aluminium</b>
Fueltype:	<b>Diesel</b>	Oil level:	<b>OK</b>
Battery functioning:	<b>Yes</b>	Parking lot:	<b>1524</b>
Number of doors:	<b>5</b>		
Number of seats:	<b>5</b>		
Number head rests:	<b>5</b>		
Rims summer:	<b>Aluminium</b>		
Category:	<b>Passenger Car</b>		
Oil level:	<b>OK</b>		
Registration Certificate Car (BE):	<b>Yes</b>

<b>Limited Technical Inspection</b>			
Airco functioning	<b>OK</b>	Battery functioning	<b>Yes</b>
Tires wear profile	<b>OK</b>	Power steering	<b>Yes</b>
Idle position	<b>OK</b>	Sound engine	<b>OK</b>
Engine startingtime	<b>OK</b>	Clutch test	<b>OK</b>
Exhaust gass	<b>OK</b>	Wiper fluid level	<b>OK</b>
Handbrake	<b>OK</b>	Transmission	<b>OK</b>
		Lighting	<b>OK</b>
		Wiperblades	<b>OK</b>

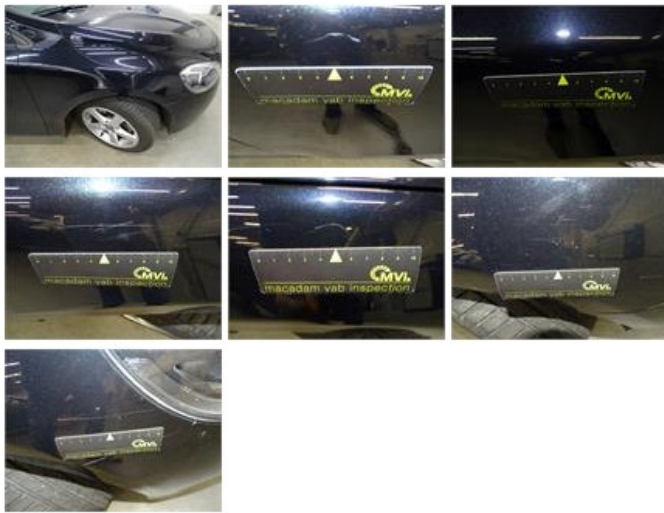
<b>Total cost ex VAT</b>	<b>2941,96</b>
<b>Wing F R, Scratch(es), LI - Repair and paint (complete)</b>	<b>220,18</b>

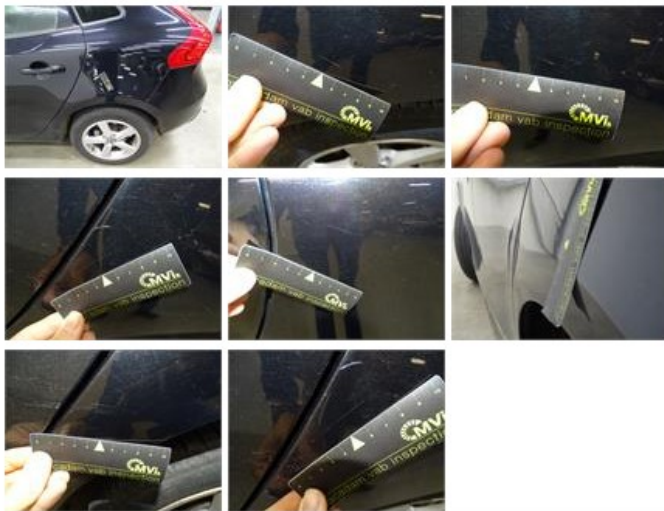
Wing R L, Dent(s) and scratch(es), LI - Repair and paint (complete) 308,20

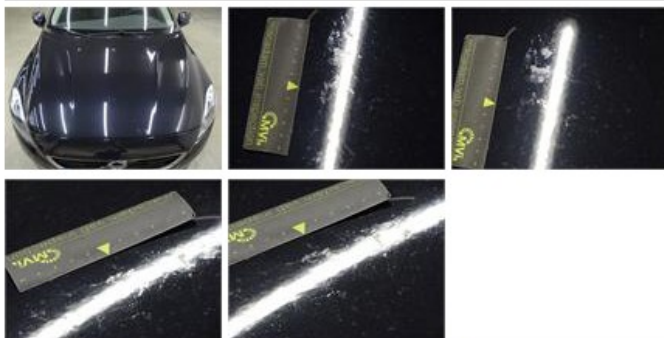
Bonnet, Chemical polution, LI - Repair and paint (complete) 290,08

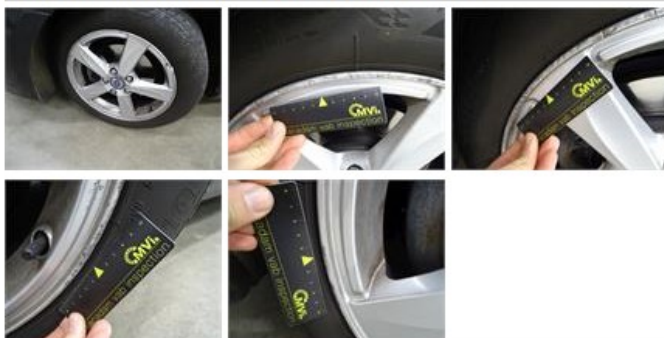
Alloy rim F L, Scratch(es), LI - Repair and paint (complete) 95,00

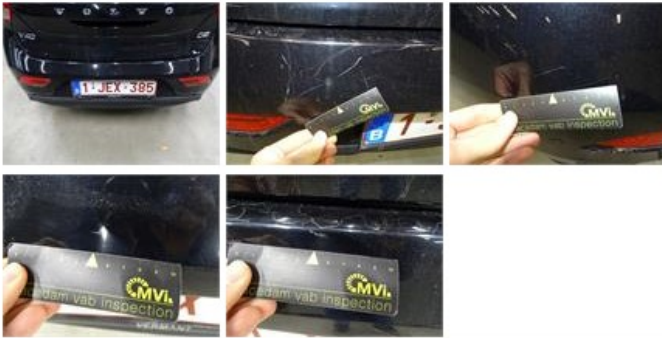
Bumper R, Scratch(es), LI - Repair and paint (complete) 211,80

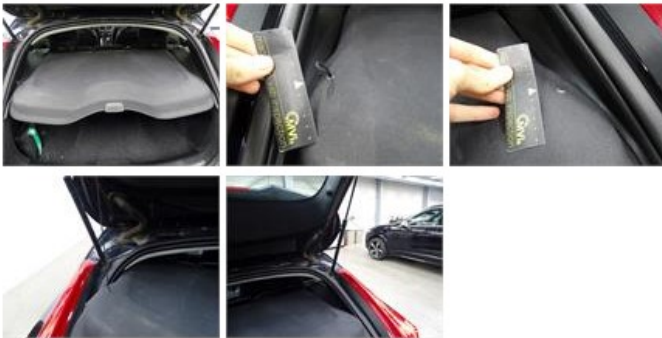
Boot cover, Broken, E - Replace 5,00

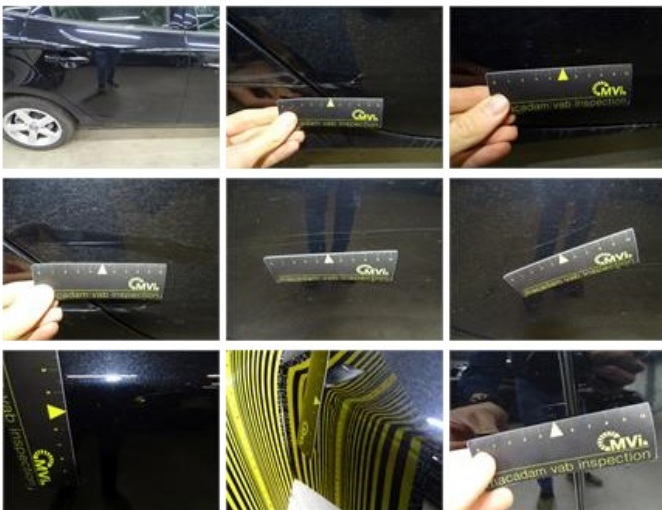
Door R R, Dent(s) and scratch(es), LI - Repair and paint (complete) 318,35

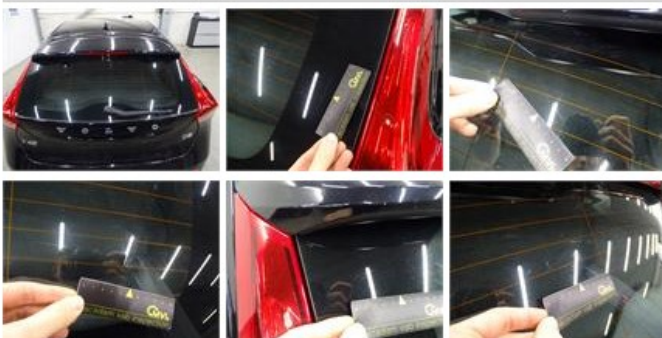
Rear window, Scratch(es), E - Replace 370,00

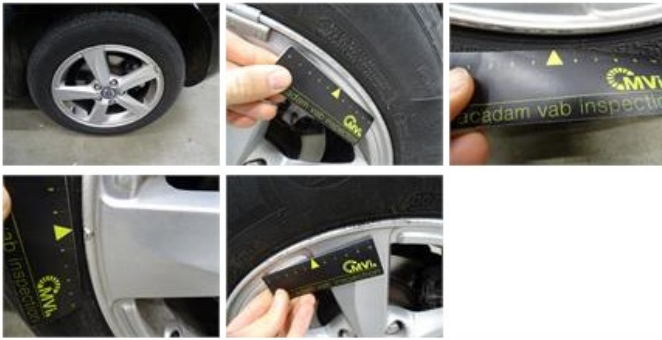
Alloy rim R L, Scratch(es), LI - Repair and paint (complete)

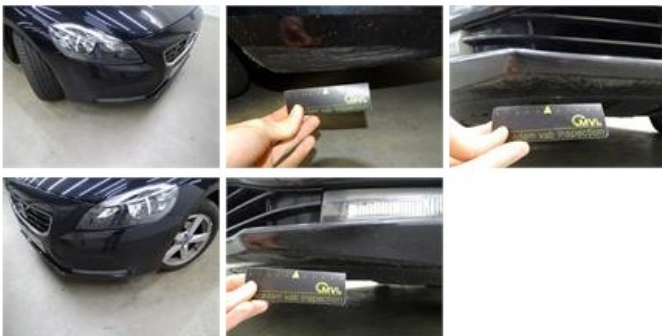
Bumper F, Scratch(es), LI - Repair and paint (complete)

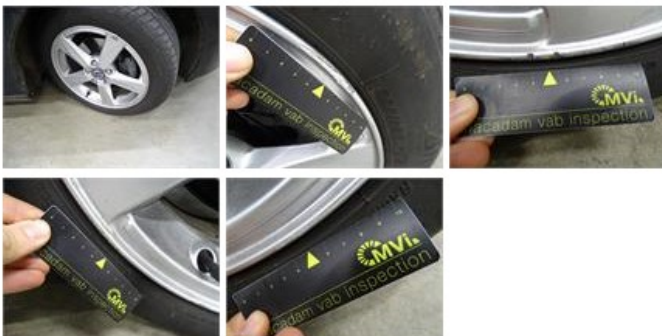
Alloy rim F R, Scratch(es), LI - Repair and paint (complete)

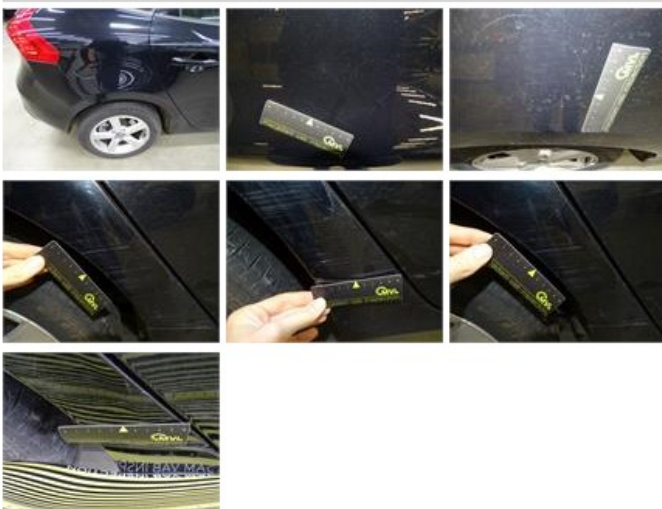
Wing R R, Dent(s) and scratch(es), LI - Repair and paint (complete)

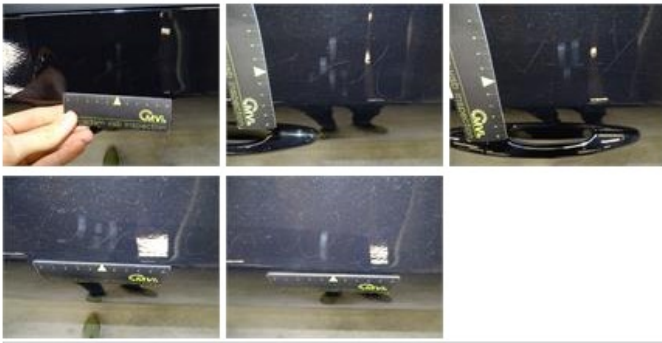
Door F R, Scratch(es), LI - Repair and paint (complete)
