SKODA Superb: 1GVL237

Limited Technical Inspection

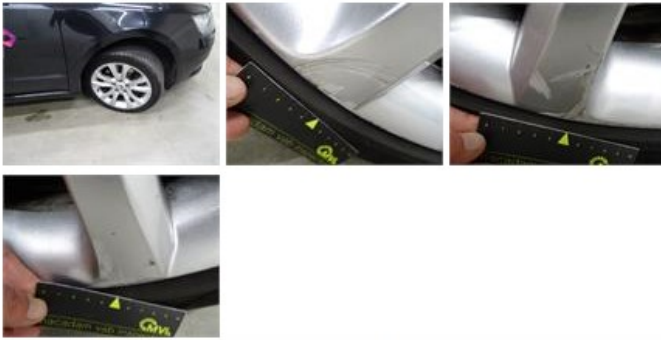
Alloy rim F L, Scratch(es), LI - Repair and paint (complete)
