VOLKSWAGEN SHARAN: 1KJK140

Limited Technical Inspection

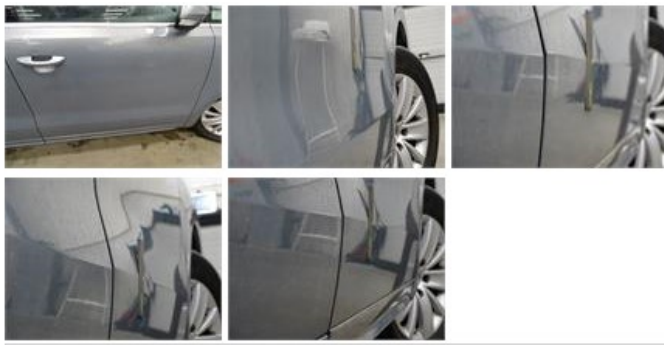
Total cost ex VAT	853,98
Wing R R, Dent(s), Acceptable	0,00
<i>No pictures to display</i>	
Door F R, Dent(s), PDR - Paintless dent repair	82,80

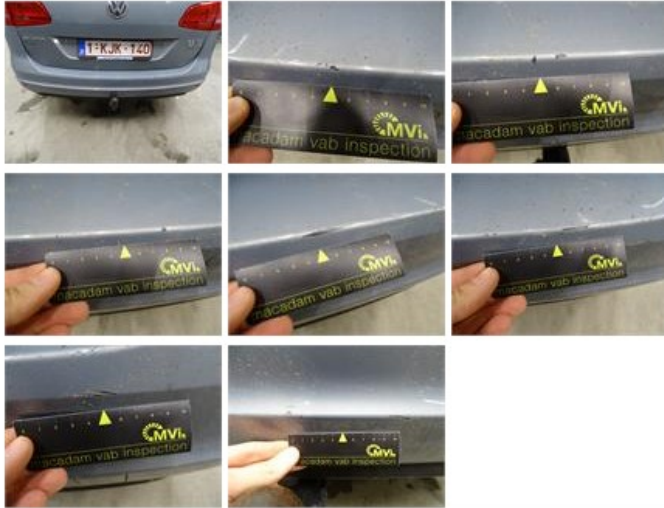
Bumper R, Scratch(es), LI - Repair and paint (complete) 254,16

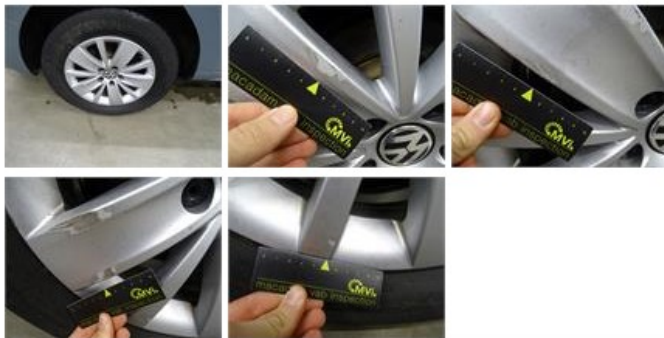
Alloy rim R R, Scratch(es), LI - Repair and paint (complete) 95,00
