PEUGEOT 5008: 1GFL616

Limited Technical Inspection

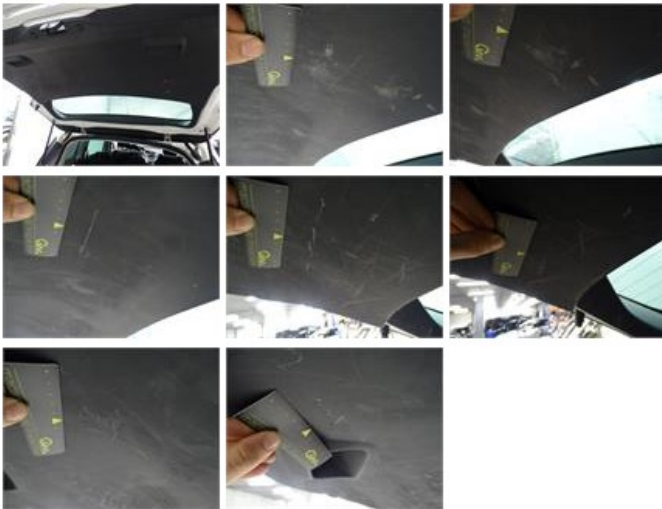
Trunk lid covering R, Scratch(es), Smart repair 110,64

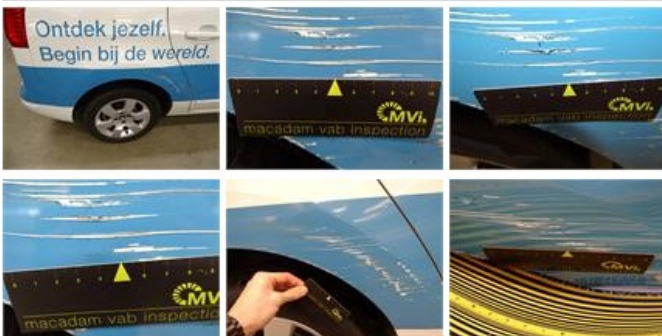
Wing R R, Dent(s) and scratch(es), LI - Repair and paint (complete) 332,20

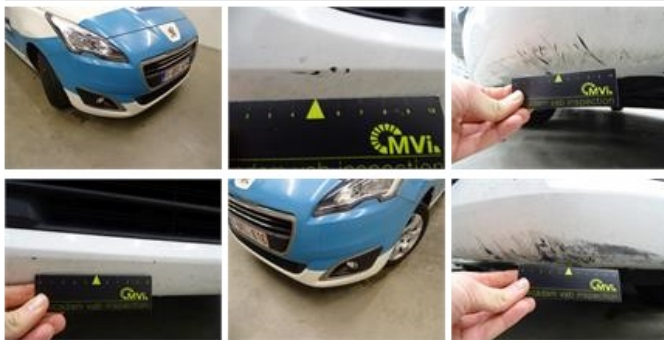
Bumper F, Scratch(es), LI - Repair and paint (complete)

211,80

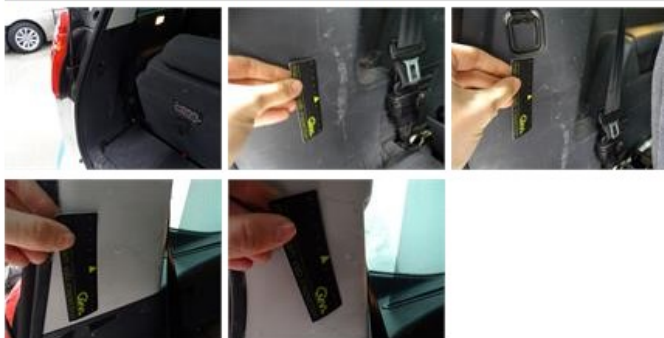
Internal Boot Lining L, Scratch(es), Smart repair

110,64

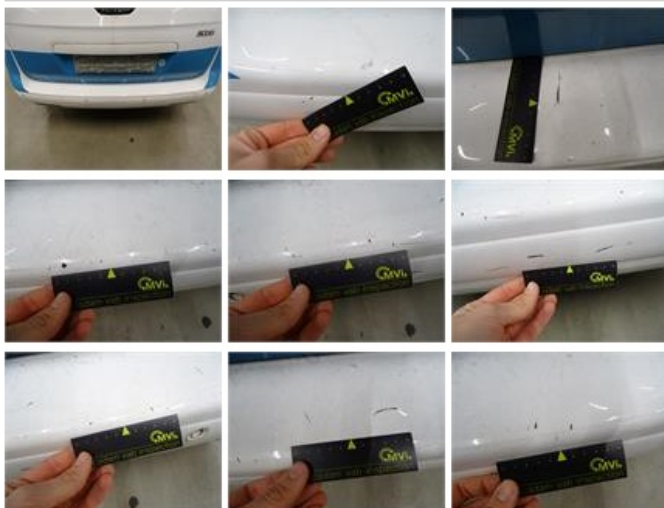
Bumper R, Scratch(es), LI - Repair and paint (complete)

211,80
