VOLVO V60: 1NKC347

Limited Technical Inspection

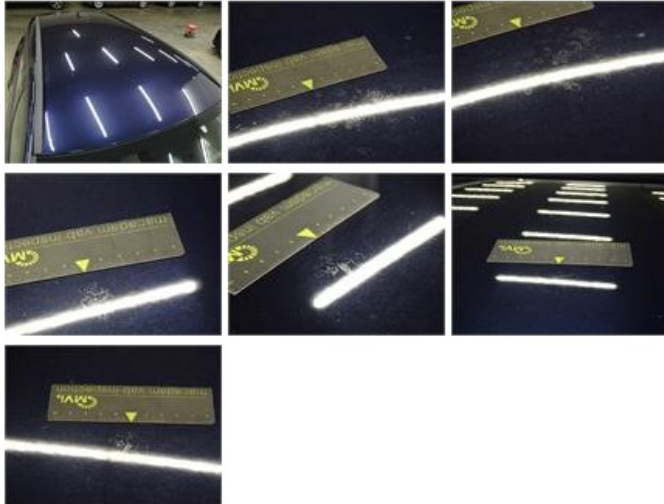
Roof, Chemical polution, LI - Repair and paint (complete)

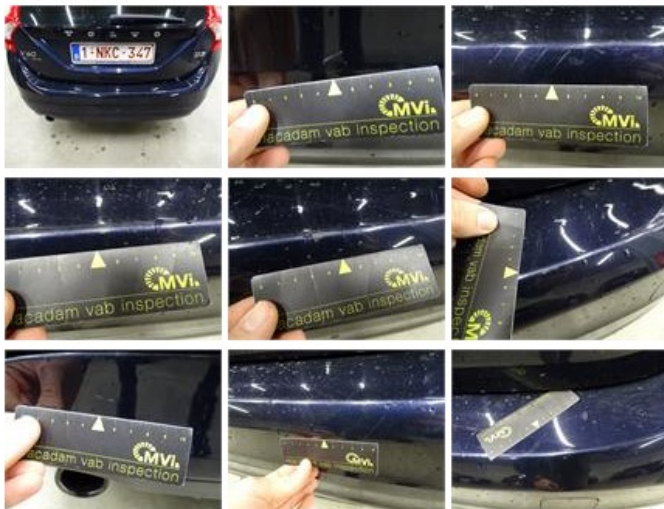
Bumper R, Scratch(es), LI - Repair and paint (complete)

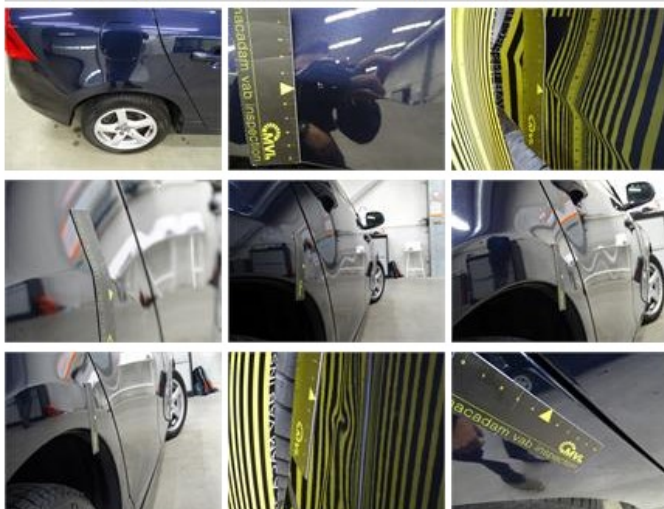
Wing R R, Dent(s) and scratch(es), LI - Repair and paint (complete)

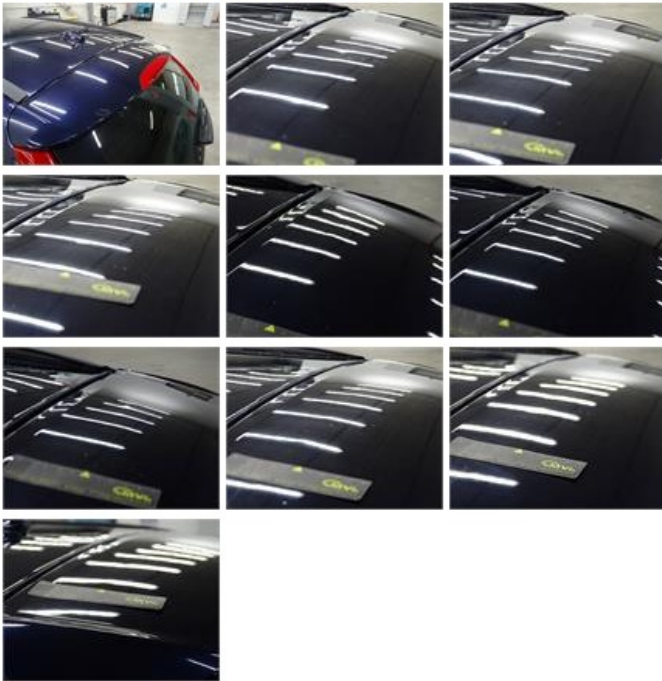
Rear spoiler, Dent(s), LI - Repair and paint (complete) 115,56

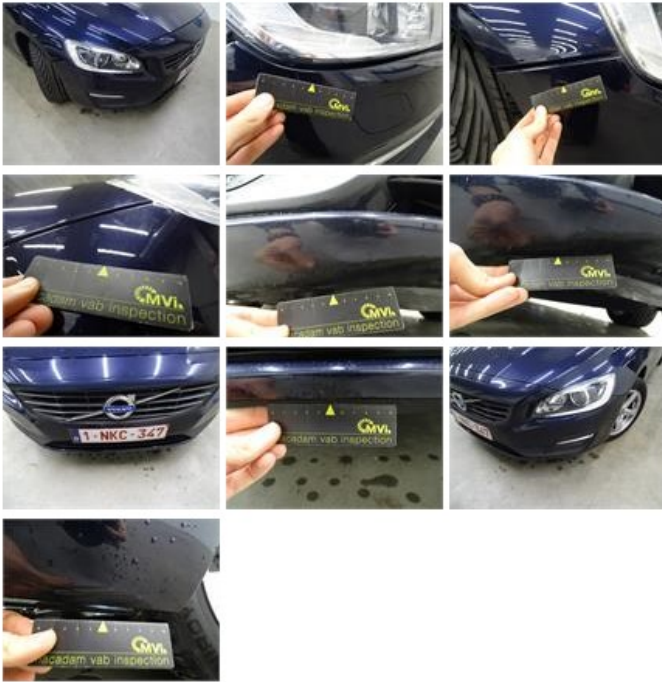
Bumper F, Scratch(es), LI - Repair and paint (complete) 211,80
