**VOLKSWAGEN Golf: 1JTH019**

**Limited Technical Inspection**

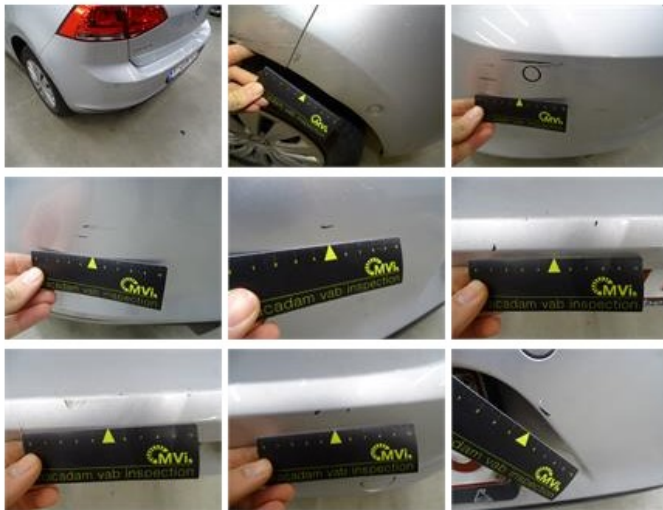
Bumper R, Dent(s) and scratch(es), LI - Repair and paint (complete) 211,80

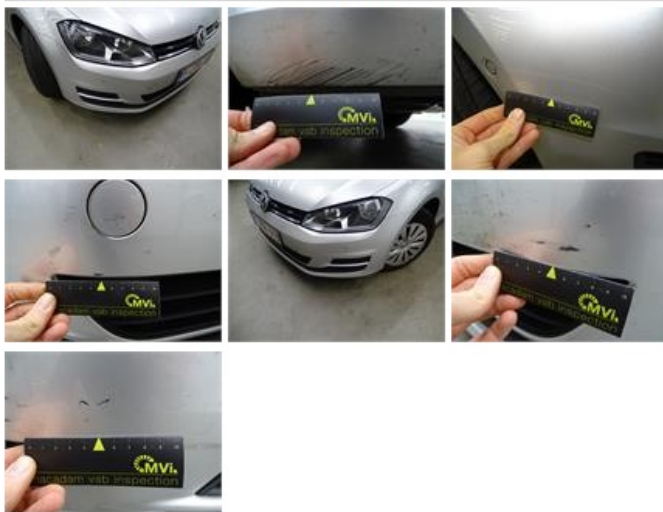
Bumper F, Scratch(es), LI - Repair and paint (complete) 211,80

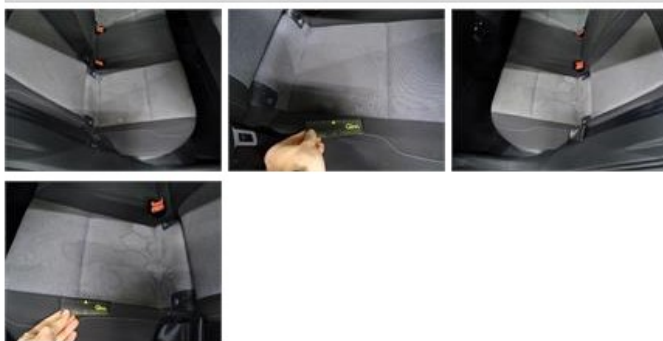
Seat cover R, Stain, Cleaning 50,00

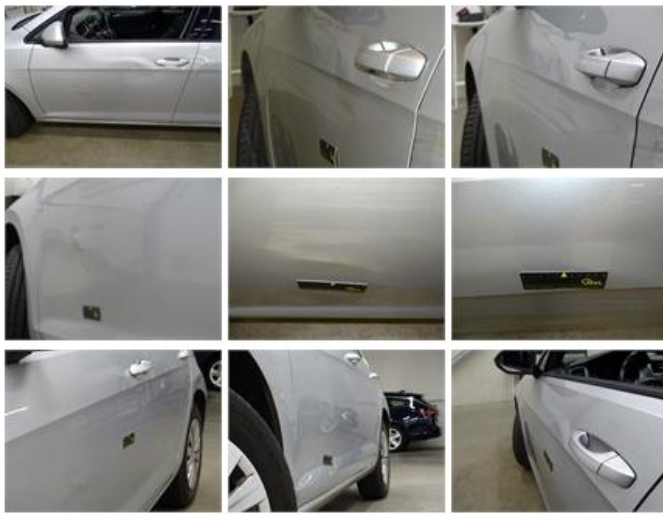
Door F L, Dent(s) and scratch(es), Le - Replace and paint 1082,52

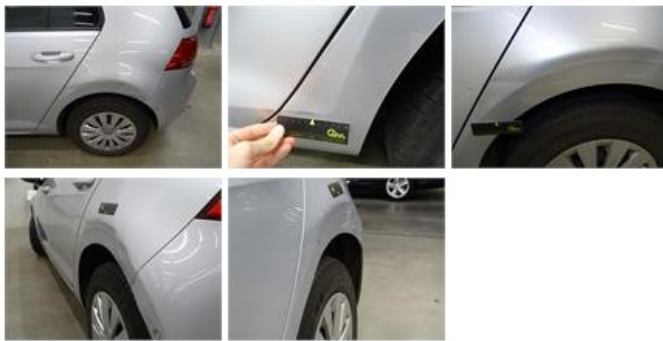
Wing R L, Dent(s) and scratch(es), LI - Repair and paint (complete)	548,20
---	--------

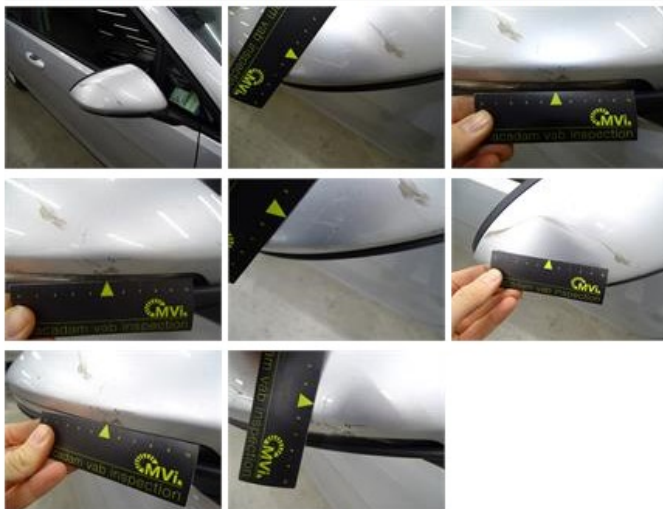
Rocker panel inner R R, Scratch(es), Acceptable	0,00
<i>No pictures to display</i>	
Rearview mirror housing R, Scratch(es), LI - Repair and paint (complete)	115,56

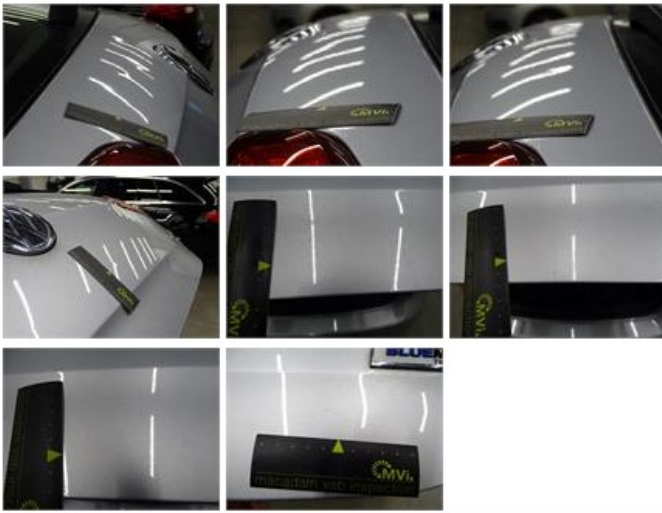
Tailgate, Dent(s) and scratch(es), LI - Repair and paint (complete)	301,68
---	--------

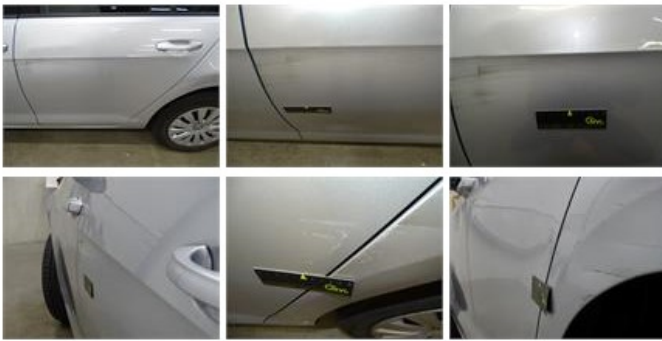
Door R L, Dent(s) and scratch(es), LI - Repair and paint (complete) 510,35
