**BMW 3: WD8478**

**Limited Technical Inspection**

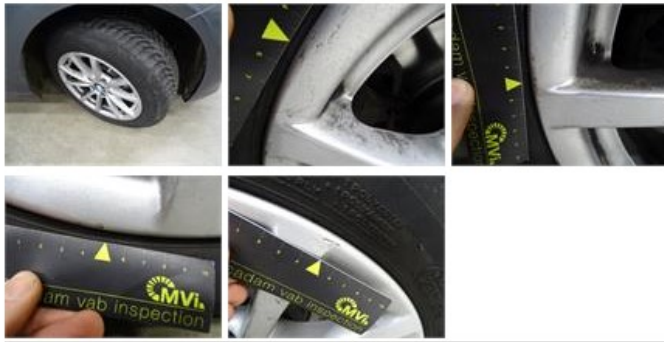
Alloy rim F R, Scratch(es), LI - Repair and paint (complete) 95,00

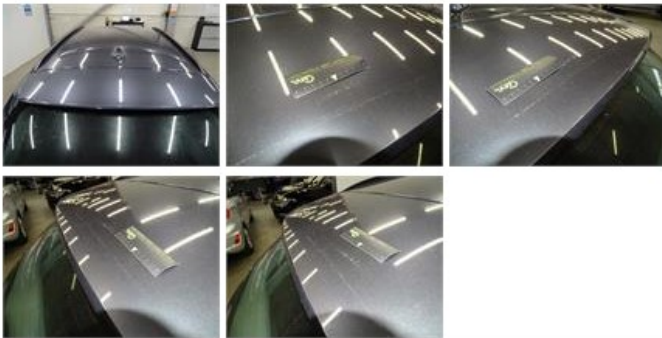
Rear spoiler, Scratch(es), LI - Repair and paint (complete)	115,56
---	--------

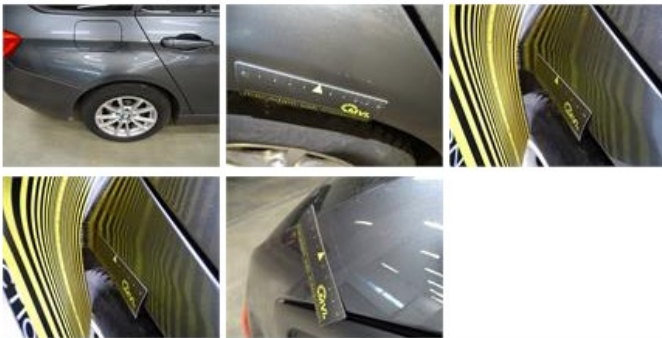
Wing R R, Dent(s) and scratch(es), LI - Repair and paint (complete)	308,20
---	--------

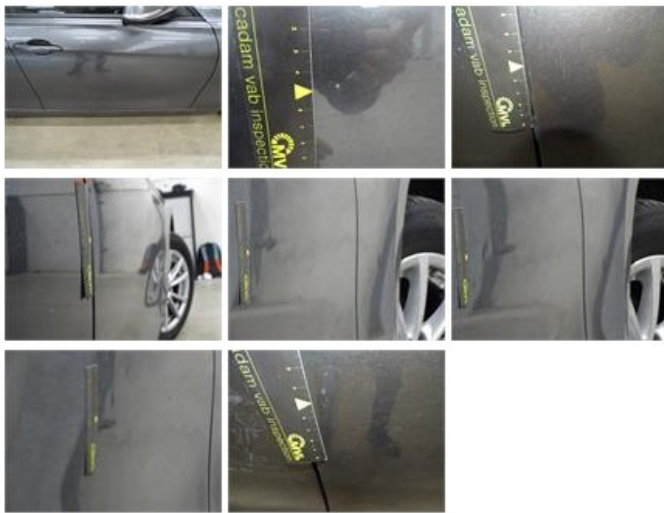
Door R L, Repaired, Acceptable	0,00
<i>No pictures to display</i>	
Door F R, Dent(s) and scratch(es), LI - Repair and paint (complete)	318,35

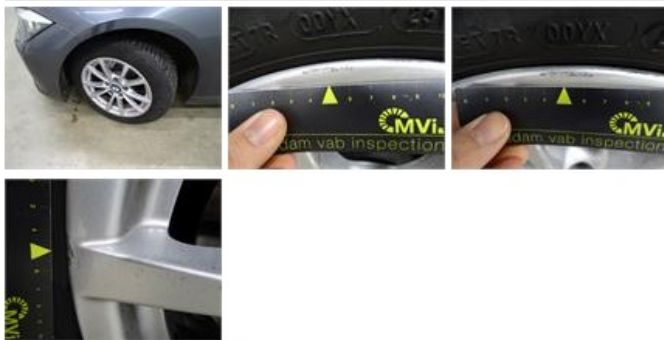
Alloy rim F L, Scratch(es), LI - Repair and paint (complete)

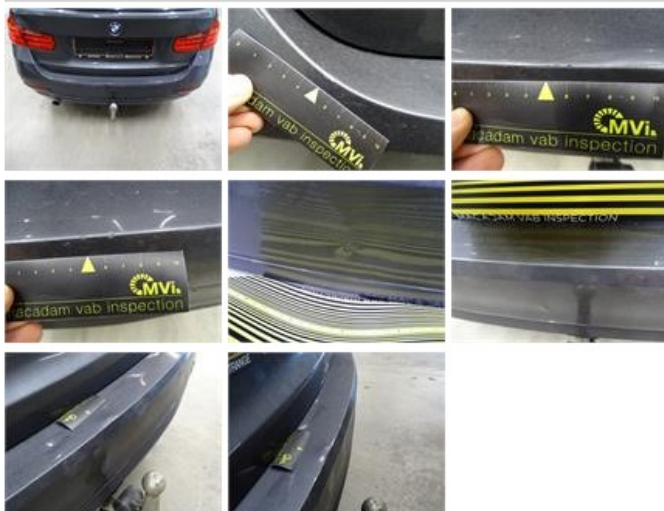
Bumper R, Dent(s) and scratch(es), LI - Repair and paint (complete)
