AUDI A5 SPORTBACK: RY6438

Limited Technical Inspection

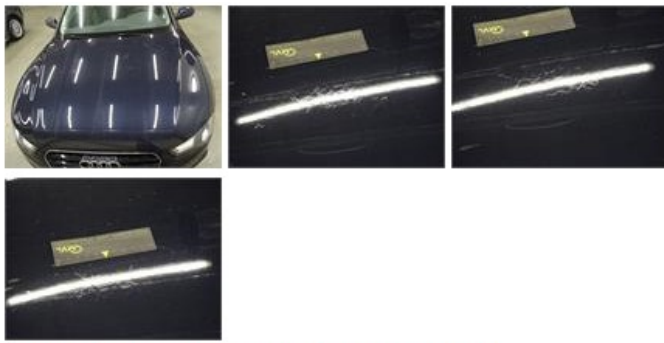
Total cost ex VAT	1056,46
Bonnet, Chemical polution, LI - Repair and paint (complete)	348,09

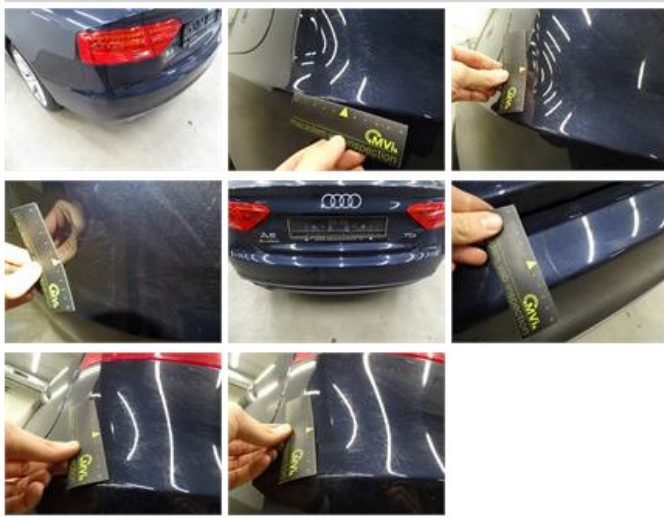
Bumper R, Scratch(es), LI - Repair and paint (complete) 254,16

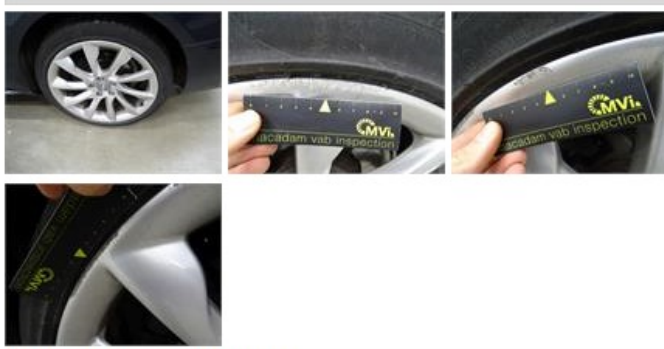
Alloy rim R L, Scratch(es), LI - Repair and paint (complete) 95,00

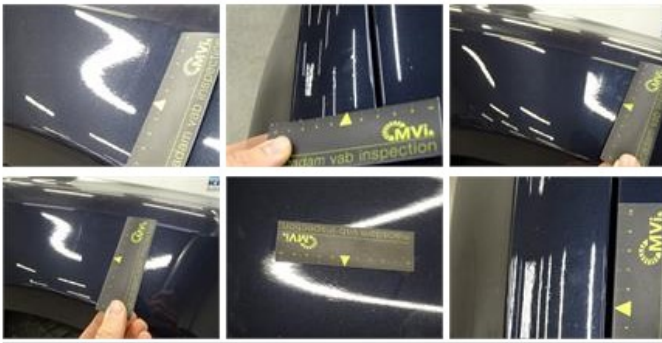
Wing F R, Chemical polution, LI - Repair and paint (complete) 264,21
